# DDASaccident487

Humanitarian Demining Accident and Incident Database  
*AID*

# DDAS Accident Report

<b>Report date:</b> 19/01/2008	<b>Accident number:</b> 487
<b>Accident time:</b> 10:45	<b>Accident Date:</b> 11/11/2005
<b>Where it occurred:</b> BF No.1196, Qala-e-Zeni Village, Nahr-e-Shahi District, Balkh Province	<b>Country:</b> Afghanistan
<b>Primary cause:</b> Field control inadequacy (?)	<b>Secondary cause:</b> Inadequate equipment (?)
<b>Class:</b> Excavation accident	<b>Date of main report:</b> 03/01/2006
<b>ID original source:</b> OPS/01/04/02	<b>Name of source:</b> UNMACA
<b>Organisation:</b> [Name removed]	
<b>Mine/device:</b> Fuze	<b>Ground condition:</b> hard
<b>Date record created:</b>	<b>Date last modified:</b> 19/01/2008
<b>No of victims:</b> 1	<b>No of documents:</b> 2

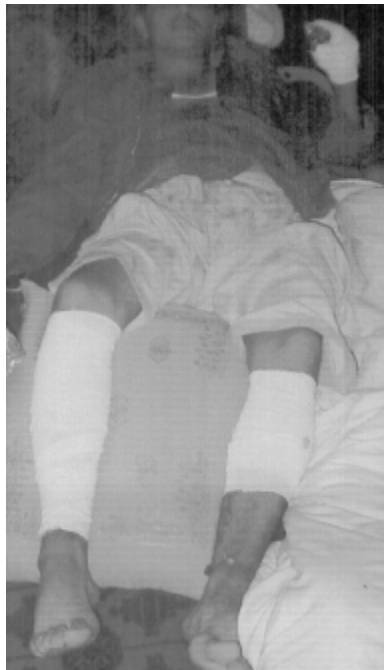
Description of Injuries: He got some injuries not serious without any amputation on his hands and legs. The detailed report of this injury will send after investigation. Over all condition of his health is not threatened he is conscious and talking.

[The bandaged Victim is shown below. Injuries indicate that he was squatting with his shins facing the detonation.]

Injuries: both legs injured. Left hand injured.

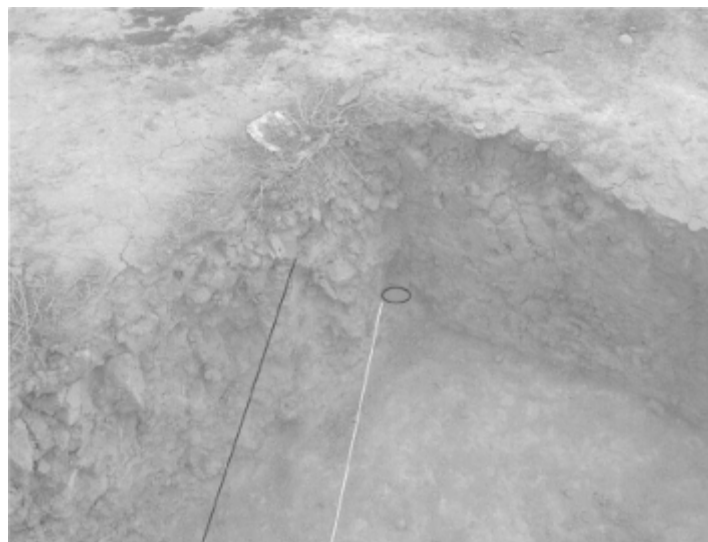
Apparently the accident has occurred in the clearance lane of the de-miner and seems that due to the hit of the fuse by trowel the 82mm mortar fuse has detonated during the excavation. There were not available any kind of piece(s) of the mentioned blasted fuse. The 12.7mm artillery was very close to fuse which was buried in the ground and can't seen. At the result the mentioned artillery front point just damaged.

The accident point did not look that blast occurred their but looked drops of blood in the mentioned point.

[The accident site is shown below: the point of detonation is circled and blood splashes indicated.]
