## DDASaccident489

# DDAS Accident Report

## **REVIEW OF BOARD OF INQUIRY**

Subject: REVIEW OF BOARD OF INQUIRY CA-87

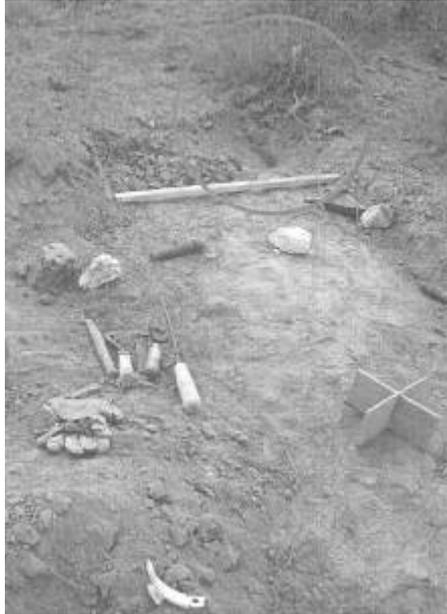
Evidence of a detonated UXO (or possibly a booby-trapped munition) was found in and surrounding the blast crater at the base of the explosion. [No evidence of this was shown. The accident site is shown below.]

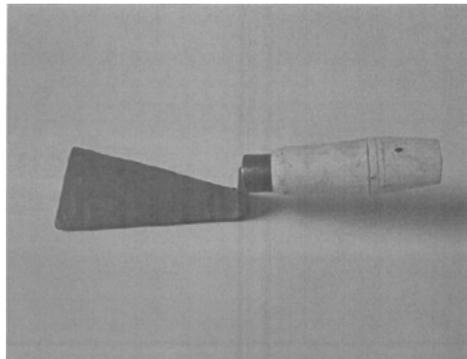
Also, that the excavation tool that the deminer was using was inappropriate and dangerous and that it should be withdrawn from issue and replaced immediately.

An alternative excavation tool will be sourced and trialled in the central region to assess whether its design would be more suitable for excavation than the current 'chipping' trowel. [Shown below.]

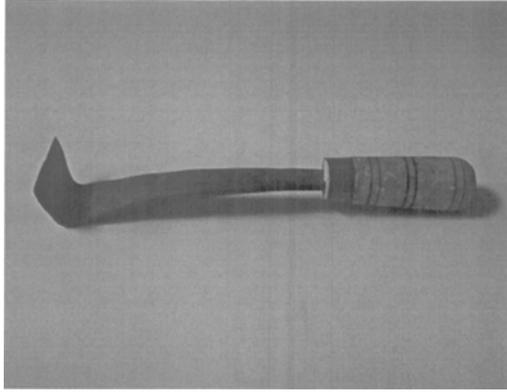
The tool to be trialled in the Central Region is shown below.

Both causes are ultimately “Management control inadequacies” because the demining group’s managers only recognised them after the event. Their proposed replacement hand-tool has all the inappropriate design features of the tool it will replace, and represents a significant failure to learn from experience.

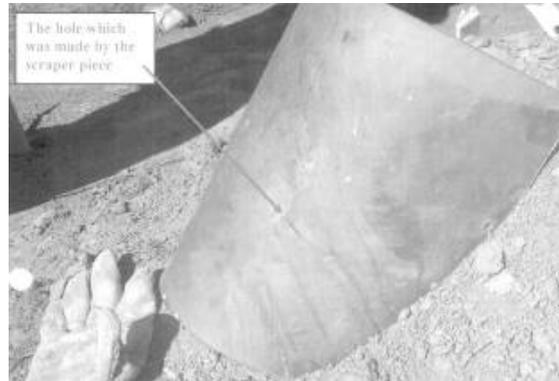
“Visor – Deminer accidentally detonated mine while excavating. Excavation tool was propelled directly at visor, causing a crack and penetrating visor. The blade of the tool and/or the crack of visor impacted the deminer’s head causing a deep wound to the forehead that proved fatal.”

The visor is shown below, pictures reproduced from the International Demining NGO's internal report.

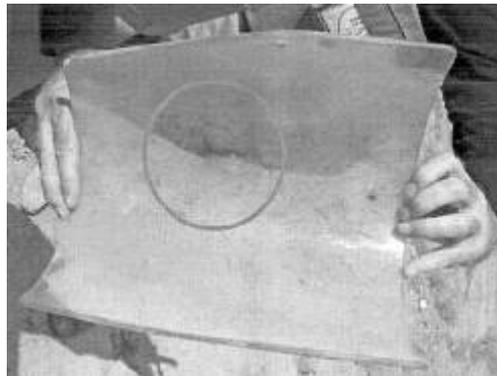
Deminer's visor — reverse ("crack" from tool circled below)

The damage is below the middle of the visor. The forehead of anyone wearing the visor correctly would have been at least 5cm higher. The Visor head-frame was shattered in the event. The brittle plastic head-frame of this design of visor frequently breaks in a blast event but rarely shatters. Its destruction may imply that it was being worn with the visor raised so the visor's position at the time of the accident cannot be known with certainty.

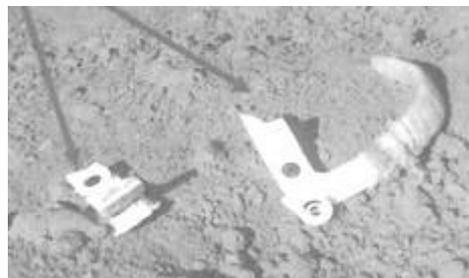
The visor had "cracked" away from a 3cm (approx.) penetration. Polycarbonate in good condition does not crack readily. A sharp object had penetrated the visor. Given the shape and the tool believed to have been in use, it was probably a part of the tool's blade. The tool is not designed using ductile blast resistant materials, so may have shattered, but it is mild steel and the entire blade may have struck the visor in one distorted piece. The crack propagating from the hole may imply that the whole piece could not pass through, and so the

blade was intact. The blade (or part thereof) would have been hot, and the visor was penetrated by a combination of speed and heat. It may have fallen out afterwards or passed right through. If a fragment passed right through, it could have gone on into the Victim's head. Because no x-rays of the head were taken, it is not possible to know whether a fragment was lodged inside.

A forehead wound caused by a fragment that passed through that hole implies that the visor was either raised, or not present when the projectile struck. Injuries suffered were the complete loss of one eye, a forehead injury that resulted in "brain tissue herniation", and a broken nose that bled profusely. This combination of injury is unlikely to have been made by a single fragment (approximately 3cm long) entering lower in the visor. Perhaps the visor was not in place in front of the Victim's face. It may have been in a raised position.
