# DDASaccident490

# DDAS Accident Report

Subject: Investigation Reports & Lessons Learned from the Demining Accident Happened on [International demining NGO] Loader at Goor-Dara village, Khwaia-Ghar district of Takhar province on 19 April 2007

DEMINING ACCIDENT HAPPENED AT [International demining NGO] LOADER AT GOOR-DARA ROAD, HAMWARSAI DISTRICT OF KHWAJA-GHAR DISTRICT ON 19th APRIL 2007

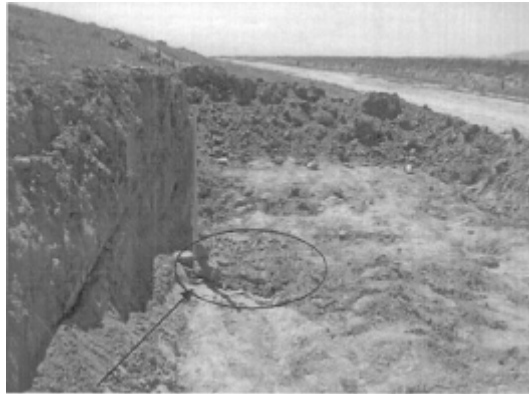
[The accident site is shown below.]

The mentioned incident has happened when the MDU-09 was levelling the loose/ excavated soil after the clearance process. The loader was excavating the ground by its bucket then by its gill system the soil was inspecting for AT mines and large UXO. During the inspection process an AP mine type YM-I was passed through the grids of bucket, and missed to be inspected. While the loader was levelling and dragging the loosed soil in reverse position its front left side tire stepped on the mine and was exploded. It haven't caused any serious damages to the machine only the robber portion of tire got some damages, fortunately didn't cause casualty as well. As soon as the accident had happened the team's operation was ceased, and the movement of the machine was stopped to avoid further accidents/ incidents and to conduct the investigation. The report was relayed to [International demining NGO] Operation section and to the AMAC Kunduz by [International demining NGO] Operation officer.

The star basket system with MDU should be used for the rest of the task: as the APMs and small UXO to be inspected thoroughly which are not able dropping through the grids of this system while in the Gill system it has the possibility of dropping due to the wider holes.

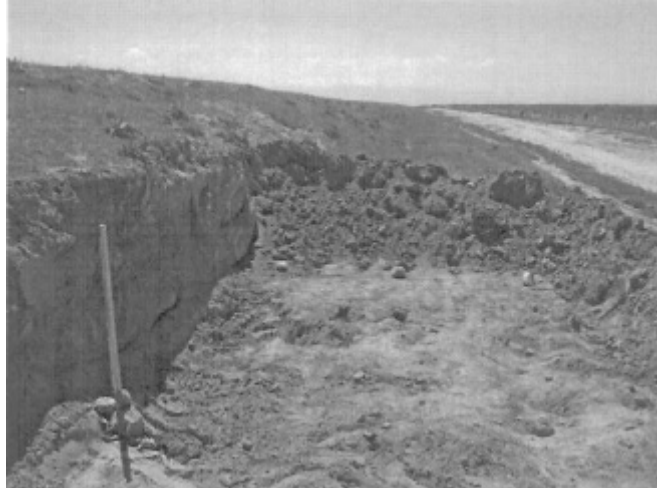
Site conditions: The ground was described as flat and open. The soil was soft and dry. The weather was clear and mild. There was no vegetation.

Depth of the mine from the hillside 1m.
