DDAS Accident Report

Report date: 21/01/2008	Accident number: 496
Accident time: 12:55	Accident Date: 08/07/2007
Where it occurred: Camp Moorhead, Rishkhor Village, Char Asyab District, Kabul province	Country: Afghanistan
Primary cause: Inadequate equipment (?)	Secondary cause: Field control inadequacy (?)
Class: Excavation accident	Date of main report: 15/07/2007
ID original source: CA-126	Name of source: UNMACA
Organisation: [Name removed]	
Mine/device: Fuze	Ground condition: dry/dusty grass/grazing area hard
Date record created:	Date last modified: 21/01/2008
No of victims: 1	No of documents: 2

Demining Accident Investigation Report

IMSMA Demining Investigation Report

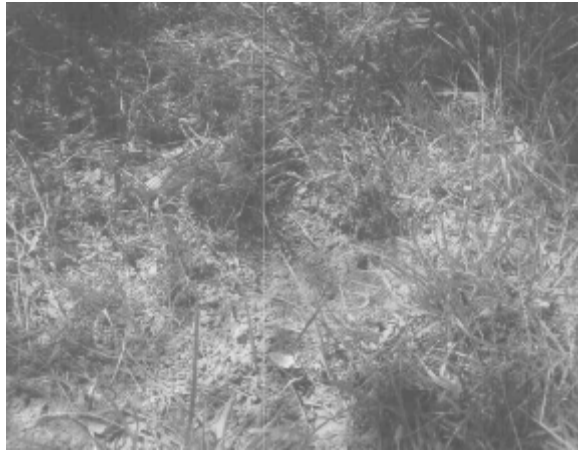
[The accident site is shown below.]

Description of the incident/accident: At around 12:55 hrs accident happened on [the Victim] while he was investigating the signal. Team leader was controlling other lane, which was at his 200 in distance from [the Victim's] lane. Section leader was controlling other section at his 50 m distance.

Site conditions: The terrain was described as flat and open. The soil was hard and dry. The weather was clear, calm and mild. The vegetation was heavy grass and “Rocky”.

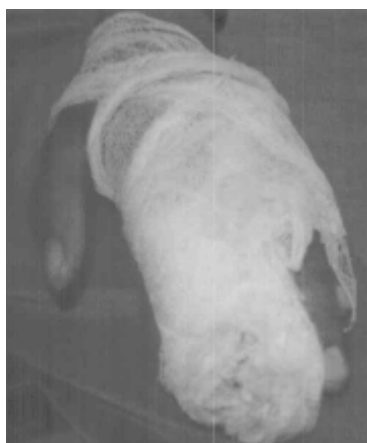
[Victim's injured hand]

They saw that [the Victim] was still conscious and asked him if he was injured in any way. He responded by saying he was okay but that his left hand was sore and bleeding and that he also had some dust in his eyes. As he was still conscious and lucid he was immediately walked to the First Aid station to the rear of where he was working. He was immediately treated by the Medic who applied a dressing to his hand and administered some fluids to intubate the eyes. His condition was monitored for a few minutes and he was then put into the ambulance by the medic and the site Doctor and evacuated from the site at 1303 hrs.

On Sunday 08-07-2007 at 12:50 pm [the Victim] TD#304 Deminer of Team No 2 Section No 4 during his work in Reshkhor project injured by UXO Explosion. He got injury in his four finger of left Hand in his face and his Both eyes injured. So he has some fragment in his Both eyes and his face.

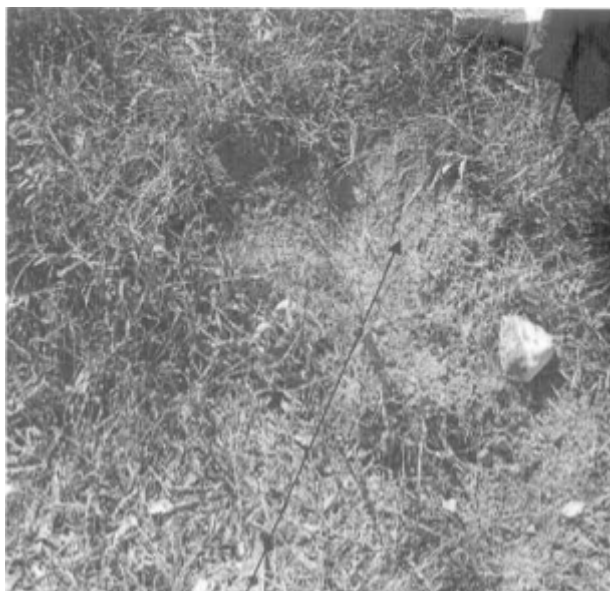
Picture 1 and 2 shows the immediate area and what appeared to be a small crater approximately 5 cms deep and approximately 20cms wide.

Crater thought to be caused by explosion.

Stage 3 — A check of the crater area revealed some small Aluminium fragments found within the soil in the crater. There were no signs of burnt residue in the crater or its surroundings nor did the ground have any real odour traces present. (This may indicate two things. The first is that the explosive charge was not a great amount — possibly a few grams at the most. The second is that the explosive event whilst capable of making a small crater did not have sufficient energy to scorch the ground. This may indicate that whatever caused the explosion

may not have been in direct contact with the ground but perhaps was just under the grass or surface of the ground).
