DDASaccident497

Humanitarian Demining Accident and Incident Database
AID

DDAS Accident Report

OF DEMINING ACCIDENT OCCURRED ON [demining NGO] DEMINER ON JULY 09 ,2007
AT QALAI GULAY VILLAGE OF BAGRAM

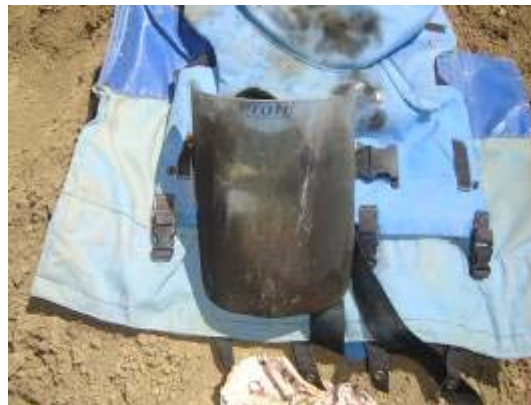
1. The two items of equipment (trowel and apron) both received blast/burn scorch marks as a result of the detonation, together with minor injuries to the deminer right hand and extensive peppering of the deminer face are consistent with the blast /burn effects experienced in many similar accidents. This directs the investigation team to conclude that the visor was not worn during the detonation of the mine.

2. Further, the intense blast/burn scorch marks to the central base of the visor indicate that this area of the visor was in very close proximity to the seat of detonation.

3. Additionally, in view of there being no blast/burn marks to the underside of the chin, or the exposed neck and no burning or singeing of the beard, the team concludes that the visor was nor worn in the correct position or more probably that it was not worn at all.

[The Victim's PPE – clearly showing soot inside the visor.]

The primary cause of this accident is listed as a “Field control inadequacy” because the investigators determined that the Victim was not wearing his visor in the down position at the time of the accident. Not only was this error not corrected, it is implied that the visor was deliberately damaged after the event in order to give a false impression that it was being worn at the time.

A full day of refresher training shall be conducted immediately for all 6 + 3 (JMAS) demining teams. The training subjects shall be the demining drills with a special concentration on the use of PPE combination of visor and vest and shaving the soil by using the small trowel.

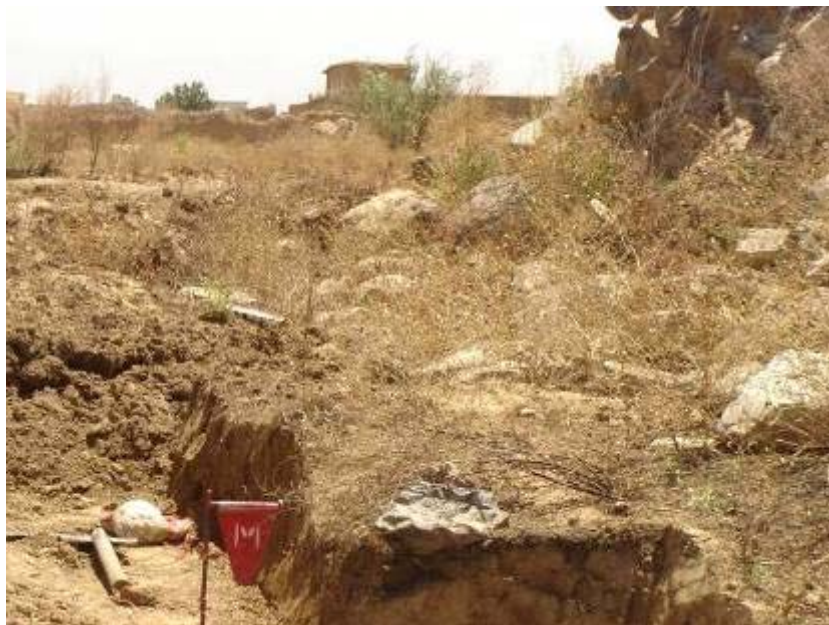
[Accident site: crater lower left.]

Within the immediate surroundings to the crater, there were numerous spots indicating the impact of artillery shelling, a Chinese 82mm recoilless projectile lying on the ground (0,5 m from the accident point), and a large amount of soil piled up in the explosion to the left side of the crater – indicating together with the injuries of the deminer and the damage to the property, that the mine was lying at an angle - not in horizontal position.

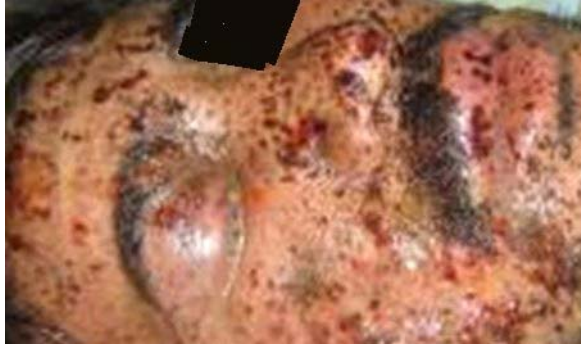
- A. Multiple erosive fragmental injuries on the face, frontal and 1st degree burns all over the face and frontal anterior view.
- B. Erosive fragmental injuries on dorsal view on right hand lateral side.
- C. Both eyes slightly injured and the right eye serious corneal defect.
- D. A fragmental wound in right side of the face include the ear auricular and an injury on the right eyelid.

E. Bruise injuries in chin and neck.
