DDASaccident498

Humanitarian Demining Accident and Incident Database
AID

DDAS Accident Report

Report date: 22/01/2008	Accident number: 498
Accident time: 06:00	Accident Date: 09/06/2006
Where it occurred: Task # 084, Abdiby Village, Charikar District, Parwan Province	Country: Afghanistan
Primary cause: Field control inadequacy (?)	Secondary cause: Inadequate equipment (?)
Class: Excavation accident	Date of main report: 30/07/2006
ID original source: OPS-271354-06	Name of source: UNMACA
Organisation: [Name removed]	
Mine/device: PMN-2 AP blast	Ground condition: building rubble dry/dusty hard rocks/stones
Date record created:	Date last modified: 22/01/2008
No of victims: 1	No of documents: 2

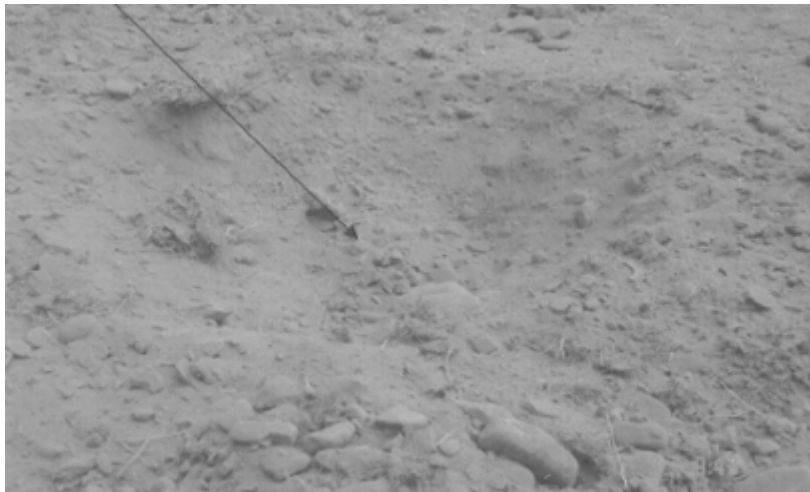
[The accident crater is shown below.]

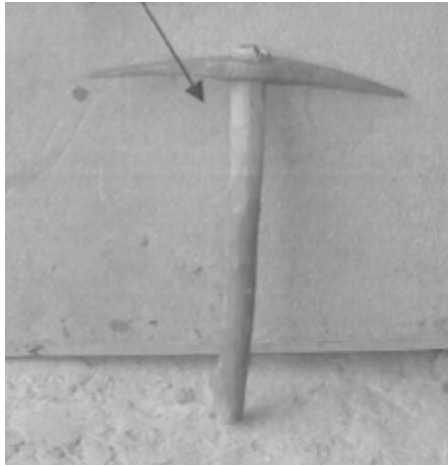
[An example of the pick that the team uses in the site.]

4. The team command group should ensure that the deminers are excavating the signals with appropriate hand tool.
5. When the team is working in a site in which they do not find any mine for a long time the teams should not be confident that there is no mine in the task at all.

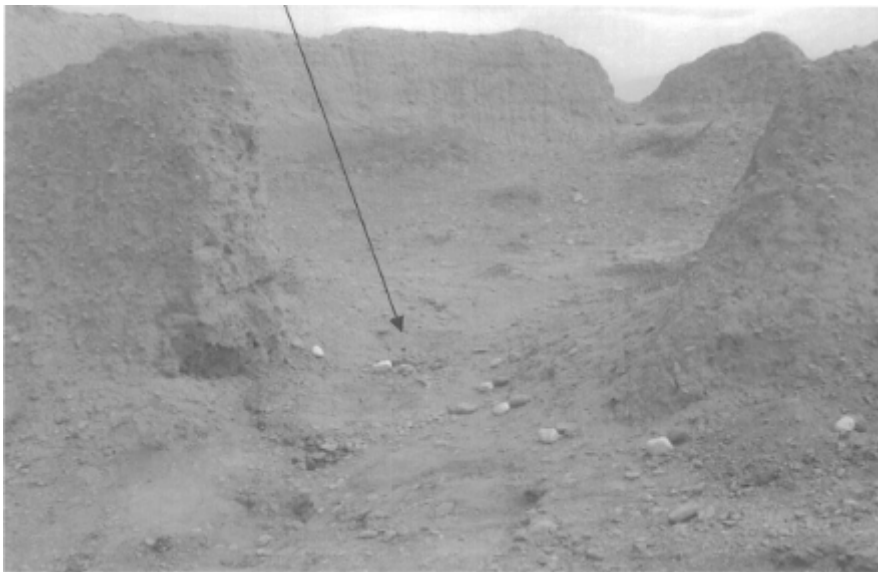
9. At the accident area which is near the entrance of the ruined house soils has been shifted by water on the original ground surface that should be worked by backhoe, but as it is seen the area instead of full excavation till original ground surface has been worked by signal reading from surface of the sediment soil. It is worth mentioning that an MDU is supporting the team.

The entrance gate of the ruined house and the accident point

1. Since a MDU is supporting the team, those places of the site having sediment soils or the grounds surface is hard should be raked and fully excavated by backhoe.

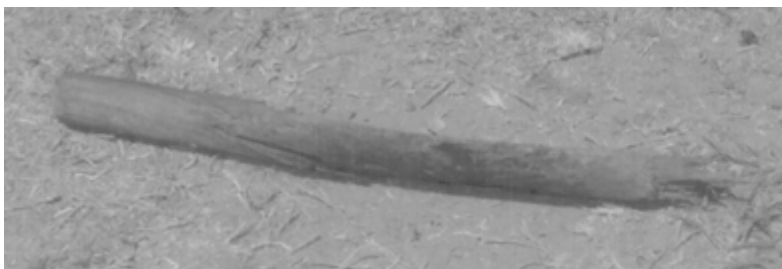
3. The deminer was working with pick not with bayonet. The following points intensifies our opinion that the victim was working with pick while the accident occurred:

- i. The broken handle of the pick was found adjacent to the explosion point.
 - ii. The Gloves of the deminer is without any damage.
 - iii. The victim hands do not have any injuries.

The broken handle of the pick which has been found adjacent to the accident point

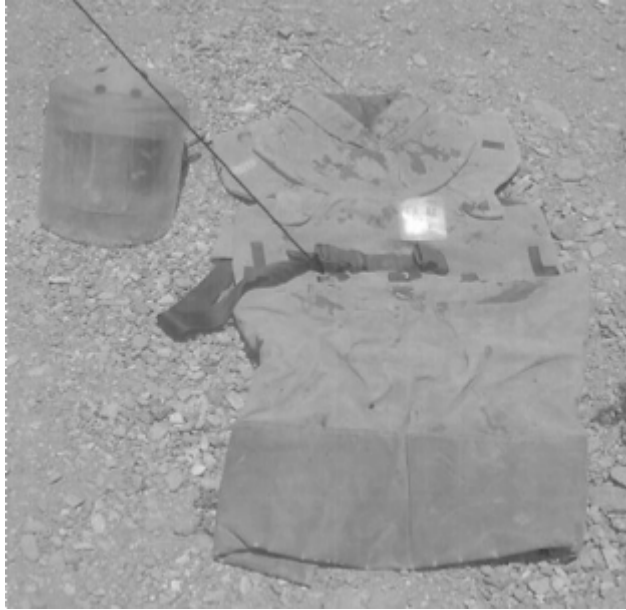
As a result of the accident he got head trauma plus serious injuries in his eyes, face and chest during the explosion he was dressed with PPE, but his visor was up.

Description of equipment damage: 1-Mine Detector: Telescopic rod of the mine detector was bent. 2-Visor: It received minor damages (un zapped strip). 3- The pick and bayonet of the party was missing.

The PPE & helmet-visor of the victim

3. The team command group should strictly control deminers to be fully dressed with PPE and keep the visors of their helmets down when they are working in the worksite.

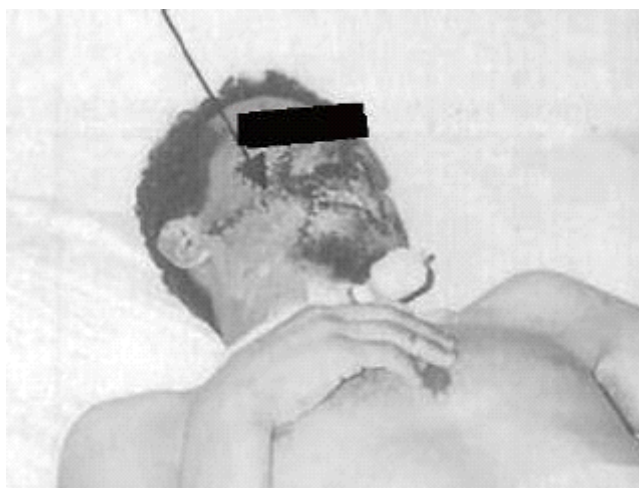
Records "Loss of" eyesight (both eyes); loss hearing (both ears), chest and head/neck injuries.

[The victim is shown below. His eyes are closed. The black block is to preserve anonymity.]
