DDAS Accident Report

Report date: 22/01/2008	Accident number: 499
Accident time: 12:00	Accident Date: 11/02/2007
Where it occurred: MF No. 0073, Kalata-l-Nayeb Ghafoor Village, Kohsan District, Herat Province	Country: Afghanistan
Primary cause: Inadequate survey (?)	Secondary cause: Inadequate training (?)
Class: Missed-mine accident	Date of main report: 12/02/2007
ID original source: MDU-06/MCT-17	Name of source: UNMACA
Organisation: [Name removed]	
Mine/device: PMN-2 AP blast	Ground condition: dry/dusty hard rocks/stones
Date record created:	Date last modified: 22/01/2008
No of victims: 0	No of documents: 2

Subject: [National demining NGO] Missed Mine Investigation Report

Missed Mine Accident Occurred on a [National demining NGO] MDU-06 on 12 Feb-2007

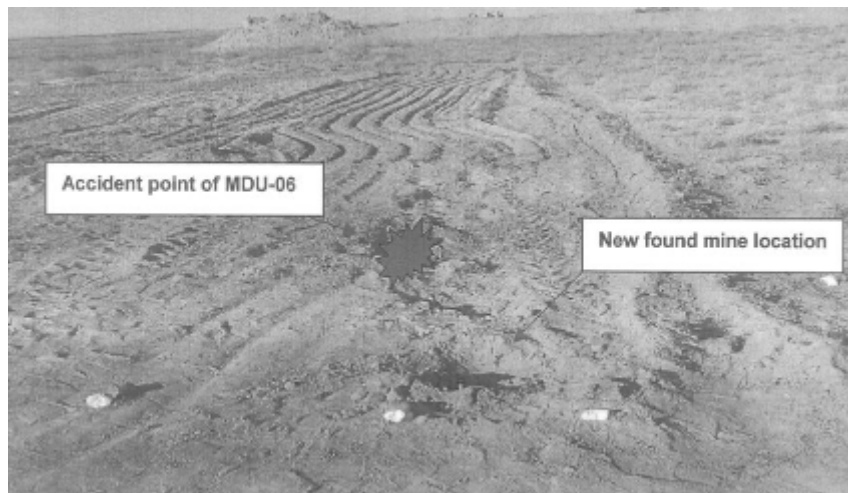
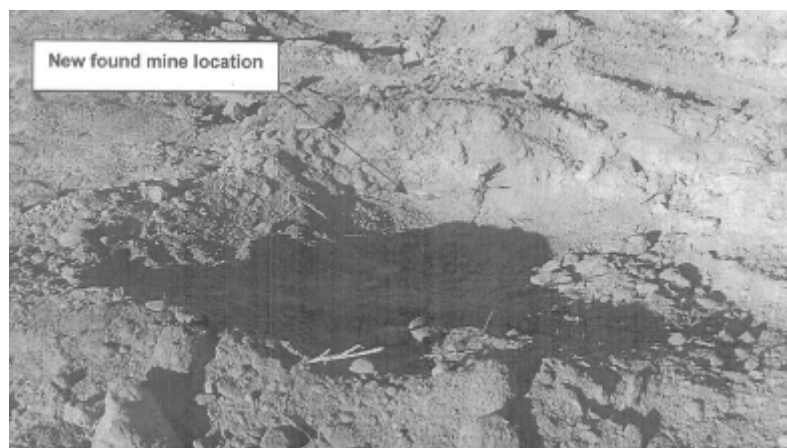
Photo of accident point on Backhoe Machine in Minefield No- AF-2008/18355/0073.

This portion of minefield No-AF-2008/18355/0073 where the accident of an anti personal PMN-2 mine occurred by [National demining NGO] MDU-06, was prepared by the mentioned MDU for the manual breaching party of section-1 of MCT-17, and was also searched and detected by the mentioned section party about 20 m long and 10 m wide. But when the MDU machine was getting ready for the preparation of another unclear portion for the mention party, when the MDU entered in this cleared area an anti personnel mine was blown up and in the result right backside tire of MDU has been damaged.

But during our investigation when we checked the second found mine by mine detector the depth of mine was about 15 cm, out of 13 cm cleared already. The mine detector did not give signal on the mine. It means that these mines were in depth of about 30 cm. Because more then 13 cm in depth of the area was prepared/cleared by MDU and breaching party already.

The backside right tire of MDU was damaged.

The MDU has repaired back and the tire has been changed and now it is ready for work in the field.

The entire minefield should be prepared by MDU more than 30 cm because the depth of mine is too much.

The Deminers are advised to detect properly MDU prepared area by mine detector.

A refresher training of mine detector is advised for the Deminers of this team.
