DDAS Accident Report

Report date: 02/02/2008	Accident number: 500
Accident time: 11:07	Accident Date: 17/07/2007
Where it occurred: MF/ No 0009, Dasht-e-Chinar Village, Rusted District, Takhar Province	Country: Afghanistan
Primary cause: Field control inadequacy (?)	Secondary cause: Management/control inadequacy (?)
Class: Excavation accident	Date of main report: 19/07/2007
ID original source: OPS/ 03/ 01 - 45	Name of source: UNMACA
Organisation: [Name removed]	
Mine/device: PMN-2 AP blast	Ground condition: dry/dusty grass/grazing area hard metal fragments rocks/stones
Date record created:	Date last modified: 02/02/2008
No of victims: 1	No of documents: 2

Subject: Demining Accident Investigation Reports of [NATIONAL DEMINING GROUP] DT-01 occurred in Dasht-e-Chinar village of Rusted district, Takhar province

Subject: Investigation Report and Lessons Learned – Demining Accident

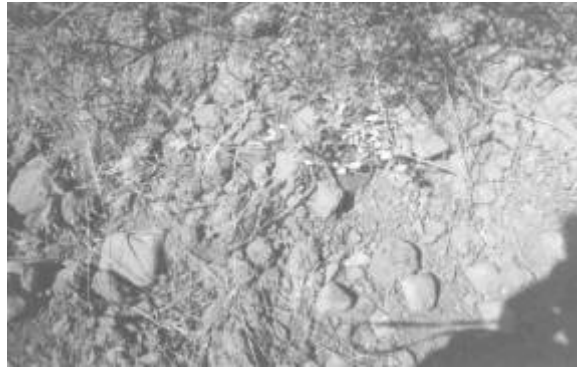
[The accident crater.]

But according to our investigation and observation from the site when we got to the accident site we found that the accident site has been changed. We didn't find any sign and pieces of destroyed helmet and jacket on the accident site and it seemed that the accident might [not have] happened here, so we searched the rest area. We found about 7 m away from the accident site an explosion point [where] there was available the signs and pieces of the destroyed helmet and Jacket.

1. All IP's are to be reminded of their responsibility to take immediate photographs of a demining incident sites, and then preserve the site intact until it is inspected and released by the investigation team. This means nothing should be tampered with or removed!

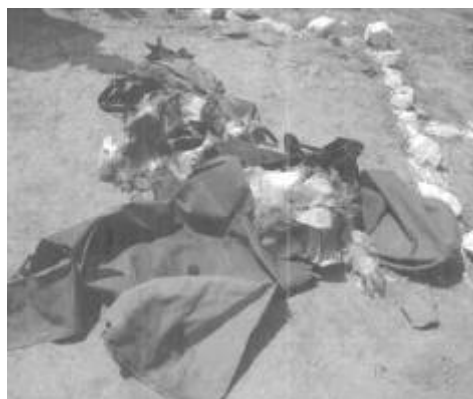
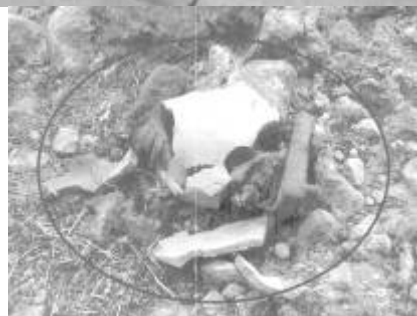
[The frontal apron and parts if the Visor helmet: damage is far too extensive for a normal AP blast.]

Description of damage to property: The helmet along with visor was completely destroyed. The protective jacket was seriously damaged. The deminer's uniform was also damaged.

There was no evidence of the helmet and PPE having been destroyed at the scene of the deminers work place. There was however evidence that indicated the helmet and PPE may have been destroyed approximately 7 metres away from the scene of the accident in a previously cleared area.

2. All staff are to be reminded that PPE shall be worn at ALL times once moving into the hazard area after leaving the administration area.
3. The Team and Section Leader of [National demining group] DT 01 shall be demoted immediately to Section Leader and Deminer respectively and re-employed into other teams.

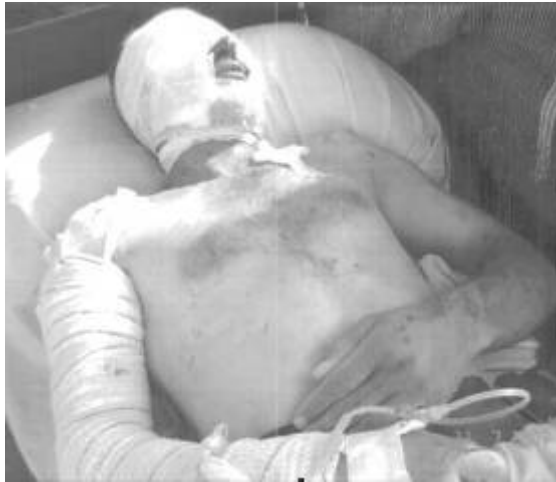
Injuries sustained: Loss eyesight (both sides), left arm. Other injuries: chest and upper limbs.

[The Victim in hospital.]
