DDAS Accident Report

Report date: 23/01/2008	Accident number: 502
Accident time: 11:00	Accident Date: 12/11/2006
Where it occurred: Task # 0007, Chaegari Village, Khulm District, Balkh Province	Country: Afghanistan
Primary cause: Field control inadequacy (?)	Secondary cause: Management/control inadequacy (?)
Class: Excavation accident	Date of main report: 26/11/2006
ID original source: OPS/01/01/04-out/437	Name of source: UNMACA
Organisation: [Name removed]	
Mine/device: PMN AP blast	Ground condition: grass/grazing area hard rocks/stones
Date record created:	Date last modified: 23/01/2008
No of victims: 2	No of documents: 2

IMSMA Demining Investigation Report

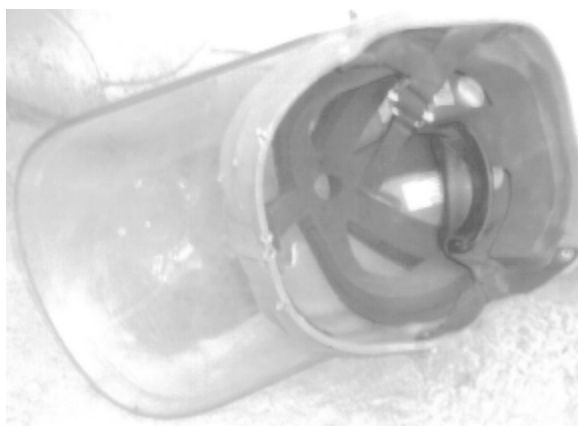
[Victim No.1's visor: fragment strikes are visible on the forehead rim of the plastic helmet.]

Description of equipment damage: Inside of the visor got fragments. PPE got fragments. Peak of the prodder damaged.

The victim's Visor was up during the excavation which is caused to receive some injuries in his face and specially eyes.

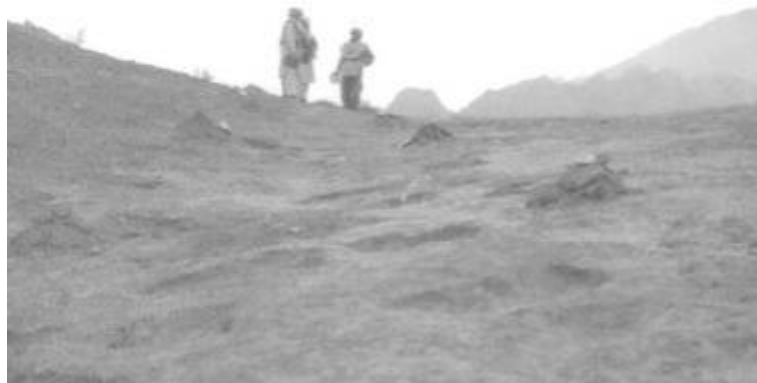
[The picture below shows the accident site. The indentations in the foreground are excavations made using a “shovel”.]

The main factor of the accident was clearance of boundary lane from up to down position because the boundary lane had 25-30 degree slope and the surveyor continued clearance operation from top to bottom direction when the deminer can not control himself during prodding and pressure come on mine through prodder, also this system is not acceptable in manual clearance procedure.

It is concluded that the victim was using the [folding] shovel instead of bayonet, based on the following factors:

1. The signs of using the [folding] shovel clearly seen over the portion of lane checked along the day.
2. As the [past] experience shows, when the accident happened on deminer during the prodding with bayonet, he almost [always] receiving amputation on his one hand's one or two fingers, but case is opposite in this accident as both hands of the victim received slight and round about same injuries without breaking of his finger bones or amputation because the shovel is used by both hands. Moreover, according to medical report, both hands of the victim Surveyor had hurts laceration in backsides of the hands,

The operation with current direction (up to down) is to stop immediately and change the direction as per the requirement of SOP, that was physically advised to the team leader.

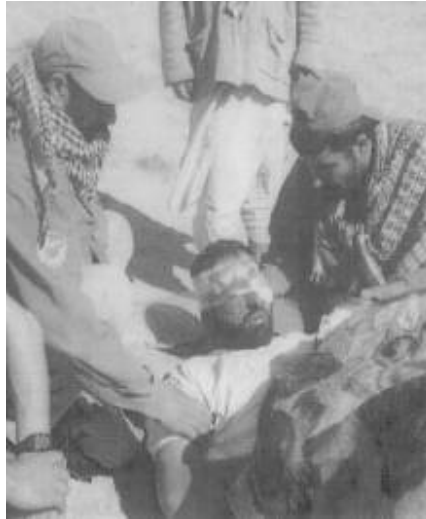
“Serious injury both eyes (loss) and a surface injury can be seen on his face, legs and stomach by fragments.”

[The picture below, showing field treatment, was included with the report.]
