# DDASaccident504

# DDAS Accident Report

<b>Report date:</b> 23/01/2008	<b>Accident number:</b> 504
<b>Accident time:</b> 09:45	<b>Accident Date:</b> 13/08/2006
<b>Where it occurred:</b> Task # 0120, Sai Dokan Village, Bagram District, Parwan Province	<b>Country:</b> Afghanistan
<b>Primary cause:</b> Unavoidable (?)	<b>Secondary cause:</b> Inadequate training (?)
<b>Class:</b> Survey accident	<b>Date of main report:</b> 05/09/2006
<b>ID original source:</b> OPS/27/399-06	<b>Name of source:</b> UNMACA
<b>Organisation:</b> [Name removed]	
<b>Mine/device:</b> not known	<b>Ground condition:</b> agricultural (abandoned) dry/dusty grass/grazing area
<b>Date record created:</b>	<b>Date last modified:</b> 23/01/2008
<b>No of victims:</b> 1	<b>No of documents:</b> 2

Subject: Investigation Report

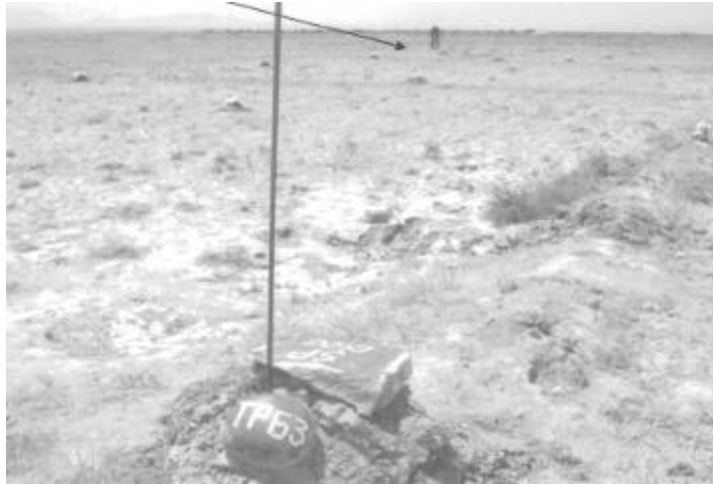
**Description of the incident/accident:** On 13 August 2006 at 09:45 am a UXO was detonated on Noor Agha dog-handler of MDS-04 and his dog. The dog name is Taska with ID#269. The UXO was on the ground surface. When the dog was moving for search in a lane as proceeded about 4 meters from start point to the lane realized smell of a UXO changed its direction and returned back toward the UXO. At that time the dog had passed the UXO. Since The UXO was on the ground surface and the leash of the dog was loose, the leash touched the ground surface and displaced the UXO from its place. The UXO was too sensitive as detonated during displacement. As a result the dog handler received an injury in his right arm and his dog received injury on its right shoulder.

[The accident site is shown below.]

1. The set leader and the dog handler had not conducted visual search of the ground surface before dog operation.
2. The leash of the dog was too loose and had touched the ground surface while the accident happened.

3. The loose leash which was touching the ground surface displaced the UXO and caused the accident.
4. During investigation we could not specify the type of the detonated UXO, but just we extracted that the UXO was on the ground surface and was too sensitive.

6. After passing the UXO, the dog realized the smell of the UXO and returns back toward the UXO, at this time the leash of the dog which was loose and in touch with the ground surface displaced the UXO and caused the accident.

1. When the dog handler commands the dog for search should not release the leash so loose as to touch the ground surface.
2. Before starting to search by the dogs, the set leader and the dog handler should strictly conduct visual check on the site.
3. The set leader should strictly control the dog and the handler to work in accordance with the set procedure.
4. The survey team leader should not be reluctant with the MDS work in the site: he should strictly control the MDS activities in the site and ensure that they are working in accordance with assigned procedure.
