DDASaccident505

Humanitarian Demining Accident and Incident Database
AID

DDAS Accident Report

Subject: FOLLOW UP ACTION ON MISSED MINE DISCOVERED IN BAGRAM DISTRICT OF PARWAN PROVINCE; MF# AF/0308/01648/092

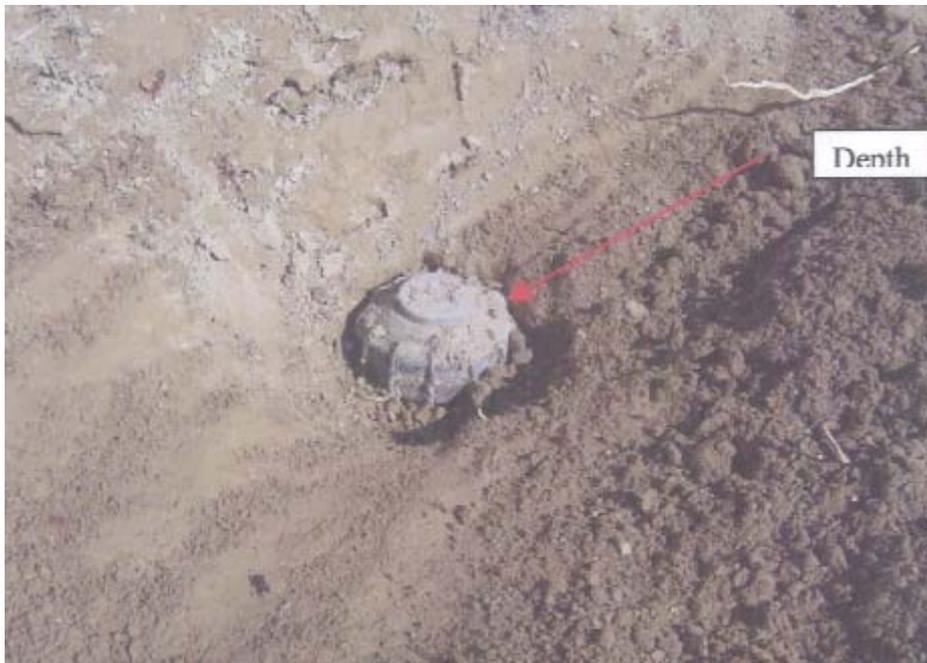
THE MINE

Device caused the incident/accident: YM-1 AP blast mine

2. As the type of the discovered missed mine is YM-1 which contains minimum metal, there is the possibility of other similar type mines in the above-mentioned site.

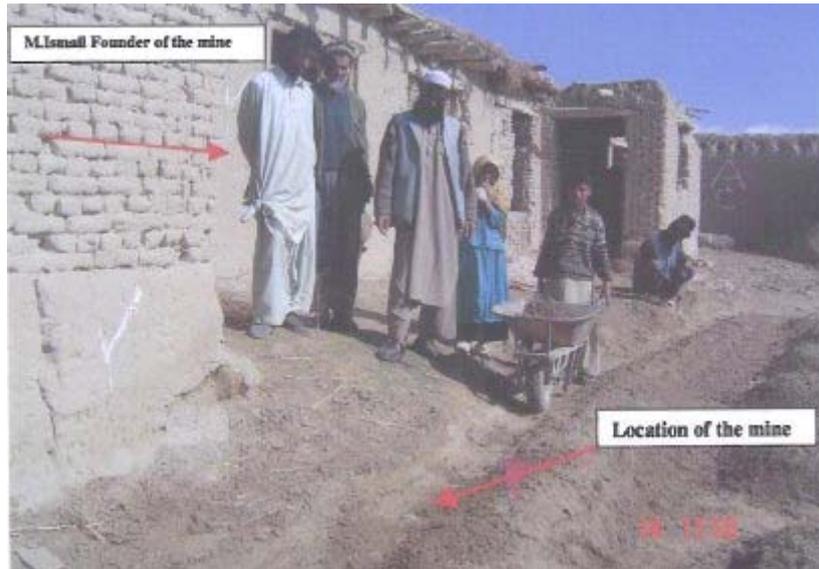
THE PLACE WHERE THE MISSED MINE WAS FOUND

The mine had not blasted and the local resident found it during excavation in his house yard. While the house owner was excavating land by shovel, the AP mine was discovered.

1. As the house is a ruined house, the presence of the extra soil on the surface of the ground was visible and it seemed that those soils were not excavated, removed and checked properly and in accordance with the requirements of the SOP and task order.

3. According to the observation of the investigation team the inner side of the house-surrounding walls with five meters width seemed as un-checked. The original undisturbed ground surface has not been considered during the clearance operation. Although it was clearly mentioned in task order that the task should be cleared/checked to the depth of 13 cm from the original undisturbed ground level. The discovered mine was also, located in this 5-meter width.

1. It is recommended that the inner side of the house walls with five meters width should be rechecked with the depth of 13 Cm from original undisturbed ground surface.
2. The clearance teams should consider the depth of 13 Cm from the original surface of the ground not from the top of the extra soils.
3. Prior to handing over of the task, the clearance team should collect all the red marks and other signs of the cleared area and mark the cleared area by the white paint properly till the cleared area and unclear area be differentiated easily. We suggest that the area in which the house owner is not sure is estimated about 600 m2 to be rechecked and cleared with 13 cm depth from original surface level of the ground.

1. The inner side of the house wall with the 5m width should be rechecked and the depth of 13cm should be considered from the original ground surface as was mentioned in task order.
2. The task should be properly marked as cleared, red marks to be removed prior to the handing over.
3. Refresher course to be conducted to the mentioned manual clearance team.
4. Disciplinary action to be taken against the team command group.
