# DDASaccident506

# DDAS Accident Report

## **REPORT FOR MINE ACCIDENT INVESTIGATION**

MDD mine accident that occurred on the 22nd January 2007 in Sarobi District Tora Tiga Khowenda, Kabul Province, Afghanistan.

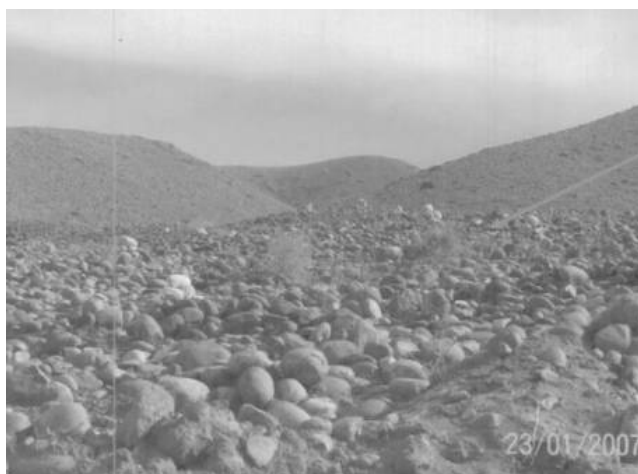
[The accident site]

32. The terrain comprised of loose rocks and large round boulders, generally as found in river beds as per photograph attached. The area was on an incline side of a hill feature. The investigation team experienced a degree of difficulty in walking and maintaining balance within the safe lane.

33. The investigation team observed foot prints outside the safe boundary lane; this indicates that someone had walked into uncleared areas.

34. The majority of the boundary/perimeter was fairly steep cross gradient, making the working procedure for the MDD very difficult.
35. The use of the MDD in the lane was in accordance with SOPs namely, the MDD searched 8 meters before moving forward.
36. The seat of detonation area was 1.5 meters forward of the last known safe area within the boundary lane.
37. The latest statement from the MDD handler states that he was under pressure from the set leader to increase productivity and that only one dog was used to search the lane.
38. On my arrival on the 23rd January 2007 the air temperature was between 7 and 8 degrees.
