DDAS Accident Report

Report date: 25/01/2008	Accident number: 509
Accident time: 09:10	Accident Date: 18/01/2007
Where it occurred: MF # AF/3208108364/MF01 1, Dwa-Mandy Village, Nadersh-Kot District, Khost Province	Country: Afghanistan
Primary cause: Field control inadequacy (?)	Secondary cause: Victim inattention (?)
Class: Detection accident	Date of main report: 24/01/2007
ID original source: OPS/2/2/21-014-07	Name of source: UNMACA
Organisation: [Name removed]	
Mine/device: PMN AP blast	Ground condition: dry/dusty rocks/stones
Date record created:	Date last modified: 25/01/2008
No of victims: 1	No of documents: 2

Subject: Demining Accident Investigation Report of [National demining agency] MCT#1

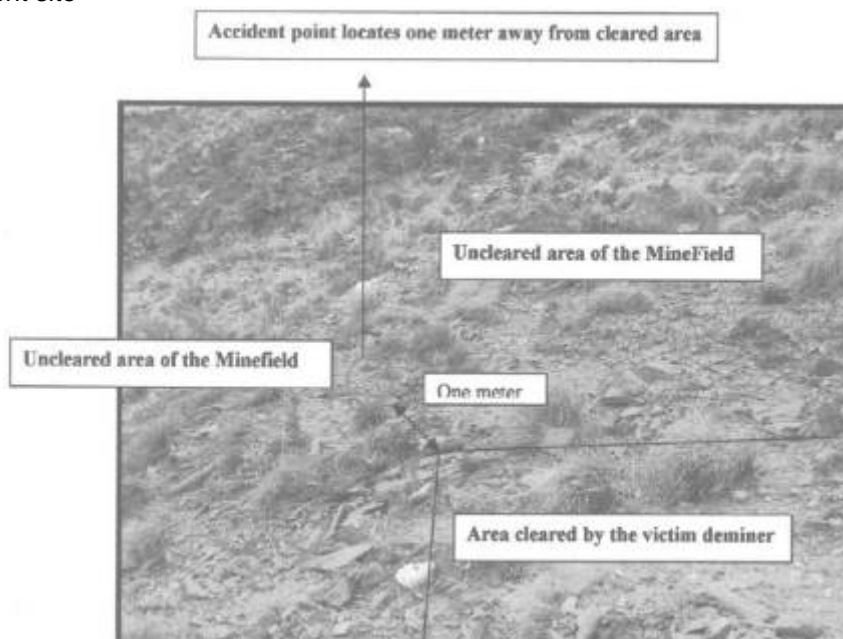
The accident site

Device was detonated in area where it was difficult to be clear from the right to left, due to sloppy [sloping] condition.

The area of ground being cleared was sloping and the deminer was clearing 1 meter across the slope before proceeding up the slope a further 5 meters.

Description of the incident/accident: The deminer was tasked to clear across the slope before clearing up the slope and it appears that he has carelessly moved into an unclear area before physically clearing it and has stepped on a PMN Mine.

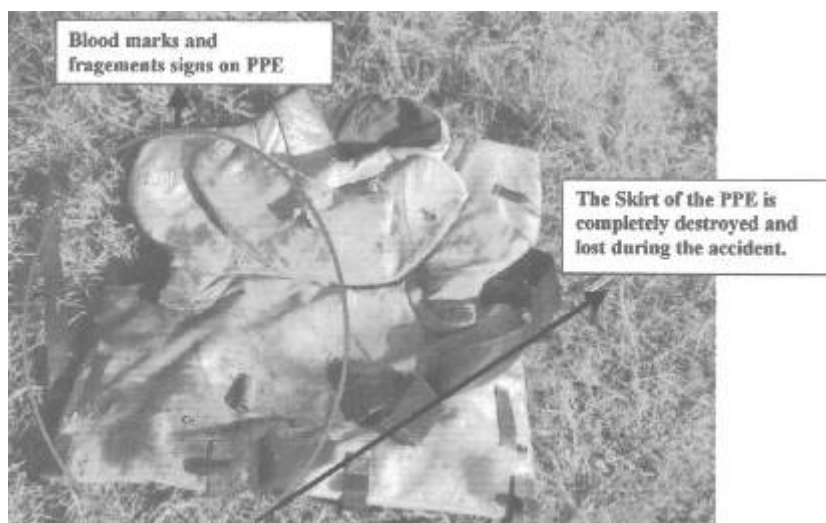
Equipment/property damage: Metal detector (MLD-1); Frag-vest; Helmet, visor. [The apron style vest is shown below.]

The lower part of the PPE was "lost", raising questions over whether the PPE design offers adequate protection to the body when stepping on a mine. The visor snapped at its fixing point, (shown below) which is a common failing of this type of helmet-mounted visor.

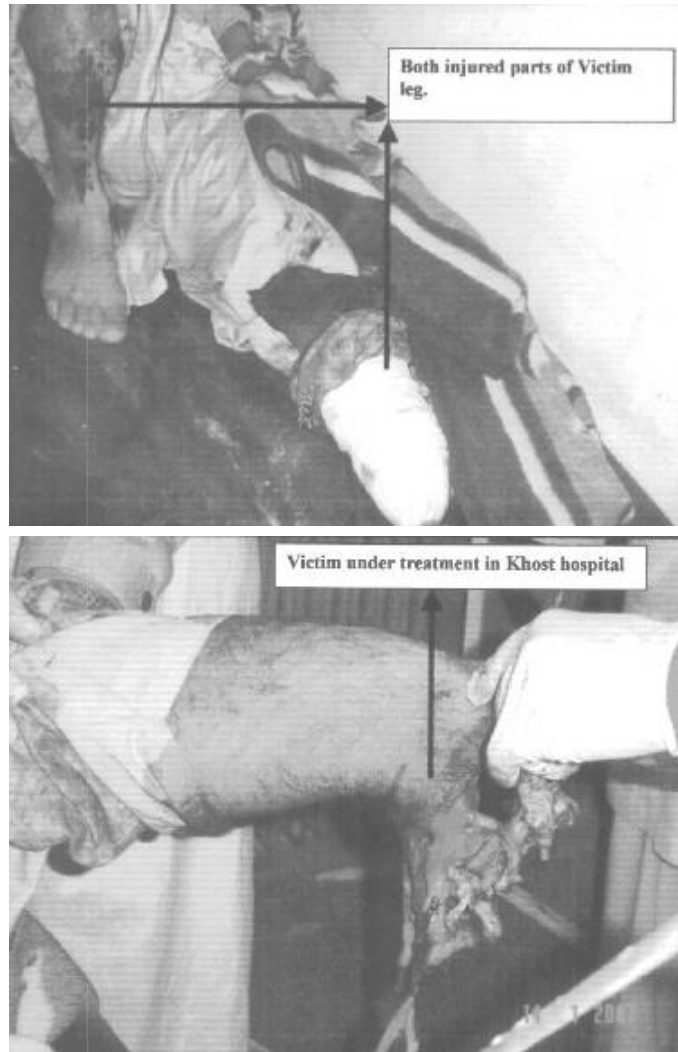
The IMSMA sketch showed loss of left foot, other injuries to upper limbs and lower limbs.

Left foot amputation. Right arm injury. Right knee joint injury.
