### DDASaccident511

# DDAS Accident Report

DEMINING ACCIDENT (February 19, 2007)

### **Investigation report of Mine/UXO accident/incident with the ground of demining**

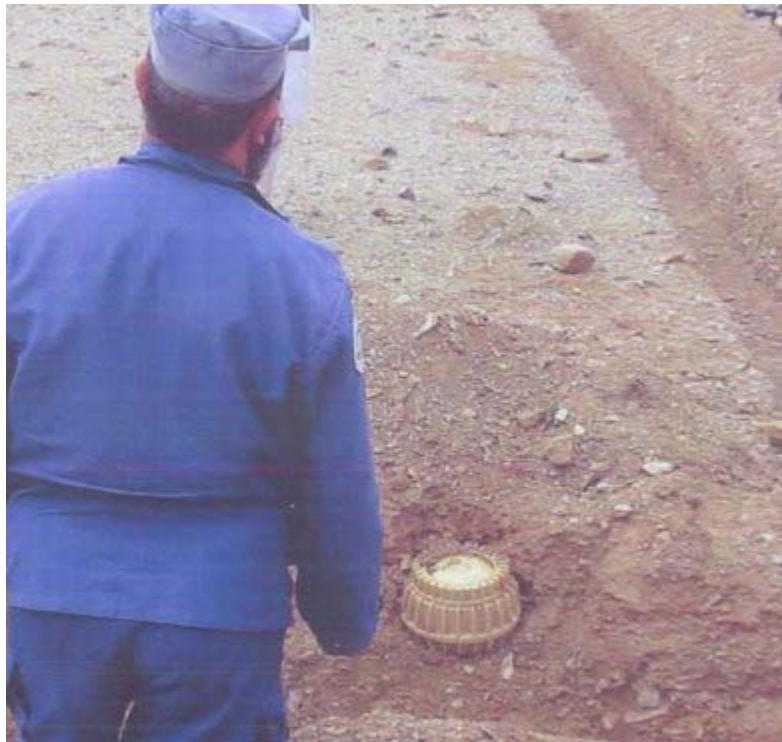
As the mine was already removed and destroyed by [National demining agency] EOD team in the area tasked by UNAMAC, the investigation team only observed the mine site, its photograph in its original cradle/frame and it shows that the mine was in normal position/depth not more than 10 cm.

[The photograph taken by the EOD team.]

The TC/6 mine is difficult to detect with a metal detector. It was buried at ten centimetres to the top of the mine in friable earth. It is "difficult to detect" with a metal detector. It has a steel ball, spring and firing pin but these are "non-magnetic" which reduces their signal with most metal-detectors. To be certain of locating them reliably in any particular soil, real targets (rendered safe) should be buried and the detector used to confirm that a signal is received.

5. To ensure safety of workers and people who use this land (disabled) the investigation team recommends re-clearance of the 300 meters area in length and 136 meters in width of the site starting from the start point (a total area size of 40,800sqm). This is purely required because the team has not cleared the area in accordance with the standard dog clearance procedures. Furthermore, the contractor, labourers working in the site are insisting for the clearance as well.
