DDASaccident513

Humanitarian Demining Accident and Incident Database
AID

DDAS Accident Report

Report date: 26/01/2008	Accident number: 513
Accident time: 08:10	Accident Date: 20/06/2006
Where it occurred: Task # 015 in Kharoti Village, Deh Sabz District, Kabul Province	Country: Afghanistan
Primary cause: Field control inadequacy (?)	Secondary cause: Victim inattention (?)
Class: Excavation accident	Date of main report: 13/07/2006
ID original source: OPS-271338-06	Name of source: UNMACA
Organisation: [Name removed]	
Mine/device: PMN AP blast	Ground condition: ditch/channel/trench dry/dusty grass/grazing area rocks/stones
Date record created:	Date last modified: 26/01/2008
No of victims: 1	No of documents: 2

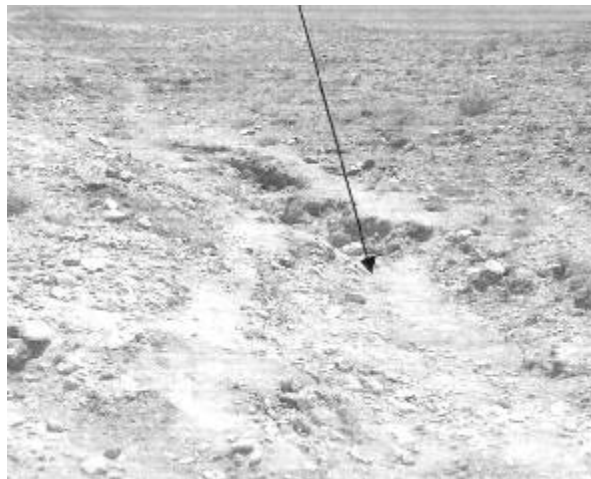
soils has been shifted gradually by water. The work procedure adopted by the team command group for the ditch was full excavation with unspecified clearance depth till original surface of the ground, the deminer has assumed that there is no longer any danger and it may be the original surface, therefore he has changed the full excavation method to signal picking and has ignored the full excavation. Proceeding about two meters in the first lane he has faced a signal. At first stage he excavated and removed a 10 cm depth soil from top of the signal. Checking the signal by detector he saw that the signal still exist then he decided to start digging of second 10 cm depth, when he checked by detector again he saw that the signal has not been dismissed. He started to third stage excavation, at this time the mine exploded and the accident occurred.

[The accident site (dry ditch) is shown below.]

1- The party was working in a ditch in which sediment soils have been gradually collected by water in the ditch and has covered the ground original surface.

6- The sediment soil from the ground surface should be removed then the deminer with consultation of his immediate command group is authorized to check the original ground surface with the detector and pick the signals.

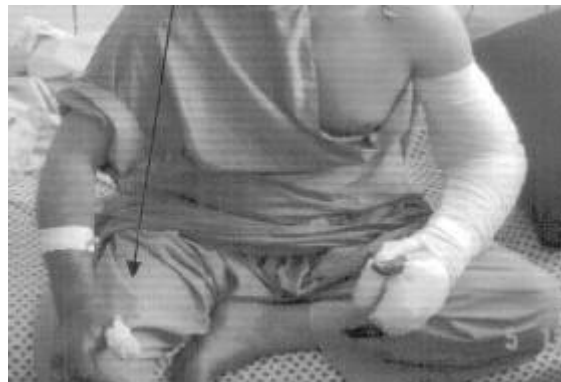
[The Victim suffered injury to] Lower/ Upper part of the left hand.

[The photograph below shows left arm and hand injuries, and a right thumb injury.]

[The Victim] sustained deep injuries on his left arm and fingers and superficial injuries on his face around his eyes and right thumb,

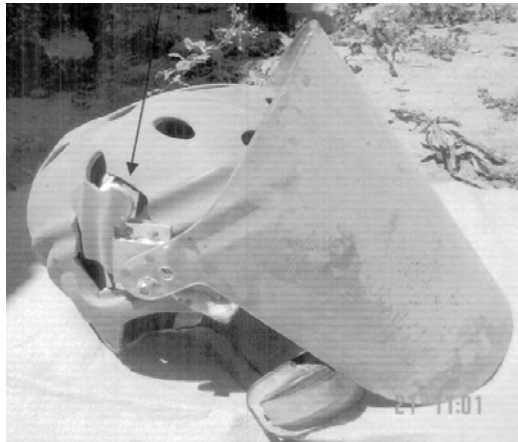
1. Helmet: Right side has been broken, down and the left side has got cracked down.
2. Prodder: According to the team leader the prodder is completely damaged but the investigation team could not find any pieces of the prodder.

[The cracked helmet is shown below. The helmet offers no protection: it merely holds the visor.]

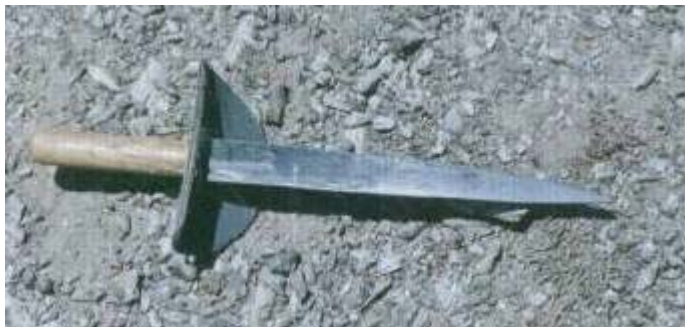
The Victim was right handed and the left hand suffered most of the injury. The locally made "bayonet" in use is shown below. It has a rubber hand-guard made from the side-wall of a vehicle tyre, and its blade is much longer than the standard AK bayonet frequently used. It seems likely that the Victim was using his left hand on top of the rubber guard when the accident occurred. In hard ground, excavating one-handed with a tool like this can be unrealistic.
