DDASaccident530

DDAS Accident Report

INVESTIGATION REPORT INTO MINE ACCIDENT

WHICH OCCURRED ON 04th MARCH 2004 AT M4101 MINEFIELD, O'Chrey Village, Kamreing Commune, Kamreing District, Battambang PROVINCE

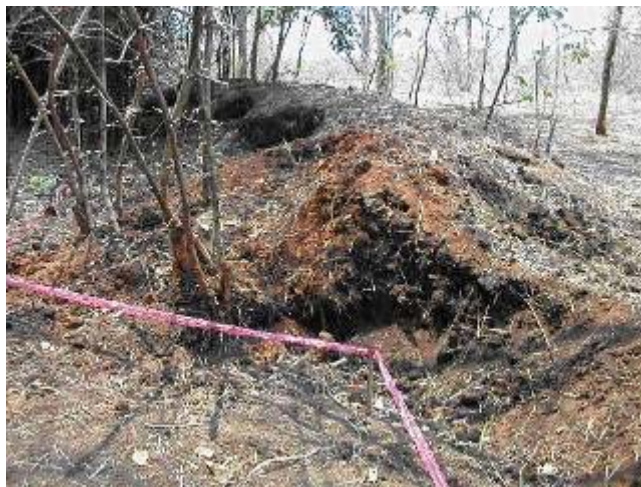
[The Victim], Id 931799, Section Commander, approached to the head of the clearing lane of the minefield M4101 where one deminer of his section reported that a mine was found, then picked up a trowel of the breaching team without wearing PPE excavated soil to identify the item found, as reported by the deminer, while doing soil excavation the trowel hit the top of the mine underneath. It exploded.

[The accident area, showing the point of detonation.]

For the case 04 March 04: Based on the nature of the injury and answers of the victim, it was caused by PMN Anti-personnel Mine while he was excavating soil, without wearing PPE, to identify item found as reported by a deminer in his section. The trowel slipped and hit the top of the mine. It exploded causing serious injuries to his face, neck and arms.

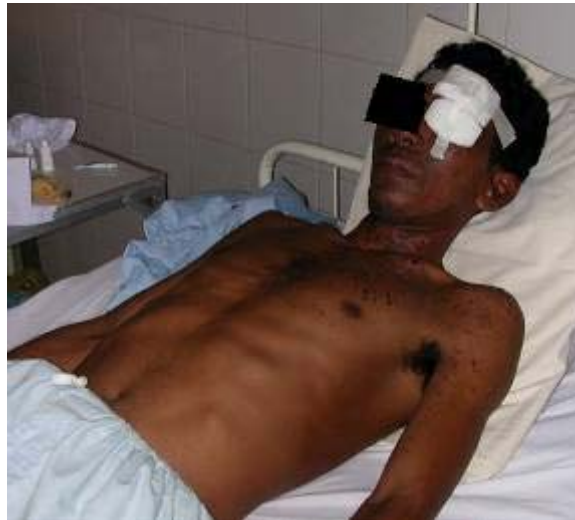
AMPUTATION/LOSS: Eye

[Photograph showing Victim with peppering of chest, shoulder, throat and face, as well as a dressing over the missing eye.]

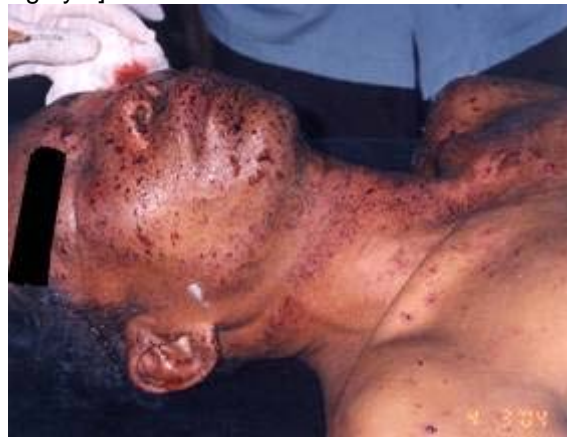
The report records “serious injured to his face, neck and right arm”, so a right arm injury is also presumed.
