# DDASaccident541

# DDAS Accident Report

<b>Report date:</b> 30/01/2008	<b>Accident number:</b> 541
<b>Accident time:</b> 12:30	<b>Accident Date:</b> 09/10/2007
<b>Where it occurred:</b> Nr Jaffna, Kaithady subdistrict, Chavakacheri District, Northern Province	<b>Country:</b> Sri Lanka
<b>Primary cause:</b> Field control inadequacy (?)	<b>Secondary cause:</b> Unavoidable (?)
<b>Class:</b> Excavation accident	<b>Date of main report:</b> 03/11/2007
<b>ID original source:</b> None	<b>Name of source:</b> [Name removed]
<b>Organisation:</b> [Name removed]	
<b>Mine/device:</b> Type 72 AP blast	<b>Ground condition:</b> clay dense vegetation soft trees
<b>Date record created:</b>	<b>Date last modified:</b> 30/01/2008
<b>No of victims:</b> 1	<b>No of documents:</b> 1

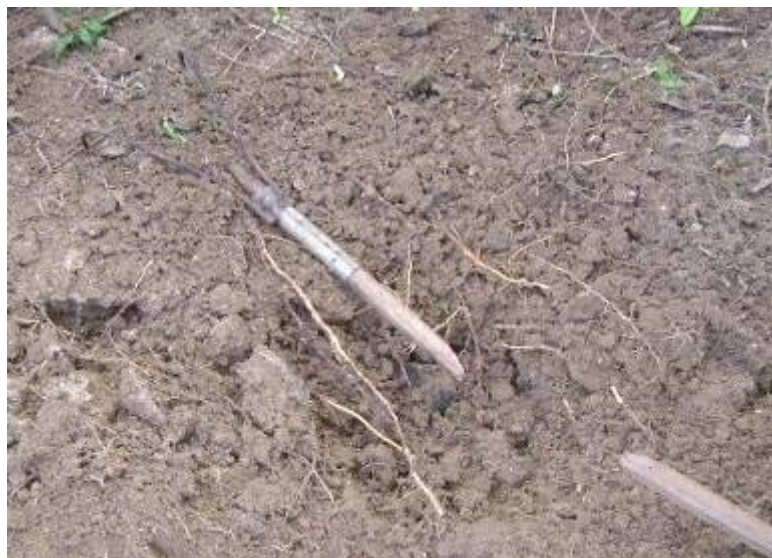
On the time of the incident [Name removed] was carrying out mine clearance by raking method in a lane where he earlier had found 7 AP mines Type 72. The area he was raking was free from vegetation and no large tree roots or any other obstacles was in the near vicinity of the ground where he was raking. The soil conditions were loose clay. The Team Leader had been checking the deminer 10 minutes before the incident and the section leader had left his lane just a few minutes before the incident. [The Victim] did by raking detonated a mine (most likely a Type 72) which broke off the rake handle and made the rake bend but not break.

[The broken rake handle and bent tines.]

The demining group had put in place the use of a long tool (rake) that kept the Victim far enough away from a blast to avoid injury, and his PPE was effective at protecting him from any risk remaining at that distance. Had he been using conventional short hand-tools, some injury would have been expected.

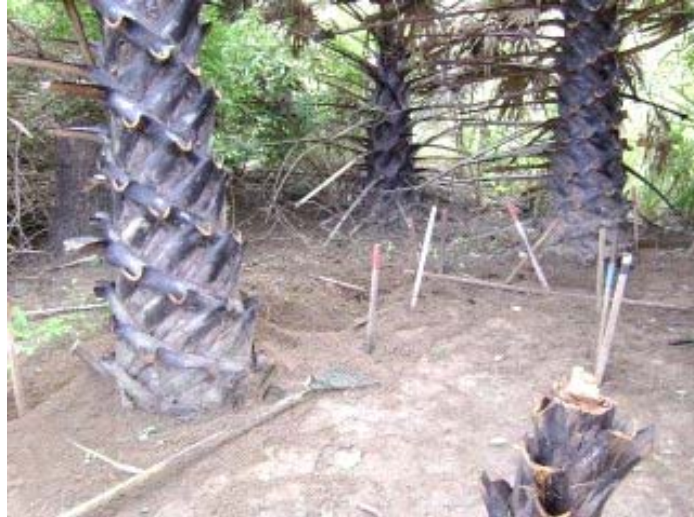
[The accident site.]

Due to the soil conditions and the fact that there were no major obstacles at the scene of incident it is most likely that [the Victim] has mis-used his rake and by force struck the ground which set off the mine. The Team Leader has on several occasions reminded his team to be careful since it is a minefield which is densely mined and also since they had an accident in the same minefield on the 9<sup>th</sup> of October.

The Primary cause of this accident is listed as a "Field control inadequacy" because the investigator determined that the ground was easy to work in and the deminer was working too roughly with the rake, but his error was not corrected. Photographs show that the ground was not without some root systems, so the secondary cause is listed as "Unavoidable" because it may be that the Victim was working as trained when the accident occurred.
