DDAS Accident Report

SUBJECT: BOARD OF INQUIRY REPORT

FOR [Demining group] UXO ACCIDENT IN AR RAFIYAH DISTRICT, SOUTHERN IRAQ, 09 January 2007

FILE REFERENCE: BOI 001 091007

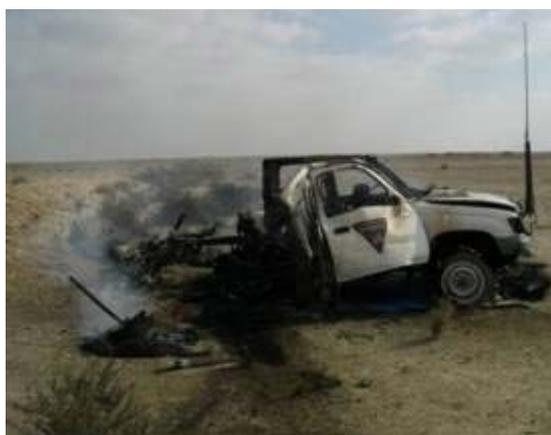
8.2 The vehicle (Toyota Hilux) had been destroyed by the effects of both explosive detonation(s) and a subsequent fire. The cab's roof was found 50 metres SW of the vehicle on a bearing of 188°.

[One side of the pick-up, showing how the load bay (bed) has been destroyed.]

8.3 The bed of the vehicle was gone. Parts of the side panels were found as far as 100 metres from the vehicle.

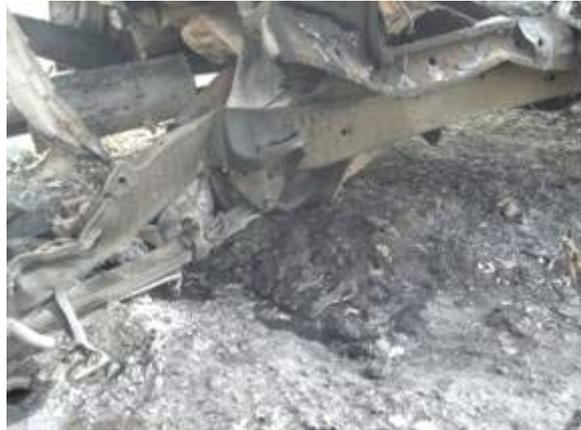
8.4 [Victim No.1]'s remains lay on the driver's side of the vehicle close to the left rear wheel. The vehicle tailgate and part of the vehicle bed had been blown off and was covering the body. The part of the vehicle bed covering the remains was missing a section in the area corresponding to that directly behind the right corner of the cab and forward of the right rear wheel. The section of frame brace directly beneath this location had been cut, the ends indicating a detonation from above. Beneath this section was found a crater 56 cm in diameter and 9 cm deep. This also indicated a detonation from the same locality.

[The crater and damaged chassis of the vehicle.]

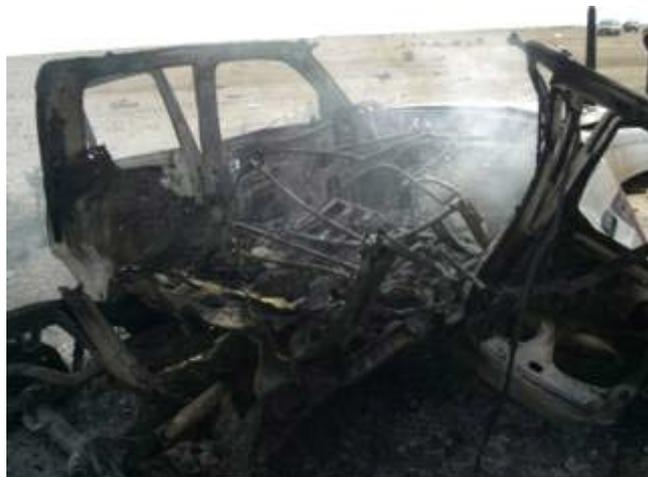
8.5 The direction of the debris field was 85% to the front and left (driver's side) of the vehicle. The farthest piece was the left tie-down rail at 104 metres. The other 10% was to the right (passenger's side) and consisted of a BLU 63 and one 125 mm Anti Tank projectile. One small piece of the vehicle bed was found 40 metres to the rear; also to the rear at 20 and 30 metres were the two halves of a BLU 63, these showed fragmentation damage and were coated with diesel fuel.

[The vehicle cab from behind.]

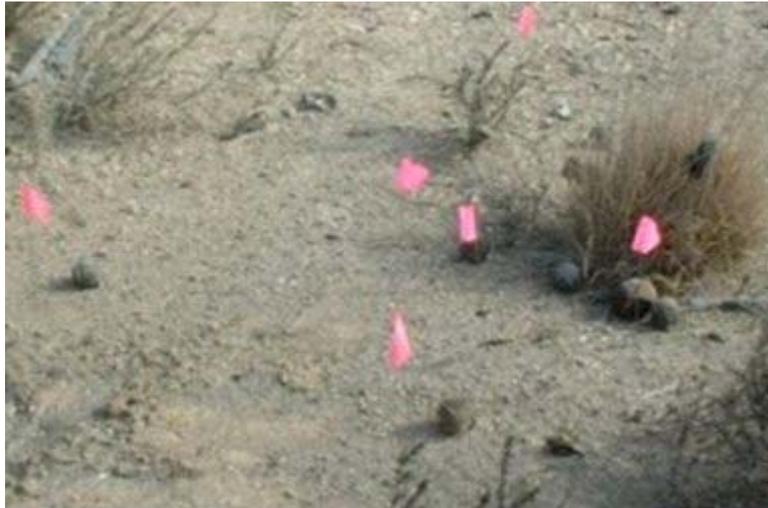
8.6 On the left side of the vehicle starting at approx two metres from it and extending in staggered line to approx 15 metres were 14 BLU 61 and 63 cluster munitions. These items did not show fragmentation damage nor were they coated with diesel fuel.

[Each red flag marks a BLU submunition on the ground surface, the BLU 61 is 99mm diameter and there appears to be one on the right, in between two smaller BLU 63s.]

9.3 The actual events that day are open to speculation and may never be known. The presence of so many BLUs in such close proximity to the vehicle is suspicious. An experienced operator would never have backed his vehicle into an area so contaminated. So, were they on the ground already or were they moved there after parking the vehicle?

10.1 Retraining of all personnel in General Safety, specifically in dealing with Cluster Munitions, transporting of UXO, and the wearing of PPE.
