### DDASaccident544

*Humanitarian Demining Accident and Incident Database*

# DDAS Accident Report

<b>Report date:</b> 01/02/2008	<b>Accident number:</b> 544
<b>Accident time:</b> 12:00	<b>Accident Date:</b> 02/03/2004
<b>Where it occurred:</b> Ward 18, Dehsabz, Kabul Province	<b>Country:</b> Afghanistan
<b>Primary cause:</b> Inadequate training (?)	<b>Secondary cause:</b> Field control inadequacy (?)
<b>Class:</b> Handling accident	<b>Date of main report:</b> Not recorded
<b>ID original source:</b> None	<b>Name of source:</b> [Name removed]
<b>Organisation:</b> [Name removed]	
<b>Mine/device:</b> Flare/ Ordnance	<b>Ground condition:</b> demolition site (explosives)  dry/dusty  rocks/stones
<b>Date record created:</b>	<b>Date last modified:</b> 01/02/2008
<b>No of victims:</b> 2	<b>No of documents:</b> 1

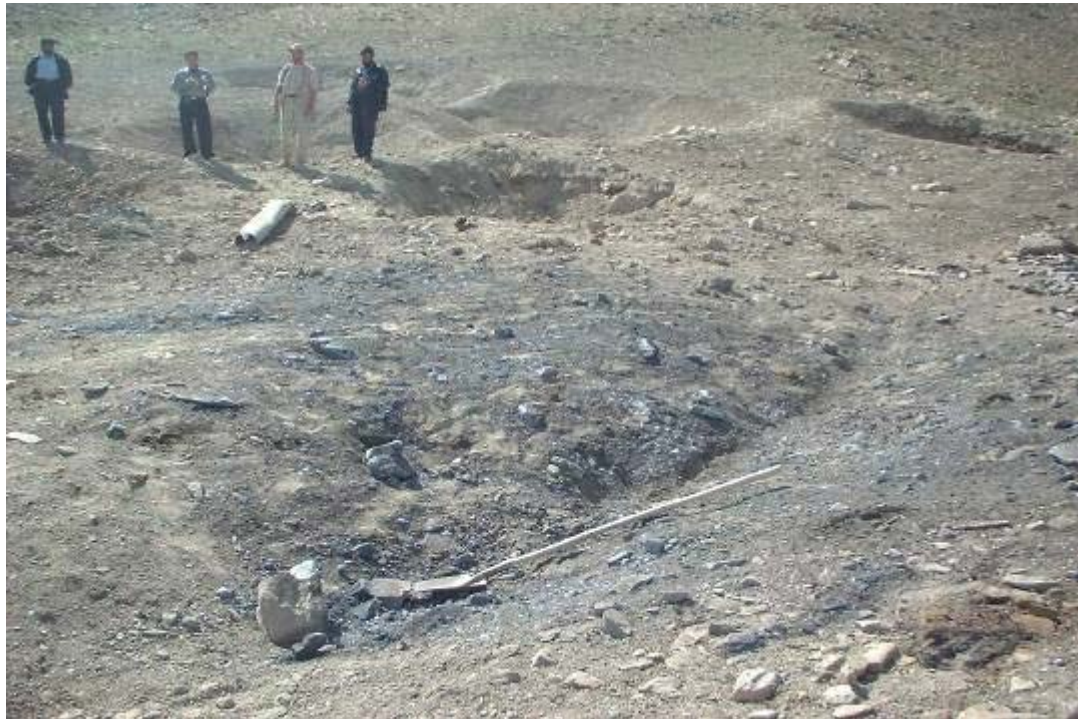
Based on the findings of investigation team from the accident point and shrapnel taken out from the wounds of the deminer, a flare has got fire and caused the injuries.

The Victims were working without PPE. This is presumed because of the injuries received and the fact that their uniforms were damaged but no PPE was damaged. The photograph of the investigation showed men without PPE. It may be that the demining group performed BAC and ordnance disposal tasks without wearing PPE, and that this was approved by the National Authority. However, given that most UXO accidents involve fuzes, it would always be worth wearing PPE.

As the flare was kicked out from the demolition and the possibility of risk was still in place therefore, the deminers should not touch the kicked out UXO without the permission of team or section leader. And also they must keep the specific distance between each other while doing BAC after the demolition.
