DDAS Accident Report

Report date: 02/02/2008	Accident number: 547
Accident time: 11:05	Accident Date: 22/08/2006
Where it occurred: Task # 709, Nr Paktia Kot, Ward 12, Central District, Kabul Province	Country: Afghanistan
Primary cause: Field control inadequacy (?)	Secondary cause: Management/control inadequacy (?)
Class: Missed-mine accident	Date of main report: 28/09/2006
ID original source: OPS-27/412-06	Name of source: UNMACA
Organisation: [Name removed]	
Mine/device: PMN AP blast	Ground condition: dry/dusty grass/grazing area rocks/stones
Date record created:	Date last modified: 02/02/2008
No of victims: 1	No of documents: 2

Demining Investigation Report

Device that caused the incident/accident: PMN AP blast

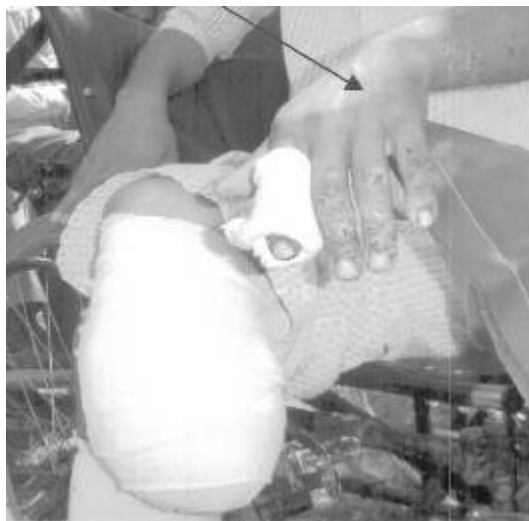
[The victim with amputated right leg and injured left leg and left hand.]

5- Amputation of RT leg also RT hand and left leg got injured

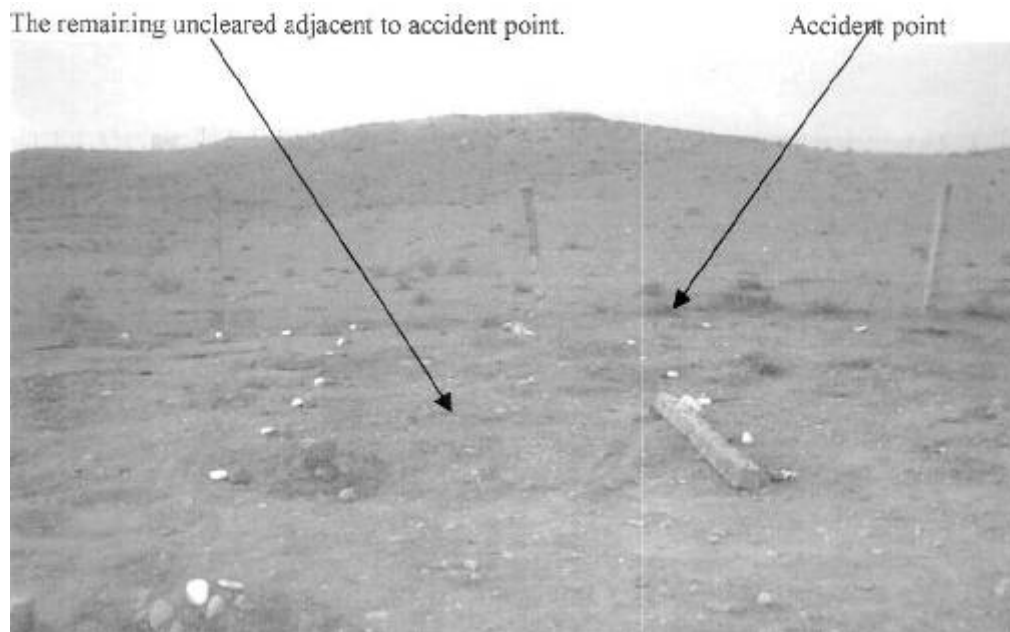
Site conditions: The terrain was hillside. The ground was soft. The weather was clear, calm and warm. There was no or light vegetation.

[The accident site was very open and relatively flat.]
