# DDASaccident548

# DDAS Accident Report

## Demining Investigation Report

Location: Former Border Regiment-5, Dopushta, Injil District, Herat Province

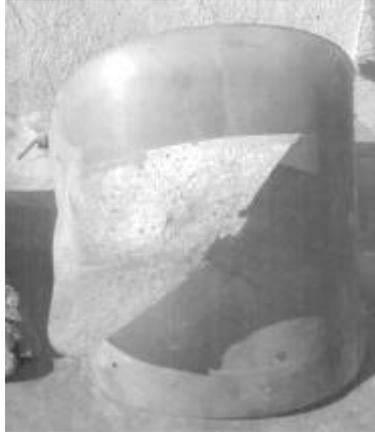
[The Victim's visor: the disposable scratch guard was heavily damaged.]

The damage to the vest was minimal and there was no damage to the lower protective piece that covers the knees and legs. This lack of damage and his injuries indicates the deminer was sitting/squatting with the lower protective piece between his legs and was not kneeling and thereby exposed his right knee to the detonation. All the blast fragmentation damage was also along the right side of the vest and visor further indicating he was facing sideways when the mine exploded. There is only damage, to the right side of the visor. The deminer was not kneeling and fully protected when the accident happened.

Equipment/property damage: Visor, vest and received some fragments. Prodder damaged.

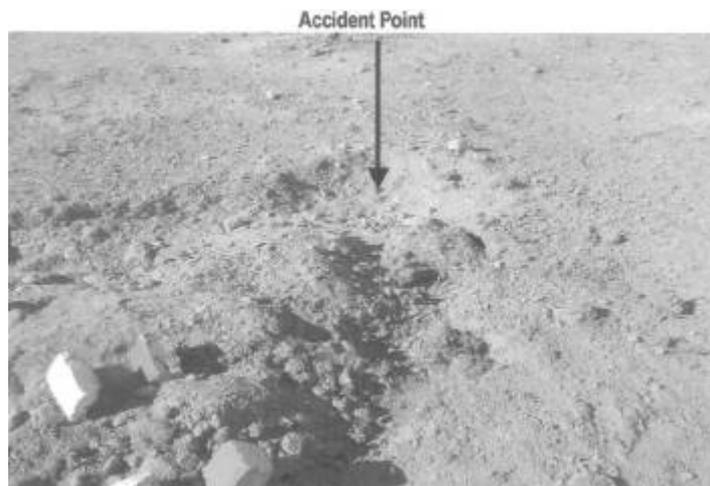
Site conditions: The terrain was flat and open. The soil was medium hard and dry. The weather was clear, calm and mild. The vegetation was grass [none].

[The accident site.]

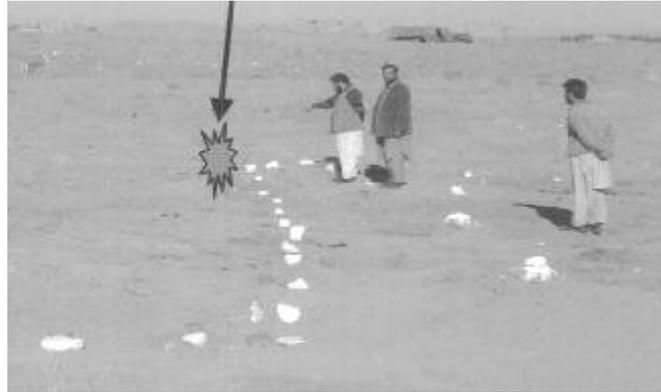
It is unfortunate that the investigators conducted their investigation without wearing PPE. This is not uncommon, but does set a bad example to the deminers. Their inclusion of a photograph showing them at the accident site implies that it is normal for them to enter a mined area without PPE.
