DDASaccident550

Humanitarian Demining Accident and Incident Database

DDAS Accident Report

Investigation Report of Mine/UXO Accident/Incident

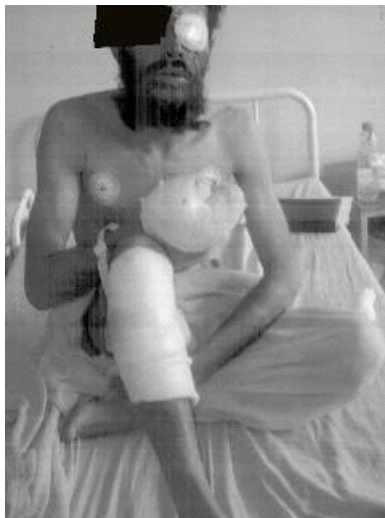
Eyesight damage both eyes: head/Neck above lips. Upper limbs. Lower limbs.

A sketch showed injured lacerations on face and eyes. Injured on right hand. Injured below right knee.

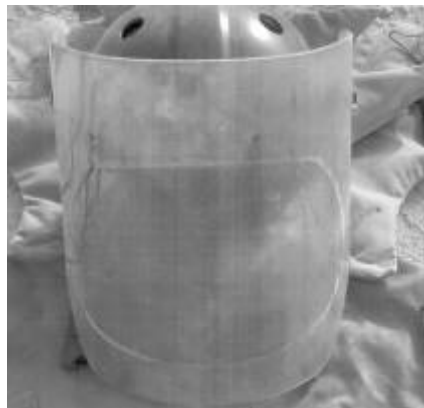
Answer No 5: Yes the deminer has worn the PPE but the visor the deminer has used was without having blocking clip and therefore during the explosion of the mine pressure kept up the visor and therefore he got injuries.

Note: In a blast event, there is nothing to raise the visor until the fragments strike, closely followed by the blast wave. A loose visor in a down position is often torn off by the passage of the blast-wave, but it could not be raised before the fragments struck. In this case, the deminers were inventing an impossible phenomenon as an excuse because they had been told that the Victim would not get his insurance if he was at fault. That the deminers had been frightened with this kind of threat illustrates a significant “Management control inadequacy” that has often been tried by demining groups, and is always quickly dropped. The deminer with a raised visor is, by definition, being poorly supervised, so is not the only one at fault.

In this case, the deminer may have raised his visor because it was in poor condition and hard to see through (some visors needed to be replaced). A picture of the Visor is shown below. Whether it sustained any damage in the accident is unknown, but the visor shown would be hard to see through.

V. The [International demining company] is recommended to provide helmets to their teams with locking visors.

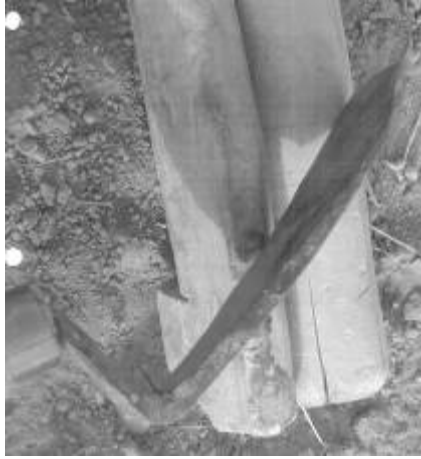
Answer No 2: While I was excavating with a small shovel (Rumbay more like an Adze).

The secondary cause is listed as inadequate equipment because the Victim’s hand tool was bizarrely inappropriate, and neither designed for purpose nor blast-resistant. A picture is shown below.
