# DDASaccident551

Humanitarian Demining Accident and Incident Database  
*AID*

# DDAS Accident Report

## Demining Investigation Report

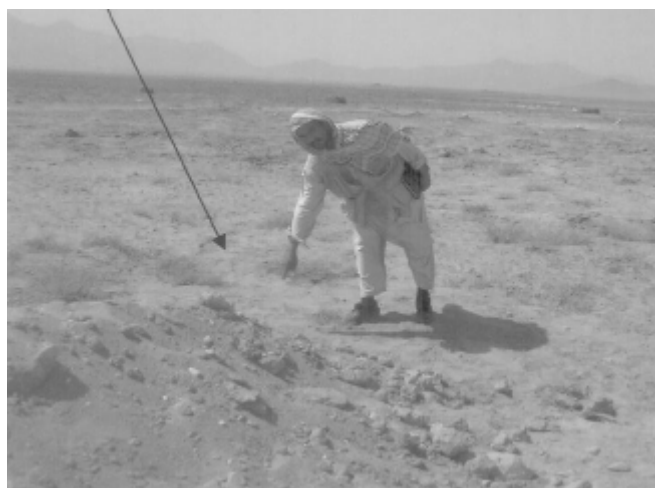
Site conditions: The terrain was open and flat. The soil was soft and dry. The weather was clear, calm and mild. There was no vegetation.

[The accident site.]
