DDAS Accident Report

| Where it occurred: CBU Site No: 483, Nr Al Smaaiyeh Village, Tyre District | Country: Lebanon |

BOARD OF INQUIRY – No 001/2007

BAC Accident that occurred in Area 7-004 (CBU 834), UTM 707747/3677539 on 19th January 2007 in which [Demining group] BAC Team Leader [Name removed] was injured.

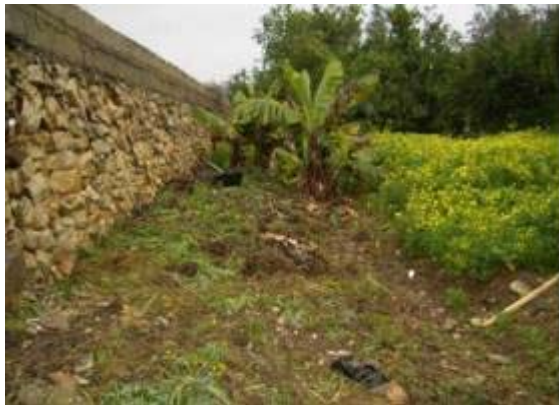
[The accident site.]

9. At approximately 1008hrs, an uncontrolled explosion occurred in box C3, involving [the Victim]. At the time of the accident all team members were wearing PPE (jacket and visor).

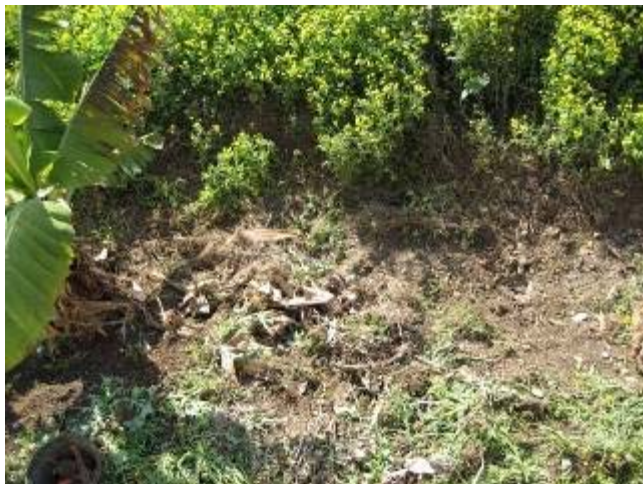
Location of the Accident

The area of the detonation was located to the rear of the area where visual search operations were being conducted.

The accident occurred in box C3.

[The left of the picture is the area in which the three searchers were conducting visual search clearance to the front of the team supervisor.]

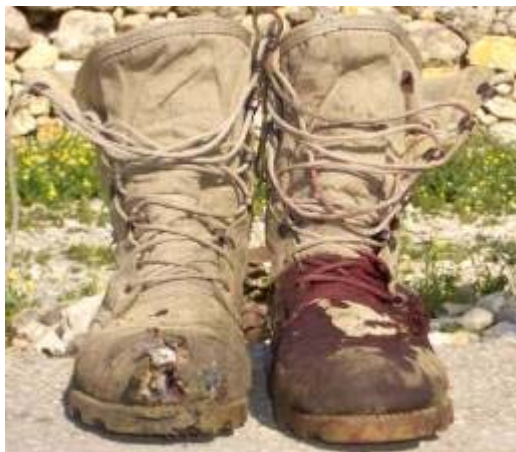
[The Victim's boots are shown below.]

The toe of the right boot confirms the contact point to the M77.

Damage to both the left and right boots was confirmed.

[The damaged area on the toe of the right boot where it made contact with the M77 is visible. There was no damage to the sole of boot. Metal fragments entered the right side of the left boot and exited through the right side.]

- c. The damage to the right boot reveals no damage to the sole. The boot has a large fragment embedded in the toe section. The left boot shows signs of fragmentation but is otherwise undamaged.

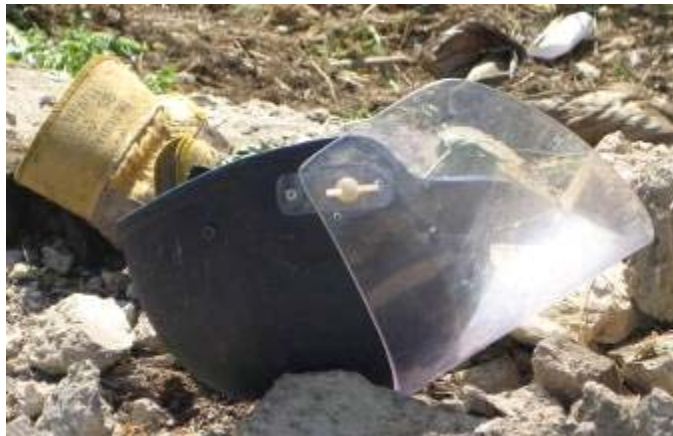
[The Victim's visor.]

15. At the time of the accident, the searchers and Team Leader were wearing protective vest, helmet and visor.

From the evidence gathered, it can be established that [the Victim] was wearing his PPE correctly at the time of detonation.
