DDASaccident557

DDAS Accident Report

INDEPENDENT INVESTIGATION REPORT 010/2007

AT TASK CBU-193 B/D 5th July 2007

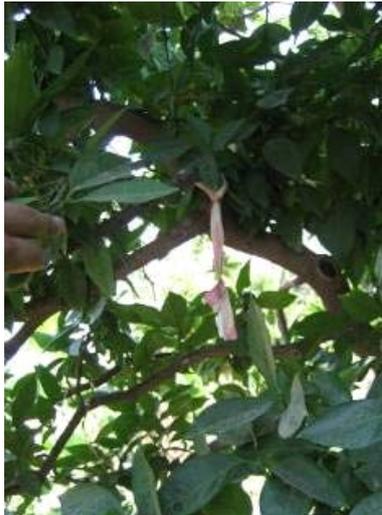
The items were found, neutralized and removed from the originally place of find by farm workers. Place from where the sub-munition (M46) had been removed was a branch knob of a lemon tree. The item was to have been hanging on the branch knob of a lemon tree, aside the farm road, 1-2m inside grown lemon trees and just about 10m away from the water pump facility.

The M46 which was hanging in a lemon tree and just 1-2m away from the farm road is very difficult to be missed if you passing every day through the area, and while conducting BAC procedures, searchers are cutting some branches to make the way into the plateau.

The suggestion that any missed devices would have been seen should be viewed in context, The picture below shows the place where the M46 was reportedly found.

The foliage makes it credible that it could have been missed.

A visual search of all branches of the citrus trees in CBU 193 B and D.

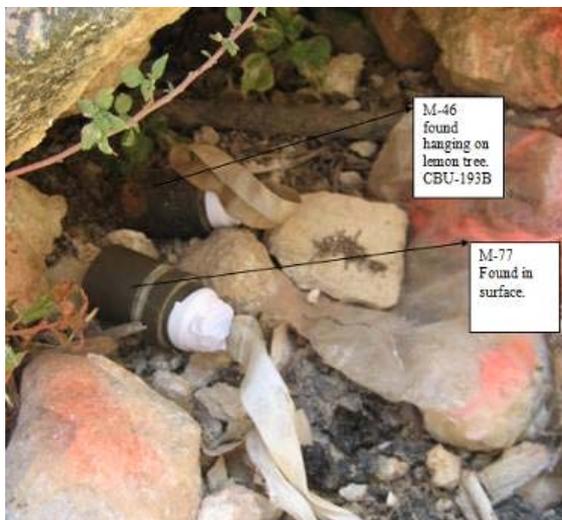
Both items had the ribbon intact, the M77 did not have any physical damages or rust of any significance possible indicating that it had not been in contact with the ground or exposed to the elements. The M46 had rust on one half of the casing, most of the rust on the lower portion possible were it was in contact with the ground.

The picture above shows the two devices where they had been moved after tapping around the arming mechanisms.

While it is unlikely that a submunition left hanging in a tee would rust on one side, a submunition pressed into the ground for a significant period would probably do so. Because the two munitions are similar and had been moved prior to the investigators seeing them, one

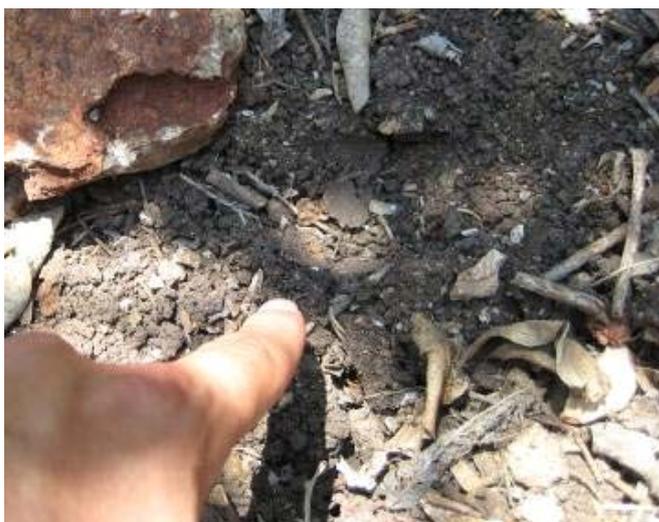
The place from where the sub-munition (M77) had been removed was still obvious and it was therefore, possible to locate the imprint. The item was situated beside the farm road, in a corner of one plateau, 1-2m inside of the orange orchard. The vegetation was low-medium on surface.

The picture above shows the site where the M77 was reported to have been found.

A visual search of the base of all citrus trees of CBU 193B and D.
