DDASaccident559

DDAS Accident Report

Minefield Task Number: UNIFIL002 CBU-33

Location: Zibqin Village (710934—672861)

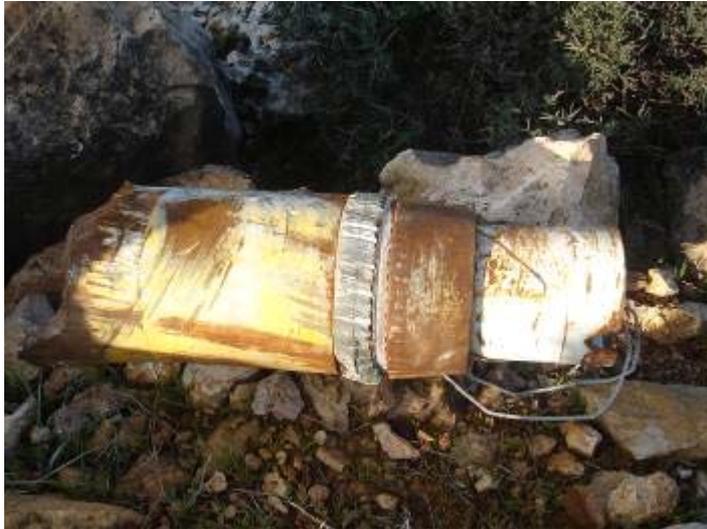
TYPE OF INCIDENT: Burning injury by an unexploded 155 mm illuminating shell (half body remains with explosives visible outside) on demolition site.

[The illumination shell.]

Conclusion: Whenever a damaged UXO is located, demolition should be carried out in-situ and no removal and direct contact is allowed.

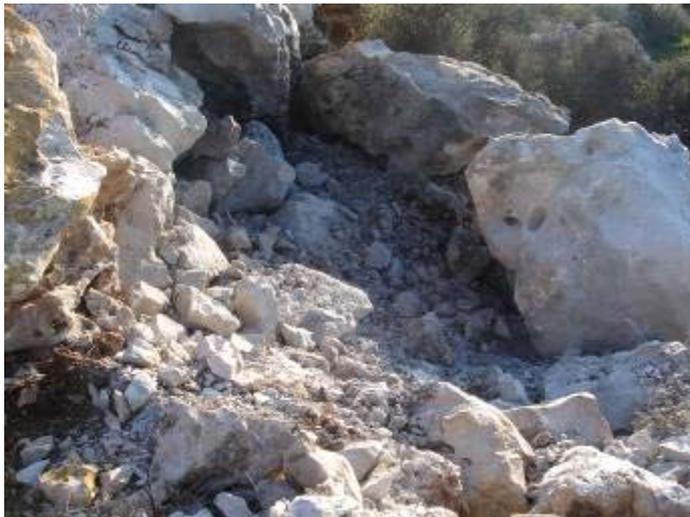
[The accident site.]

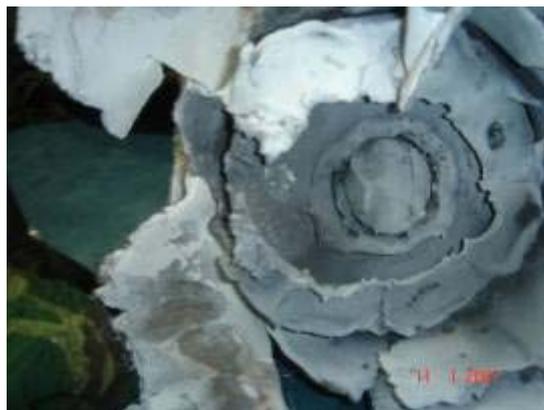
[The device did not detonate, merely burned, and was photographed again after it had burned out.]

We are strongly believe that the explosion happened, because there are still a white powder in the illuminating canister in the rear part of the UXO. Any friction or disturb for the white powder make a chemical reaction, a flame will occur and after that explosion will take place for the detonator and TNT Charge that was placed by the deminer for disposal. The white powder was disturbed for unknown reason, which it caused the flame and explosion, [the Victim] gets injured because of the flame.

All kinds of illumination UXO should be disposed in Situ unless it is located in built up area, it is required to move or relocate the UXO to safer place.

DO NOT disturb the white powder.

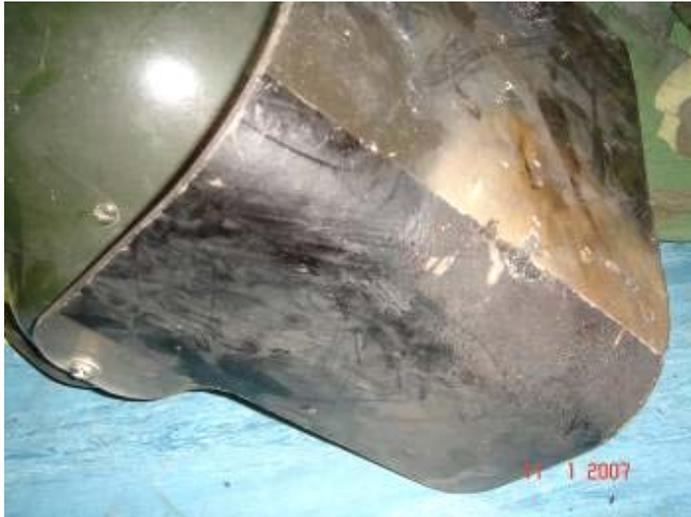
PPE was partially burned; visor was still in good condition.

The flame get under the visor where no protection for the neck.

Without a Medical report it is unclear whether the Victim's eyes were affected. A photograph showed the top of his protective vest burned through, showing that the flames struck jim in the neck area. The visor used was a cold pressed polycarbonate visor attached to a combat helmet

The sides appear to have been painted to prevent glare, and the front appears flame damaged – possibly on the inside – but with some marks on the outside.

During the examination, relocating or disposal procedures for the UXO, at least it is required to wear PPE EOD-7B during the whole process of disposal.

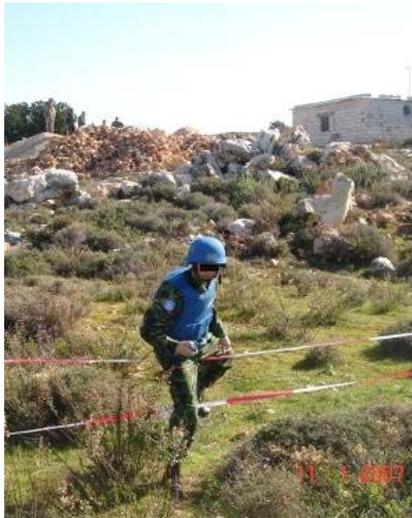
As is frequently the case, the internal investigators seemed to enjoy taking photographs of each other without visors and even when stepping outside the marked area.

The investigators from the National MAC also recommended that the investigators should carry metal-detectors when on site. A metal detector would certainly have made it safer to move around in relative safety.
