DDAS Accident Report

INDEPENDENT INVESTIGATION REPORT 011/07

FOR [International commercial company] DEMINING INCIDENT

AT TASK CBU- 771 2nd July 2007

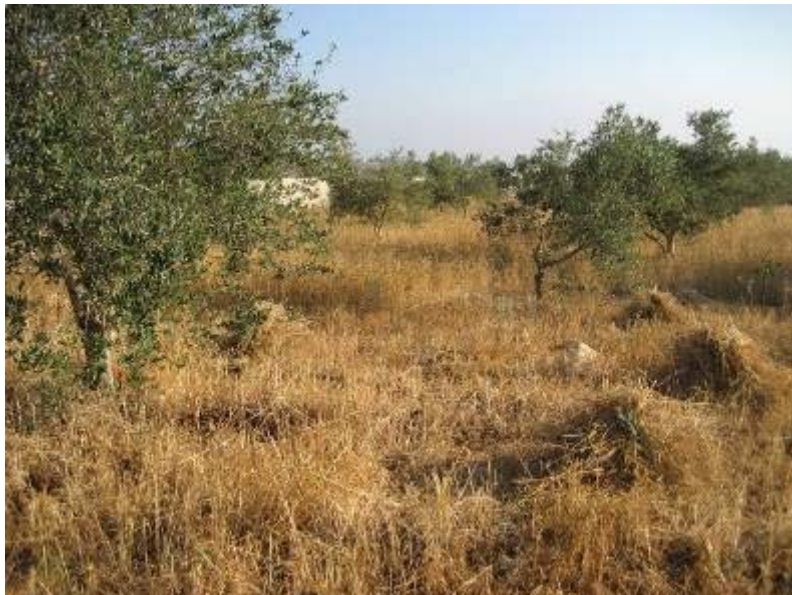
The ground was flat, comprising hard soil and the area had been covered with wheat. A significant area where the items were located had been harvested by the land owner. This had been piled for removal. See photographs at Annex E. The local land owner was harvesting the wheat and located the sub-munitions.

[The accident site is shown above.]

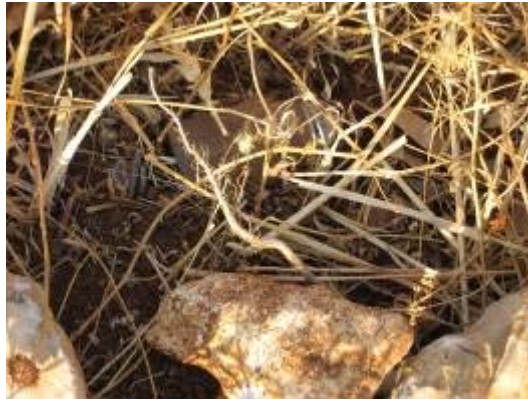
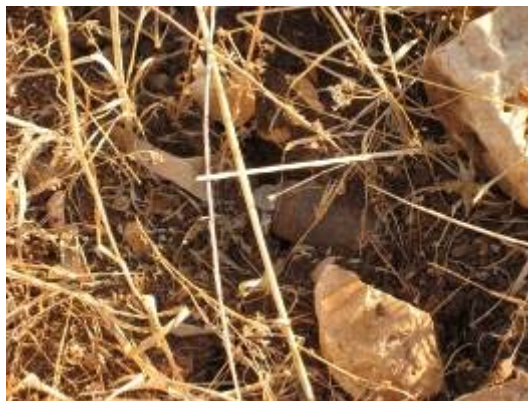
The items had not been removed; the location had been marked with pickets and stones. The items were clearly visible on the surface but would be difficult to see but not detect during sub surface clearance. The area where the items were located was identified and confirmed as part of the CBU that had been cleared sub surface. The items were situated in the middle of the area cleared sub surface approx. 10-15m apart.

[The munitions are shown above – easy to locate with any metal-detector search.]

The area was not cleared sub-surface in accordance with the [International commercial company] SOPs or the NTSGs.

c. The area in question is to be re-cleared using the appropriate sub-surface clearance procedures, in accordance with [International commercial company] SOPs and the NTSGs, until fade or the MACC Ops Officer confirms not additional clearance is required in this site.
