# DDASaccident562

# DDAS Accident Report

<b>Report date:</b> 08/02/2008	<b>Accident number:</b> 562
<b>Accident time:</b> 10:26	<b>Accident Date:</b> 23/08/2007
<b>Where it occurred:</b> Task No: 6-015, DA CBU No. 585, Near Najdh	<b>Country:</b> Lebanon
<b>Primary cause:</b> Unavoidable (?)	<b>Secondary cause:</b> Field control inadequacy (?)
<b>Class:</b> Handling accident	<b>Date of main report:</b> 25/08/2007
<b>ID original source:</b> None	<b>Name of source:</b> UNMAS
<b>Organisation:</b> [Name removed]	<b>Ground condition:</b> bushes/scrub leaf litter rocks/stones trees
<b>Mine/device:</b> DPICM M77 submunition	<b>Date last modified:</b> 08/02/2008
<b>Date record created:</b>	<b>No of documents:</b> 1
<b>No of victims:</b> 1

Task No: 6-015, RECCE 1: DA CBU No. 585

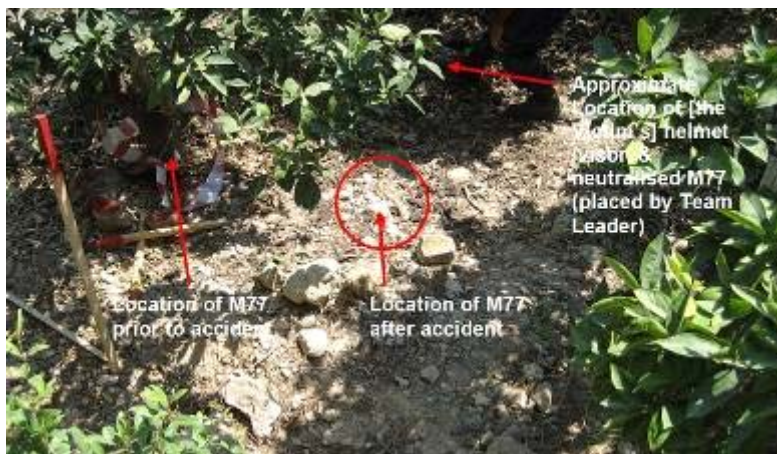
[The victim was handling a device when the accident occurred. Another “gagged” device was close by.]

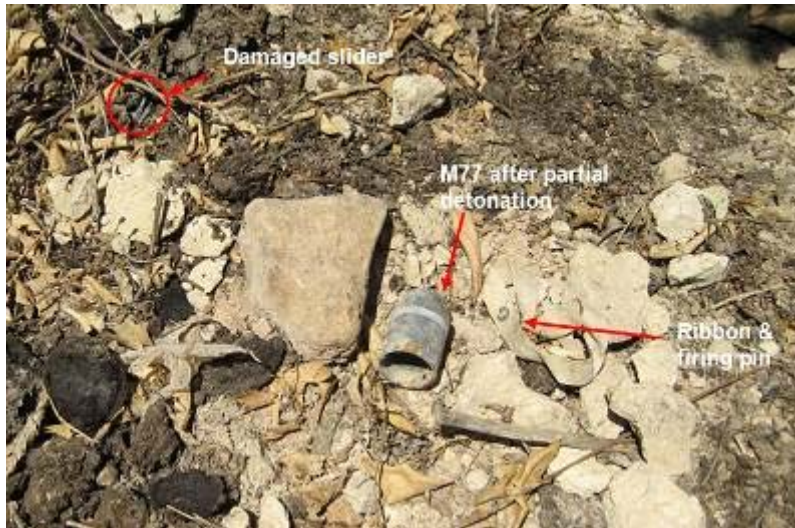
[The M77 partially detonated in the Victim’s hand, but the main charge did not explode. The picture below shows the device afterwards, with the firing pin and ribbon separated.]

The M77 involved in this accident did not detonate properly and may have been damaged. If this was visible, it would imply that the Victim made an error by touching it. But if the damage was not visible, the Victim was just extremely lucky.

The primary cause of this accident is listed as "Unavoidable" because it seems that the Victim may have been operating as instructed and the accident occurred due to a device that was damaged and unstable, but not obviously so.

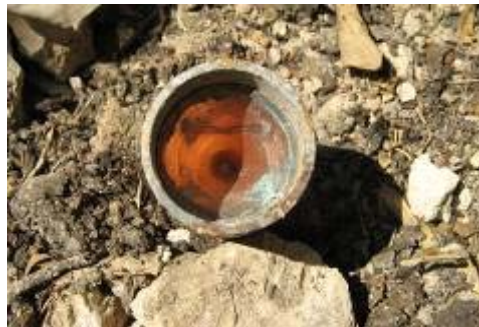
[The copper cone of the shaped charge inside the M77 was visible at one end, and the high explosive fill at the other.]

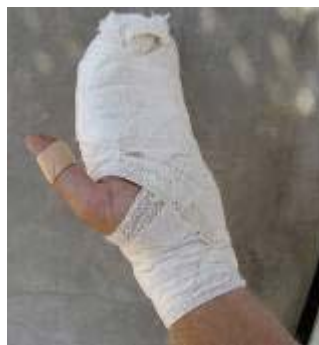
[The Victim's right hand was injured.]

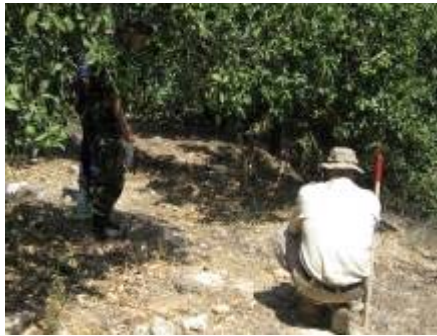
[Pictures of another disarmed M77 showed that this was not a non-intrusive survey. Technical Survey is usually intrusive, but the tasking order from the MAC into the order that "No" clearance be conducted - and this was stressed in Bold.]

[Pictures of the Victim's PPE showed an undamaged visor and a short frag-jacket with blood stains.]

[Pictures of the investigators at work showed that they did not wear PPE.]

The failure of the demining group’s investigators to wear PPE at the site is common, but sets a bad example.
