# DDASaccident563

Humanitarian Demining Accident and Incident Database  
*AID*

# DDAS Accident Report

## **BOI Investigation report**

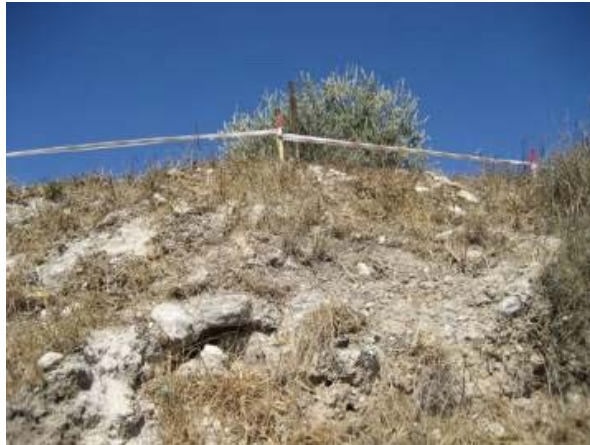
[The site on the steep side of a ridge. The point of detonation is roughly central in the photograph below.]

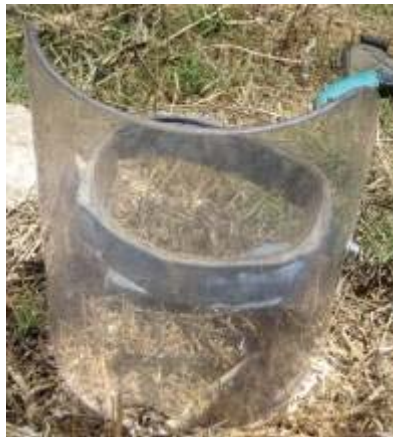
[Victim No.1]'s visor was located approx 5m from the seat of detonation. The visor was inspected during the investigation and there were no evidence of any damage to it.

Dust/dirt was located on the inner side of the visor and it was positioned in such away that the inner side was facing the direction of the detonation is believed to have occurred.

It is inconclusive as to whether searcher ([Victim No.1]) was putting on his visor during the time of detonation as the injuries he sustained were to his right ankle and his right buttock and nothing on the left leg/side.

[The undamaged visor.]

- e. Supervisory staff should ensure that PPE is worn correctly at all times when working in the hazardous area; this should be followed up by [International commercial demining agency] internal QA requirements.

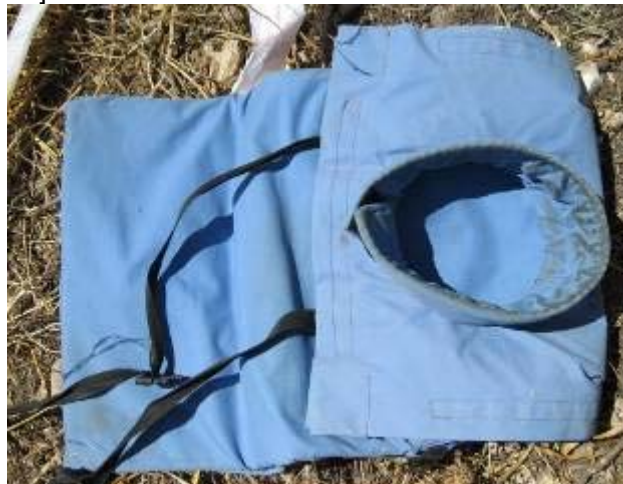
[The unused protective apron.]
