# DDASaccident566

# DDAS Accident Report

## **BOARD OF INQUIRY (BOI) REPORT 003/2007**

on [International demining company] INTERNATIONAL LIMITED DEMINING ACCIDENT that occurred on the 05th March 2007 in which a [International demining company] Deminer was injured

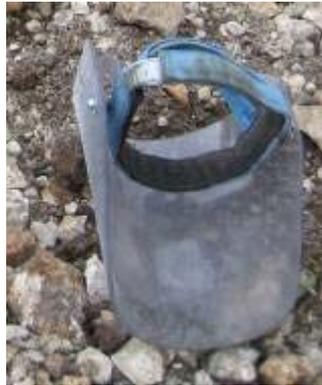
examined at the site by the MACC investigation team on 05 March and by the BOI team on 06 March 2007, at the [International demining company] office in Nanbatiyah. The visor is still complete with the headband in place. The exterior of the lens is covered in shallow indentations / scuff marks which it is believed was caused by rock fragments from the explosion. The exterior of the lens is covered in a thin layer of dirt / dust. The interior of the lens is slightly dirty / dusty which is more evident on the left side. There are no holes or cracks in the visor. **The condition of the visor indicates that it was being worn correctly at the time of the accident.**

[The Visor: see Analysis.]

The visor was raised because facial injuries extending to the Victim’s forehead could not have occurred if the visor has been in its correct position. The Victim’s eyes were probably saved by the fact that this demining group (uniquely at the time) wore industrial safety spectacles as well as the visor, and the spectacles were in place. They were broken in the blast and a photograph of one “arm” of the spectacles under a rock is shown below.

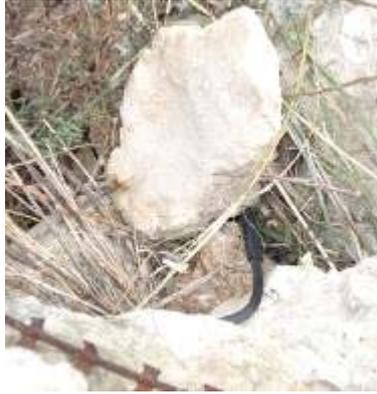
The demining group started to wear industrial safety spectacles underneath the visor after a series of visor failures in Lebanon. Subsequent investigation showed that the visors involved had been in service for many years and had probably been hardened by UV exposure. See Accident No. 383, for an example.

The picture above also shows razor wire, which was present at the accident site and may have made metal-detector use unreliable.
