DDASaccident567

DDAS Accident Report

REPORT FOR ACCIDENT INVESTIGATION BOARD OF INQUIRY – No 004/2007

INVESTIGATION REPORT ON A M77 SUB-MUNITION ACCIDENT AT CBU 040, AREA 7-001. Al Bazuriyah

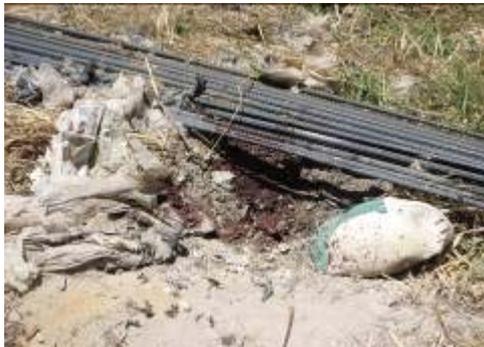
[Point of detonation was beneath the pile of reinforcing bar.]

- The area in which the suspected sub-munition had detonated would seem to indicate that the munition was sub-surface
- A quantity of concrete reinforcing bar was directly adjacent to the site of the explosion.
- The site of the explosion was also contaminated by other construction and general debris.

- The area of the accident is to sub-surface cleared, immediately.

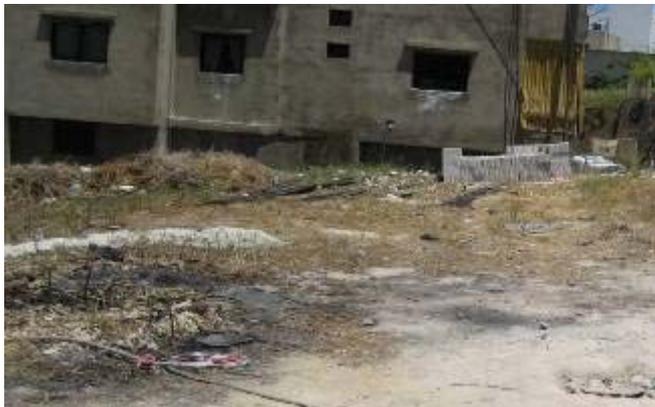
[The reinforcing bar is in the centre of this picture near to the building.]
