# DDASaccident568

# DDAS Accident Report

REPORT FOR ACCIDENT INVESTIGATION BOARD OF INQUIRY – No 005/2007

BAC Accident that occurred in Area 7- 008 (CBU 071), UTM 728309/3676516 on the 21st June 2007 in which a searcher was injured.

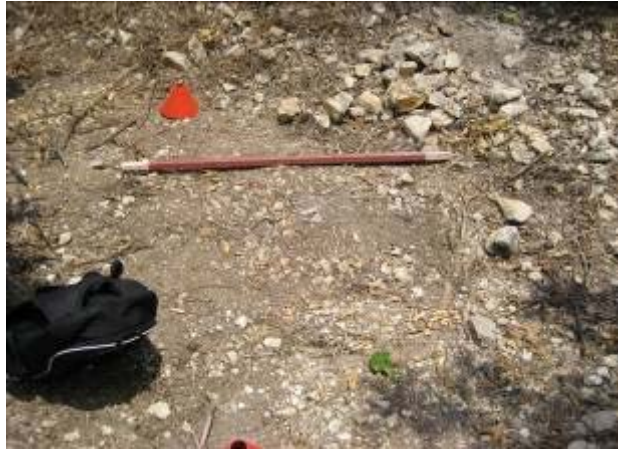
- There had been an uncontrolled detonation of an M42 Sub-munitions,
- The M42 was either partially or completely buried,
- The area of the detonation was at least 1m forward of the base stick, in an uncleared area.

[The crater is top right, the red cone is the marking system in use.]

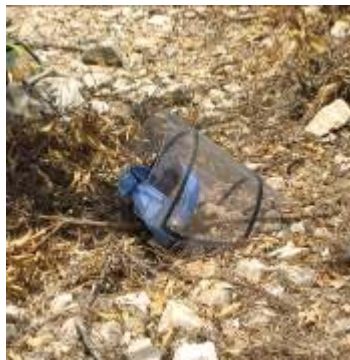
[The undamaged visor approximately 9 metres away.]

The visor was laying in good order on 9 meters distance from RP, indicating that the searcher or other person has intentionally put the visor down on the ground without to prevent getting scratch marks.

The Visor position could indicate that the searcher has taken the visor off inside the hazard area during work time. If so, this is a major safety violation and not follows the [Demining group] SOP.

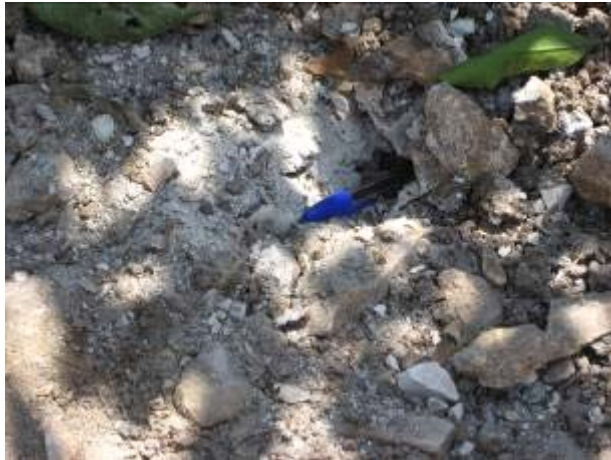
- b) An uncontrolled detonation occurred in an area where the earth had been gathered to provide a bund around citrus trees to retain water for irrigation.

[There was no earth in photographs, but stones – and no obvious “bund”. This picture shows a pen at the seat of detonation.]

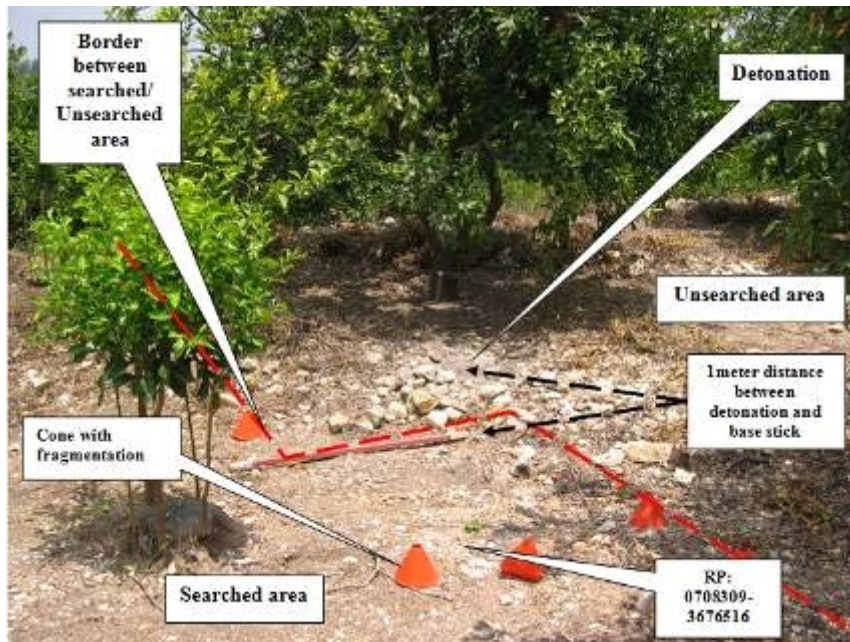
Picture 1.

The border of searched/not searched areas was well marked. The location of detonation was 1 meter in front of ongoing search, in not searched area. One cone was lying flipped over and was most likely moved by air pressure. One cone is penetrated of several fragmentations.
