DDASaccident569

DDAS Accident Report

BOARD OF INQUIRY (BOI) INVESTIGATION REPORT

Ref: 06/2007

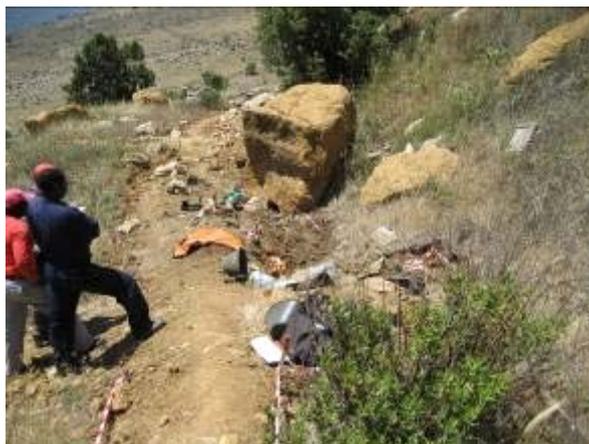
[Photographs taken by the internal demining group investigation showed staff not wearing PPE.]

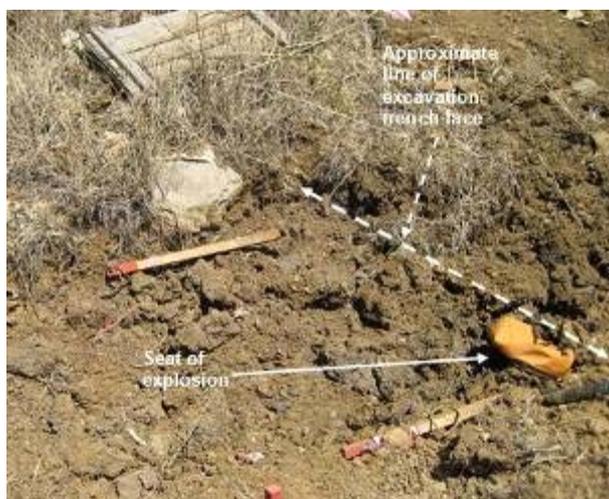
Photographs of the crater and the accident site were taken during the investigation, however it was not possible to physically examine the crater as the immediate area is pending further clearance as part of the on-going investigation. The crater was partially obscured by an orange bag and comprised loose clumps of earth and there was evidence of burn marks on the inside of the crater which is consistent with the effects of an explosion. The crater was shallow which may be attributed to the hardness of the ground and that the explosive device had been close to the surface. The BOI team had been informed by (Commercial demining group) that the closest mine located had been at a depth of 3 cm and that mines were generally found at a depth of 3-10cm.

[It is strange that people stood this close to the seat of initiation but did not think it safe to move the orange bag.]

Although, it was apparent that some excavation had taken place in the area of the crater, the precise location of the excavation trench face was not obvious due to the nature of the ground.

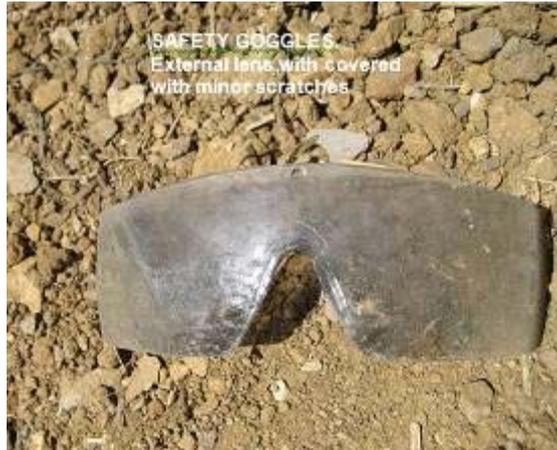
According to information received during the interview process, the casualty was wearing safety goggles beneath the visor prior to the accident. The lens was intact, slightly scratched on the outside and dirty across the inside. Both of the arms were missing. The goggles had retained their integrity during the explosion. The dirt on the interior lens, injuries sustained to the right eye and information from the medic that both eyes required cleaning, indicates that although, the goggles may have been worn correctly, they were unable to provide complete protection to the eyes during the explosion. It is possible however, that had they not been worn, the damage to the both eyes may have been more severe.

[The goggles did not “retain their integrity” because their arms broke off. They appear to be 2mm thick.]

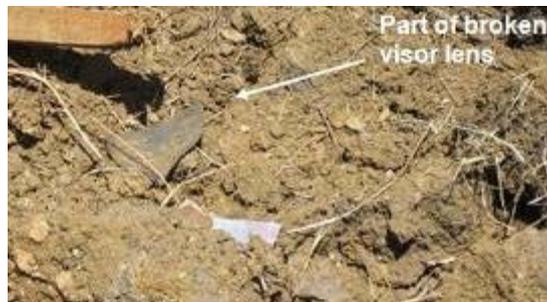
According to information gained during the interview process, the Team Leader had seen [the Victim] wearing his PPE consisting of body armour, visor and inner safety goggles, correctly. The only visor evidence at the accident site was part of the lens which was positioned in the front / left side of the clearance lane and the harness. The broken lens was dirty and in the proximity of clumps of earth which appeared to be burnt. The visor harness was visible a few metres slightly forward and left of the clearance lane on the bank of the hill in an uncleared area. The lens was not attached.

[See Analysis.]

This evidence and the injuries sustained by the casualty indicate that the visor had been worn at the time of the explosion. The colour and shape of the lens fragment indicates that it had been broken off from the edge of the visor during the explosion and the location of the harness signifies that the visor had been pulled from the deminer’s head by the blast from the explosion. There was no other visor evidence in the immediate accident area which suggests that it had either shattered or been thrown into another area.

Visor lens broken and the location of harness;

It should be possible to conduct a thorough examination of the lens fragment and visor harness after additional clearance of the lane has been conducted.

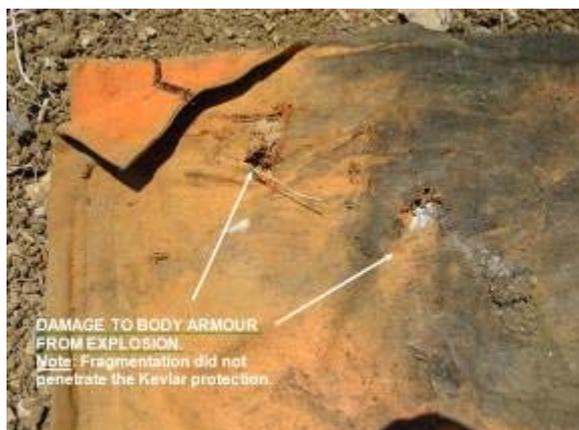
The body armour is a one-piece 'apron style' design and comprises Kevlar protective material which covers the neck, chest, abdomen and groin regions of the body. The apron was covered in dirt and blackened through the blast effects of an explosion. There were tears on the outer cover primarily in the centre lower, right lower, right upper, right shoulder and right side of the collar which corresponds to the fragmentation effects of an explosion. There is evidence of blood on the right shoulder and around the rim of the collar. The Kevlar retained its integrity and the only evidence of penetration was a small hole on the seam of the collar.

[The apron is not made from Kevlar but a cheaper ballistic aramid. The position of its collar and the STANAG V50 rating of 380 m/s mean that it does not meet IMAS (as formulated in 2007).]

- l) The condition of the apron indicates that it had been worn correctly and that the right side took the brunt of the explosion.
- m) There is no evidence to suggest that the PPE was worn incorrectly by the casualty at the time of the accident. The type of PPE is in compliance with the NTSG and IMAS.

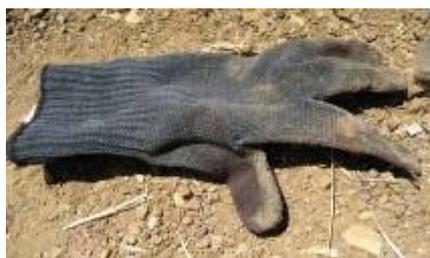
According to information gathered during the investigation, Aramid protective gloves had been worn by the casualty prior to the accident. It was only possible to locate the left hand glove at the accident site and its appearance corresponded to information that it was worn by the casualty at the time; dirt on the palm and fingers with evidence of blood stains. The absence of the right hand glove is consistent to the traumatic amputation of the casualty's right arm by the explosion.

[The glove that was not on the Victim's other hand. "Aramid" simply means nylon. There is no evidence that any aramid or Kevlar glove is of any value at close quarters to an AP mine blast.]

The issue of thin "aramid" working gloves is a novelty. Aramid is a nylon, and thin aramid could make severe burns worse by trapping the burning fragments (fragments "weld" themselves inside body armour at times). In order to be flexible, the gloves have to be thin. The protection offered by aramid varies by weave and by the number of layers used (12-16 layers is common), so the fragmentation protection the gloves offered must have been very low.
