DDASaccident571

DDAS Accident Report

Report on [Name removed] BAC ACCIDENT that occurred on the 29th January 2007 in which [Name removed] BAC members were injured.

EOD – Technical report, written by Cdt [Name removed] and 1MC [Name removed].

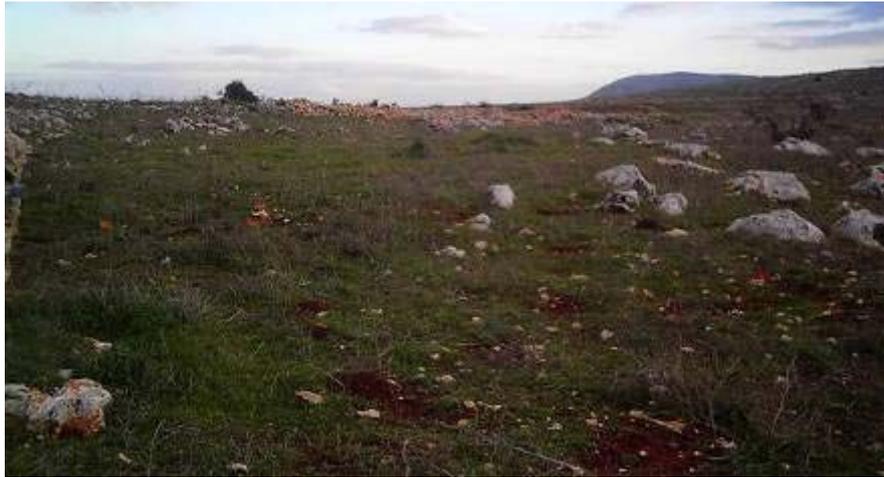
[The accident area.]

There was inadequate site marking. The photographs show no obvious marking at all. This allowed Victim No.1 and the medical team to enter an uncleared area without knowing it. A further accident was only avoided by luck.

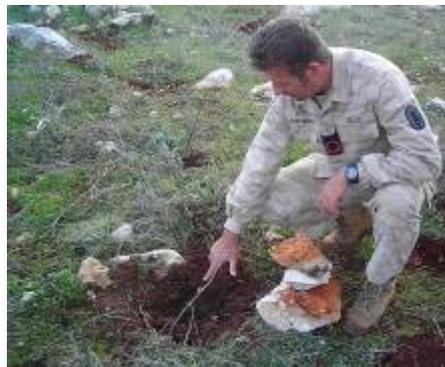
The place of the crater was in the cleared zone at 11.5 meters from the nearest marked rock, which marks the right limit of the cleared zone.

Dimensions: the crater has a diameter of 22 cm and a maximum depth of 16 cm.

The circular traces of the detonated explosives are 4 cm in with and were located at a depth between 8 and 12 cm in the crater.

We can conclude that the cluster was located at a depth of minimum 8 cm.

[An investigator examining the crater, without wearing PPE.]

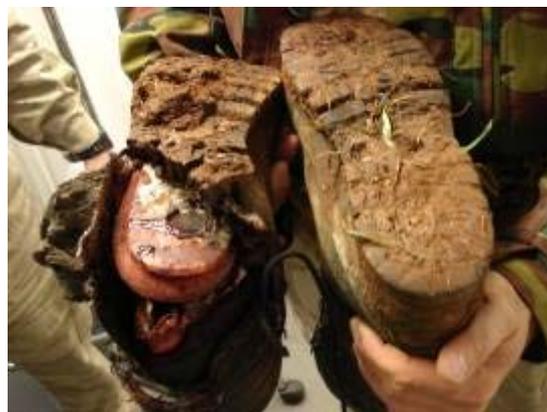
The shock wave and the fragmentation have cracked and ruptured the heel of the shoe of the victim.

Only the outer sole of the shoe is damaged. The inner soles are intact. We can suppose that the heel of the right foot was broken by the blast.

The nature of the injuries and the damage of the shoe suppose that the jet formed during the detonation of the M77, was directed to the underside and the detonation of the M77 was caused by the pressure of the heel of the right foot on the striker.

The boots of Victim No.1]
