DDAS Accident Report

Report date: 17/04/2008	Accident number: 571
Accident time: 09:30	Accident Date: 31/01/2007
Where it occurred: Nr Aytarun, Nr Aynata, Bint Jbeil Southern District, Nabatiyah Province	Country: Lebanon
Primary cause: Management/control inadequacy (?)	Secondary cause: Field control inadequacy (?)
Class: Missed-mine accident	Date of main report: 01/02/2007
ID original source: None	Name of source: UNMAS
Organisation: [Name removed]	
Mine/device: DPICM M77 submunition	Ground condition: grass/grazing area metal fragments rocks/stones steep slope
Date record created:	Date last modified: 17/04/2008
No of victims: 2	No of documents: 2

Report on [Name removed] BAC ACCIDENT that occurred on the 29th January 2007 in which [Name removed] BAC members were injured.

Object: EOD accident on the 29 Jan 07 at AYTARUN (UTM 730540 670297)

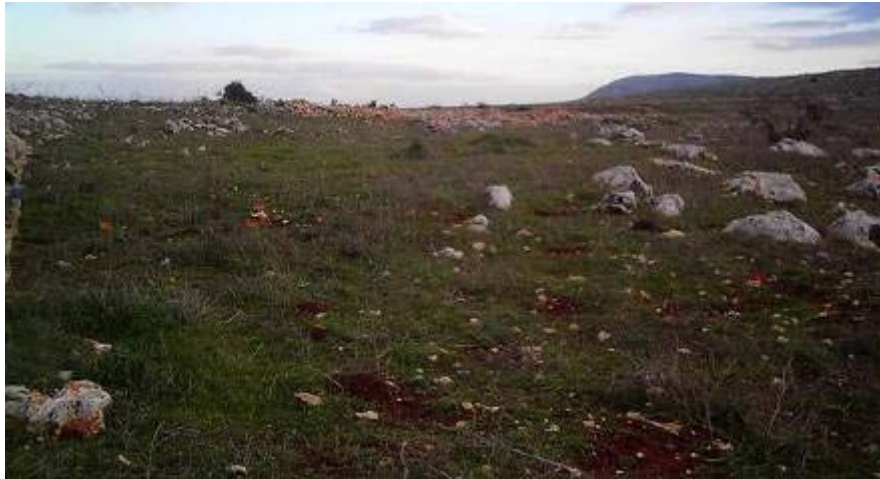
[The accident area.]

There was inadequate site marking. The photographs show no obvious marking at all. This allowed Victim No.1 and the medical team to enter an uncleared area without knowing it. A further accident was only avoided by luck.

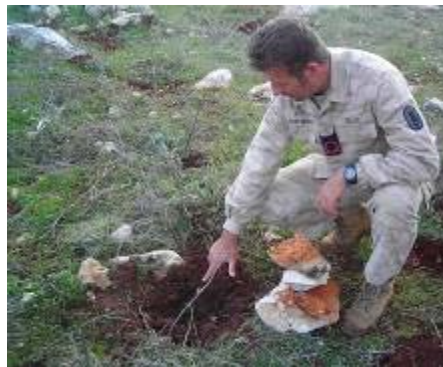
The place of the crater was in the cleared zone at 11.5 meters from the nearest marked rock, which marks the right limit of the cleared zone.

Dimensions: the crater has a diameter of 22 cm and a maximum depth of 16 cm.

The circular traces of the detonated explosives are 4 cm in with and were located at a depth between 8 and 12 cm in the crater.

We can conclude that the cluster was located at a depth of minimum 8 cm.

[An investigator examining the crater, without wearing PPE.]

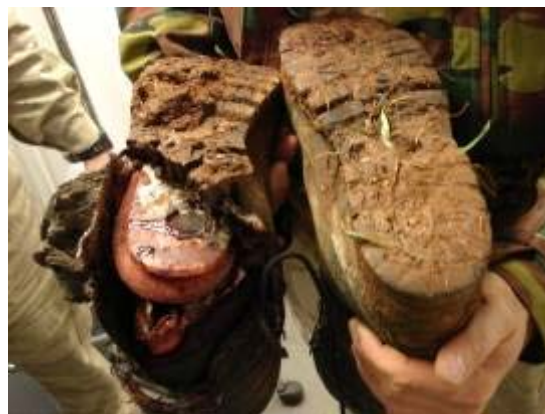
The shock wave and the fragmentation have cracked and ruptured the heel of the shoe of the victim.

Only the outer sole of the shoe is damaged. The inner soles are intact. We can suppose that the heel of the right foot was broken by the blast.

The nature of the injuries and the damage of the shoe suppose that the jet formed during the detonation of the M77, was directed to the underside and the detonation of the M77 was caused by the pressure of the heel of the right foot on the striker.

The boots of Victim No.1]
