DDASaccident572

Humanitarian Demining Accident and Incident Database
AID

DDAS Accident Report

Report date: 25/05/2008	Accident number: 572
Accident time: 10:23	Accident Date: 12/09/2007
Where it occurred: CBU 1038, Near Sidiqin village, Sur District	Country: Lebanon
Primary cause: Field control inadequacy (?)	Secondary cause: Field control inadequacy (?)
Class: Vegetation removal accident	Date of main report: 24/09/2007
ID original source: DS	Name of source: [Name removed]
Organisation: [Name removed]	
Mine/device: DPICM M42 submunition	Ground condition: agricultural (abandoned) bushes/scrub hard rocks/stones
Date record created:	Date last modified: 25/05/2008
No of victims: 1	No of documents: 1

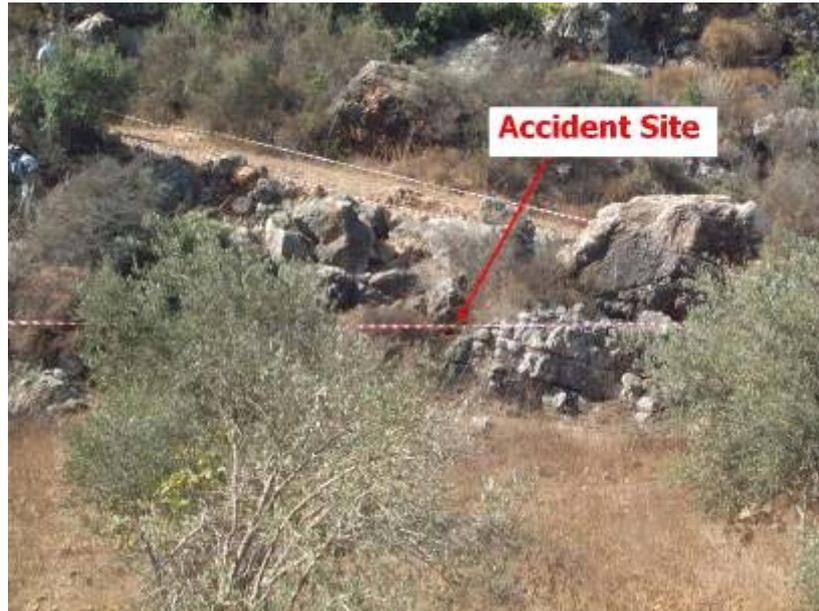
45. **Detectors.** Although this team is issued with; four Ebinger 421 GC and four Schondstat 72cd; it is worth noting that there was no detector found in the vicinity of the accident lane. When asked why? the Site Supervisor informed me that the searcher was not

using one due to the vegetation being encountered, which was sparse grass with high thorny bushes. See photograph [of site earlier in this report].

68. All members of the [Demining group] BAC operation will undergo eight hours of refresher training before returning to operations.
69. All searchers will deploy with and utilise a locator in their lanes, if [the Victim] had been using a locator he would have been forewarned of the presence of a metal signal and extra care could have been taken whilst visually searching and cutting the vegetation.

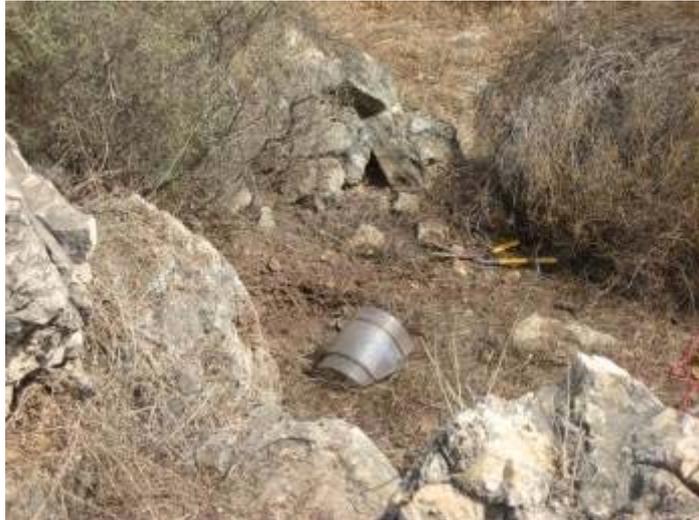
16. The marking in the search lane where the accident occurred was present although the rope to the left of the search lane had been moved during the course of the accident and subsequent casualty extraction. This included the blue start of work picket.

[Accident site showing inadequate marking which may have been moved after the event.]

From the photographs made available, it is obvious that site marking was not present. If it was moved after the accident, that would have been another field-control failing. It would be stupid to move the safe-area marking in order to evacuate a victim through uncleared areas.

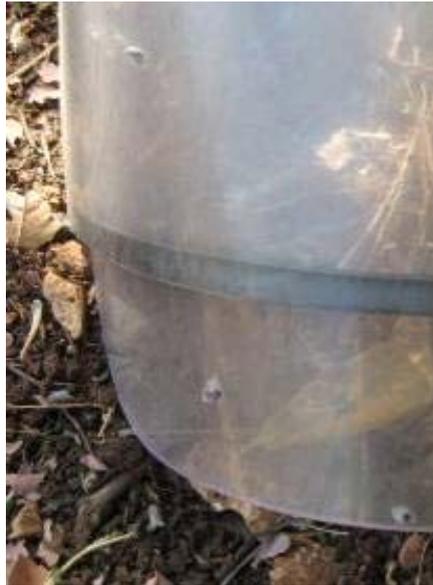
41. Visor. The visor worn by [the Victim] was struck four times by fragmentation as a result of the explosion. One of the fragments passed through the visor leaving a hole of approximately 2mm in circumference (it is thought that the fragment went through the visor and caused the wound on [the Victim's] neck). Photographs of the Visor are attached at Annex F. [Annexes not made available: photograph sourced separately.]

[The picture above shows the small hole in the lower part of the blast visor. The visor is not designed to protect against fragmentation, only blast.]

The fact that the visor was penetrated illustrates clearly that the equipment is designed for blast threats. The M42 is a combined effects munition with a very small quantity of high

explosive but very destructive fragmentation and a shaped charge capable of penetrating armoured military vehicles. The requirement to wear a visor in these circumstances may require rethinking. The visor distorts vision and this may have led to the Victim not seeing the M42 as he cut vegetation.

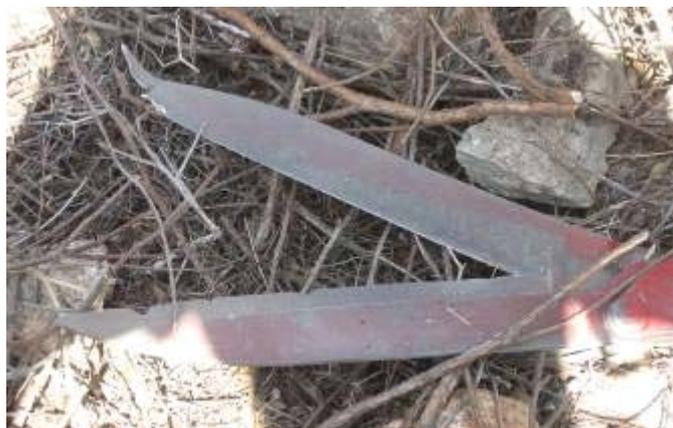
43. **Shears.** The shears are purchased locally for use in the cutting of visually or instrument assisted visually searched vegetation on the sites. The shears are damaged on the tips of the two blades, and were in close proximity to the explosion. [The Victim] stated that he was using the shears at the time of the accident. Photographs attached at Annex H. [Annexes were not made available.]

[Photograph sourced elsewhere. The short-bladed shears are not purchased locally but are part of a tool-kit sourced from Zimbabwe.]

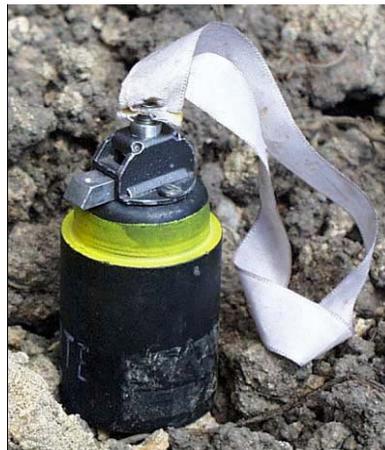
46. During the investigation of the crater several pieces of fragmented metal were recovered, although it is not possible to determine the exact sub-munition involved it is believed that it was an M42. This assumption is based on the fact that there have been four M42s removed from the area in the past.

47. The M42 is a DP grenade or bomblet designed as a ground burst sub-munition containing 31 grams of explosive; with both the shaped charge and high fragmentation effects.

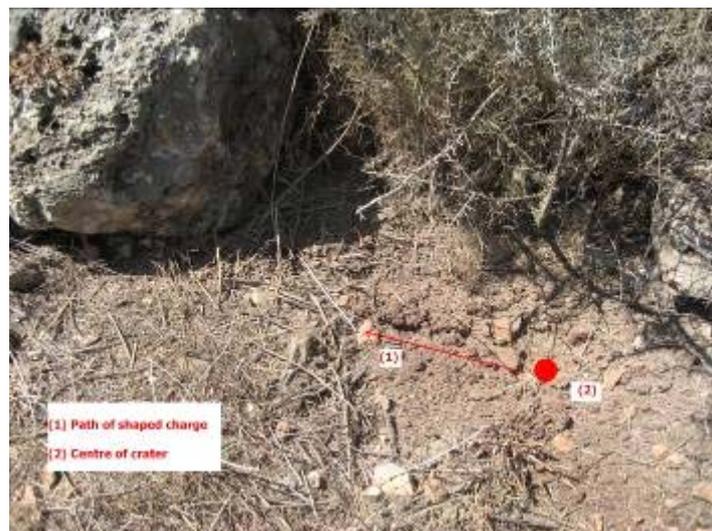
Photograph of Crater

48. Analysis of the crater suggests that the item was either partially or fully on the surface of the ground as with the majority of the items that have been found in the area. The crater clearly showed the path of the cone / shaped charge from the site of the detonation.
