# DDASaccident574

Humanitarian Demining Accident and Incident Database  
*AID*

# DDAS Accident Report

<b>Report date:</b> 13/06/2008	<b>Accident number:</b> 574
<b>Accident time:</b> 14:35	<b>Accident Date:</b> 15/04/1999
<b>Where it occurred:</b> Ba?ište, Kopaonik	<b>Country:</b> Serbia
<b>Primary cause:</b> Inadequate training (?)	<b>Secondary cause:</b> Other (?)
<b>Class:</b> Handling accident	<b>Date of main report:</b> None
<b>ID original source:</b> None	<b>Name of source:</b> Printed report
<b>Organisation:</b> [Name removed]	
<b>Mine/device:</b> BLU-97 submunition	<b>Ground condition:</b> not recorded
<b>Date record created:</b>	<b>Date last modified:</b> 13/06/2008
<b>No of victims:</b> 1	<b>No of documents:</b> 1

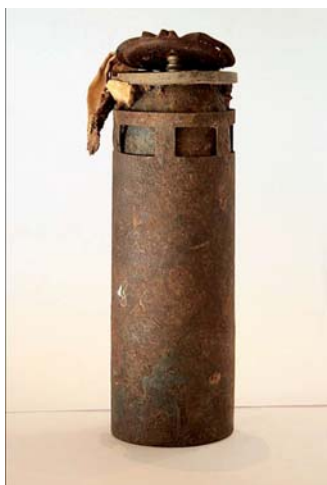
BLU-97 submunition, yellow paint removed by frequent burning of the grass

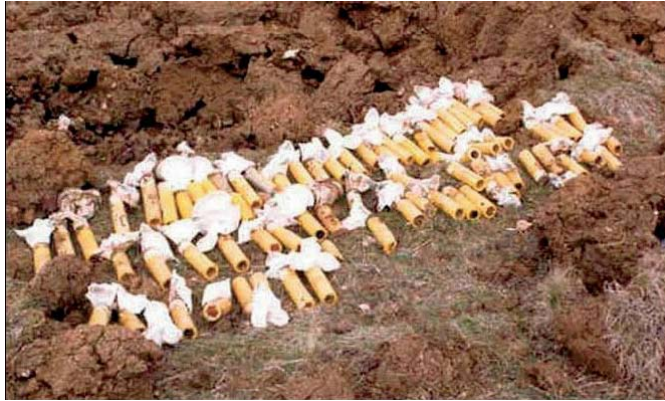
[EOD teams often collected BLU-97s by hand prior to destruction.]
