DDASaccident579

DDAS Accident Report

Report date: 14/06/2008	Accident number: 579
Accident time: 11:45	Accident Date: 26/11/2005
Where it occurred: Lutaya, 3.5 km West of Yei town	Country: Sudan
Primary cause: Field control inadequacy (?)	Secondary cause: Inadequate training (?)
Class: Excavation accident	Date of main report: 30/11/2005
ID original source: None	Name of source: UNMAO Sudan
Organisation: [Name removed]	
Mine/device: M14 AP blast	Ground condition: dry/dusty grass/grazing area hard metal fragments metal scrap
Date record created:	Date last modified: 14/06/2008
No of victims: 1	No of documents: 2

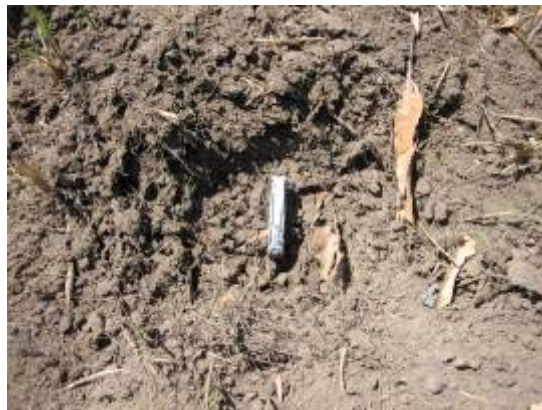
[Name removed] from UNMAS was informed 1 hour and 15 min after the time of the accident. He was taken to the accident site where he did his inquiries. The crater from the explosion is 30-40 cm away from the old crater. It is a small crater, 15 cm in diameter. The deminer's base stick was 20 cm behind the edge of the crater, one meter from the base lane. The handle of the deminers shovel was found 15m away from where he was working, the blade blown off. This confirms the deminer's story that he was excavating at the time of the accident. The size of the crater indicates a small AP blast mine. The blast has gone between the visor and the vest of the deminer.

Crater from detonation

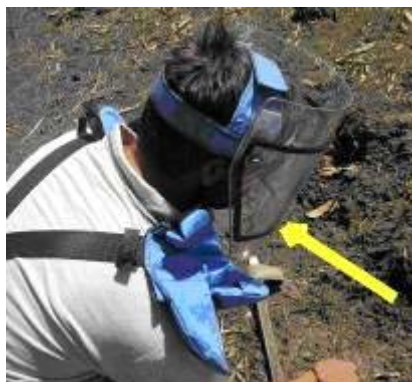
As for the facial injuries, a test done at the accident site show that it is possible to get a gap between the visor and the vest even if the PPE appears to be worn correctly.

Gap between visor and vest [See analysis]

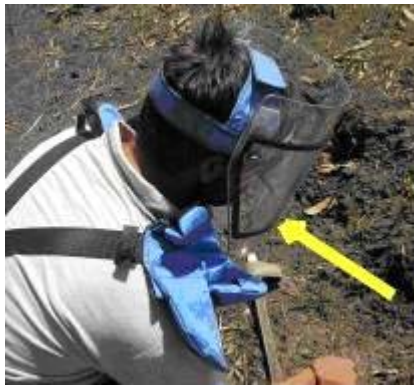
The supposed “proof” that environmental fragmentation could enter between the visor and the vest at an angle that allowed eyebrow injury while wearing the visor correctly illustrates the internal investigator’s lack of understanding about blast events. When an AP blast mine detonation occurs while a deminer is kneeling and excavating, the environmental fragmentation (earth and mine casing) strikes the visor face marginally before the blast wave. The blast wave may raise the visor, but it follow the fragments. The fragmentation is tumbling in the air but has forward momentum. If it has enough momentum to cause injury, that momentum imposes a direction that prevents any fragment turning sharply and heading in an entirely different direction.

This picture was included in the report to show how fragments could get between the visor and the vest. In fact it illustrates how it could not.

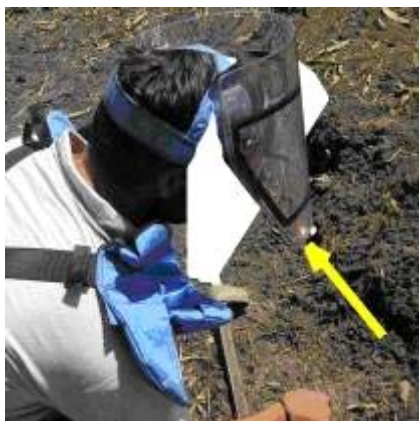
In order to strike the wearer’s face to the eyebrow, the deminer was wearing the visor raised in something more like this position. He was looking out from under it as he worked, and if he did not sustain eye injury that is because the M14 mine is very small (29g Tetryl) and he was lucky.
