DDAS Accident Report

Report date: 21/06/2008	Accident number: 581
Accident time: 07:58	Accident Date: 21/11/2007
Where it occurred: MF: A-Kurmuk, M/F NR 91, DA NR 286.	Country: Sudan
Primary cause: Field control inadequacy (?)	Secondary cause: Management/control inadequacy (?)
Class: Missed-mine accident	Date of main report: 05/12/2007
ID original source: None	Name of source: UNMAO Sudan
Organisation: [Name removed]	
Mine/device: PRB M35 AP blast	Ground condition: bushes/scrub dry/dusty sparse trees
Date record created:	Date last modified: 21/06/2008
No of victims: 1	No of documents: 2

Summary: At approximately 07:55hrs on 21 November 2007 a mine accident occurred within the hazardous area of Minefield NR 91 during operations being conducted as part of Task NR 206. The accident resulted in injuries being sustained by a member of the MCT 1 of the [Demining group]-II.

To Inquire Into The Circumstances Under Which [the Victim] Of [Demining group] Got Injured (Left Foot Heel) On 21 November 2007 In Minefield Area Due To The Mine Blast.

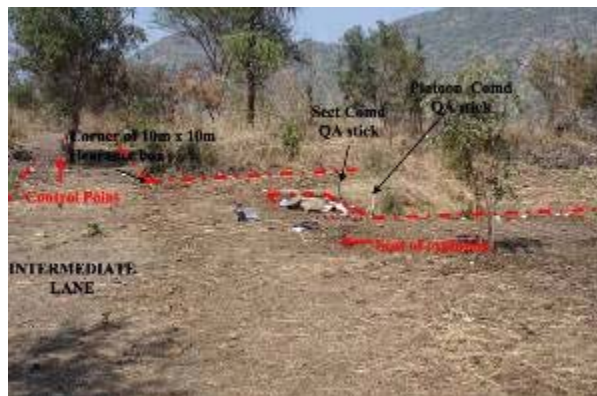
[The accident site after post-accident marking had been removed.]

Scene of Accident: When the PIT arrived at the scene of the accident there was initially a great deal of confusion and concern. The site marking encountered indicated that the specific spot of the accident had occurred within a hazardous area. After consultation and discussion with relevant appointments of the [Demining group]-II, it was determined that the scene of the accident had been interfered with and the marking stones moved. Following instructions from the NQAC, the site marking was restored.

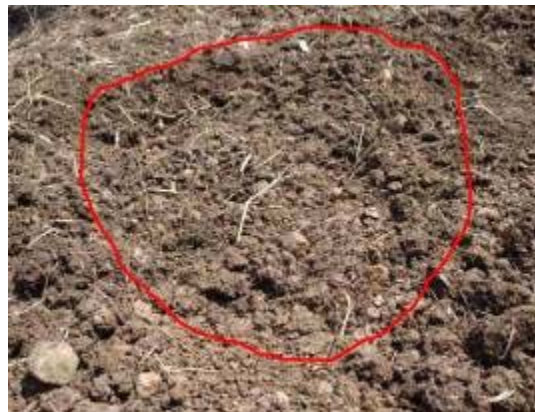
[The "crater" before excavation.]

The site was severely disrupted after the accident, presumably in the attempt to avoid censure. The disruption included moving the marking and the apparent levelling of the crater. AP mine blasts do not leave level loose ground that must be dug out to determine the depth of ground disturbance. Digging did not confirm the depth at which the mine had detonated. It did confirm that the undisturbed ground marked the depth of the original excavation, proving that the ground was not processed to the required depth during clearance. Because disturbed ground has more bulk than compacted ground, the actual depth of clearance was probably less than that measured.

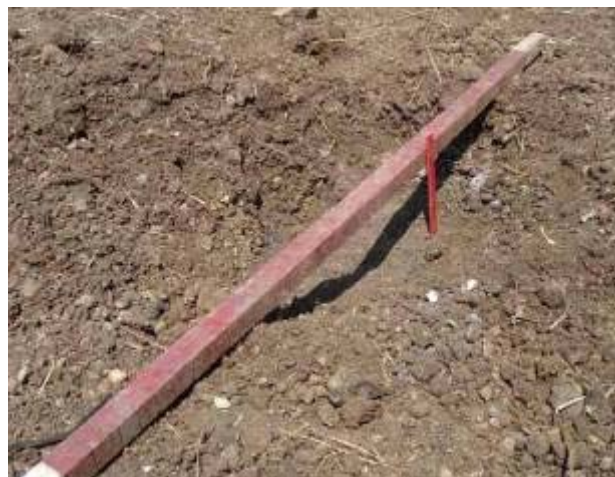
[The crater after excavation. See Analysis.]

4.1.1.2 That, from the investigation of the seat of the explosion, the floor of the crater caused by the explosion was at 18 cm below the surrounding ground level.

4.1.1.4 That, from an investigation of areas randomly chosen and within the immediate vicinity of the accident spot, required clearance depths were found to have been achieved i.e. 15cm.

The primary cause of this accident is listed as a "Field control inadequacy" because the investigation determined that the accident occurred on "cleared" land that had not been processed to the required depth. The demining group left inexperienced personnel in charge in the field and one of them was the Victim in the accident.
