DDASaccident584

DDAS Accident Report

Report date: 25/06/2008	Accident number: 584
Accident time: 12:45	Accident Date: 13/04/2008
Where it occurred: Sabha, Almafraq, Sabha1(392)	Country: Jordan
Primary cause: Other (?)	Secondary cause: Field control inadequacy (?)
Class: Missed-mine accident	Date of main report: 13/04/2008
ID original source: None	Name of source: Demining NGO involved
Organisation: [Name removed]	
Mine/device: M14 AP blast	Ground condition: rocks/stones
Date record created:	Date last modified: 25/06/2008
No of victims: 1	No of documents: 1

Preliminary Demining Incident Report

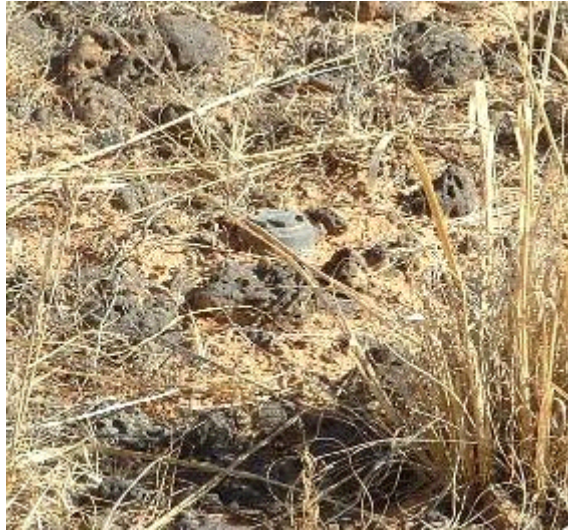
According to the preliminary investigation the incident is caused due to unpredictable risk (the mine is not in the predict depth and site) according to the Mine field record and laying pattern.

[Many mines are visible in the minefield.]

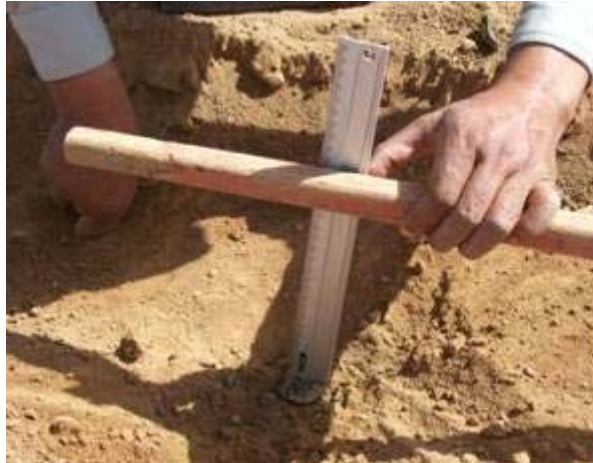
- i. All the mines around the cluster in the mine accident vicinity were on the surface and there is no indication for a water course or flood to support the suspicion that the mine deeply buried.
- ii. By investigating the site accident and gauged the distance from the explosion remnants (which represent the bottom of the mine) the depth was 17cm and if subtract the mine length (5cm) the result (12cm) represent the distance from the top of the mine to the surface (the depth of raking).

[Measuring crater depth]

The primary cause of this accident is listed as "Other" because it seems likely that the mine was either concealed too deeply to be found during the raking method used to clear breaches into the minefield, or the mine was deliberately moved into a cleared area. Calculating the depth of the mine by examining the crater is unreliable without a soil-hardness tester, so the

investigator's belief that it was deep is unproven. The ground was hard and rocky and most mines were either shallow or visible. Having examined the area myself, I can see no way that a single mine could have become deeply buried. This means that the deliberate replacement of one of the many mines that were visible surrounding the breaches in the minefield appears the most credible explanation of the presence of this mine in the centre of a well traversed area that had been cleared using rakes.

B. Conclusion.

- i. The mine maybe missed by the deminer as a result of not applying the required depth or by not applying the raking methodology standard especially raking tray.
- ii. To avoid a similar accident the raking depth must be applied by enforcing the internal QC from the Section commander up to the Ops Manager.
- iii. The areas around the clusters and in the expected [area] checked thoroughly and evaluated from the sector coordinator before continuing the work.

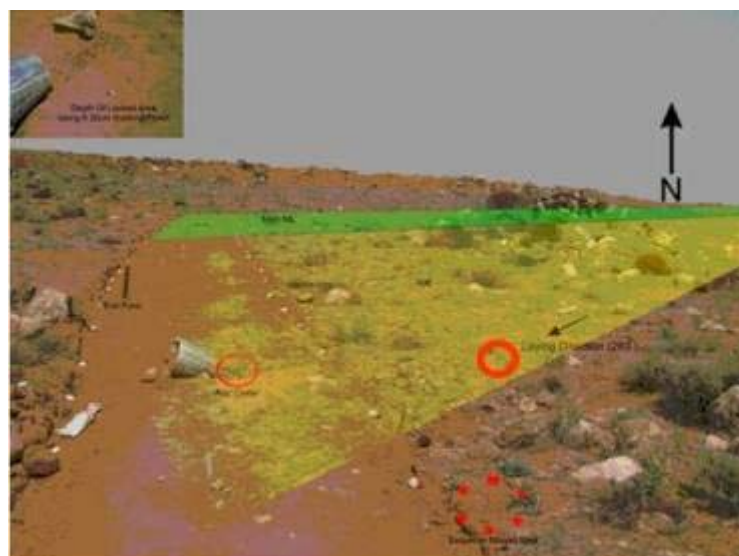
On 13 Apr 2008 the casual assign to continue the work in that lane as a part of SP to identify the turning point in that site and he recovered an AT (M19) mine and returned it to the mine pit after been defused by the section commander and proceeded his work and while he trying to move some stones out side the Lane in the area which supposed to be cleared he stepped on mine in his right foot.

[The accident site.]

1. Assumptions 1 and 2 controlled and the accident can be avoided by following the mentioned recommendations.
2. Assumption 2 is not controlled but following the mentioned recommendations the risk can be minimized and even if it's not reasonable it still assumption.
3. Assumption 2 is more likely represent the fact because the inputs for this assumption are more reasonable and the site investigations supporting it.

1. Reinforcing the internal QC.
2. Increasing the depth of raking in the site preparation stage to 20 cm.
3. Applying the missed mine drill.
4. disposing all the recovered mines by the end of the working day and if for any reason the mines need to be disposed later the mines must counted and sustained in a locked cage.
5. Issuing a written warning letter for in charge sector coordinator.
6. Replace the team leader and the section deminer.
7. Suspend the deminer who cleared the lane.
