DDAS Accident Report

Report date: 16/03/2011	Accident number: 586
Accident time: 05:55	Accident Date: 23/11/2002
Where it occurred: Task No.116, Kamchewai, Northern Red Sea Zone	Country: Eritrea
Primary cause: Inadequate training (?)	Secondary cause: Management/control inadequacy (?)
Class: Missed-mine accident	Date of main report: 07/12/2002
ID original source: AM HT	Name of source: MACC Eritrea
Organisation: [Name removed]	
Mine/device: AT (unrecorded)	Ground condition: dry/dusty grass/grazing area
Date record created:	Date last modified: 23/08/2010
No of victims: 8	No of documents: 3

FATAL INCIDENT REPORT, DEMINING INCIDENT AT KAMCHEWAY 23 NOVEMBER 2002 - AN ANTI TANK (AT) MINE MISSED BY THE MINE DETECTION DOG (MDD) TEAM

Demining Incident Preliminary Investigation Report for Submission to the Director of the [Demining group] and the Eritrean Demining Authority

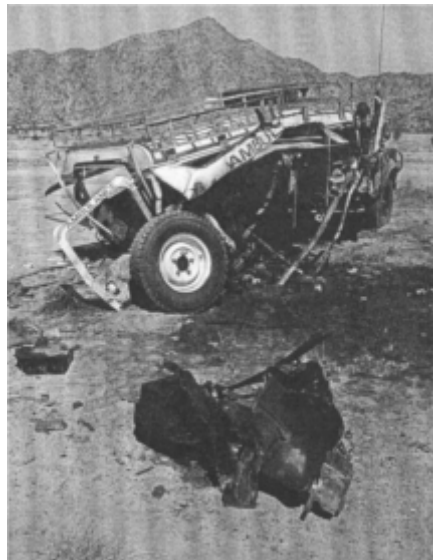
After studying the minefield maps which had been carried to, and retrieved from the scene it was possible to identify that the detonation had taken place within an area cleared by Manual deminers and Mine Detection Dogs (MDDs).

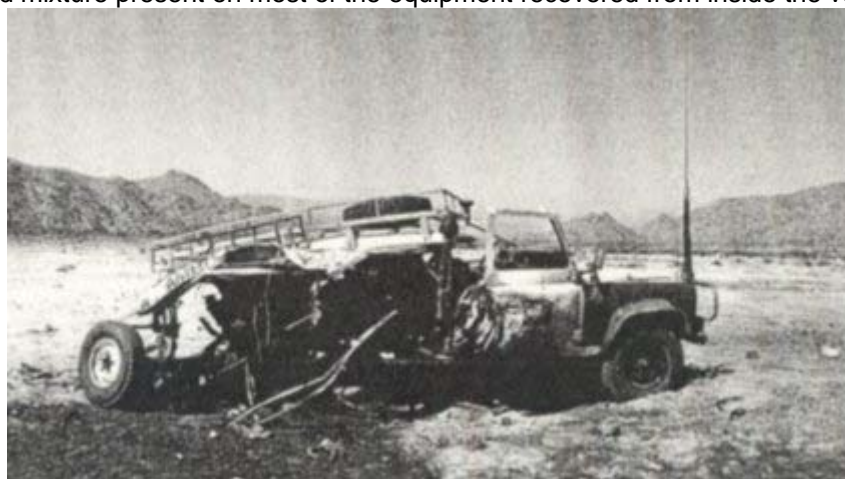
The rear right wheel of the Landrover 110 Ambulance detonated the AT mine. The vehicle was thrown through 180° coming to rest facing back in the direction it had come. The rear right wheel was completely destroyed, the axle had been forced upwards through an angle of more than 45°, the floor of the rear of the vehicle had been forced through a similar angle. The entire right hand side of the vehicle from the back door to the cab had been destroyed. The vehicle had buckled approx. midway along the chassis causing the roof above the cab to fold up and back. Team equipment such as detectors, tool bags, and marking rope reels that were being carried on the roof of the vehicle were thrown clear. The trauma bag (used by the medic at the scene) was recovered intact from the rear of the vehicle. Vests and visors removed from the interior of the vehicle were covered in a mixture of diesel and mud, some of the visors had broken headbands and fogged fronts. The demolition exploder case had been partially damaged and the exploder itself had shattered. The detonator boxes carried inside the detonator compartment built into the rear left frame of the vehicle (situated under the rear most seat on the left) were undamaged as was the compartment itself. The explosives box carried inside the rear of the vehicle was dented but otherwise intact. The second stretcher (orange, vinyl) also carried inside the vehicle was badly damaged and coated in the same diesel, mud mixture present on most of the equipment recovered from inside the vehicle.
