DDAS Accident Report

Report date: 16/03/2011	Accident number: 586
Accident time: 05:55	Accident Date: 23/11/2002
Where it occurred: Task No.116, Kamchewai, Northern Red Sea Zone	Country: Eritrea
Primary cause: Inadequate training (?)	Secondary cause: Management/control inadequacy (?)
Class: Missed-mine accident	Date of main report: 07/12/2002
ID original source: AM HT	Name of source: MACC Eritrea
Organisation: [Name removed]	
Mine/device: AT (unrecorded)	Ground condition: dry/dusty grass/grazing area
Date record created:	Date last modified: 23/08/2010
No of victims: 8	No of documents: 3

FATAL INCIDENT REPORT, DEMINING INCIDENT AT KAMCHEWAY 23 NOVEMBER 2002 - AN ANTI TANK (AT) MINE MISSED BY THE MINE DETECTION DOG (MDD) TEAM The [Demining group] Demining Incident, 23 November 2002

Demining Incident Preliminary Investigation Report for Submission to the Director of the [Demining group] and the Eritrean Demining Authority

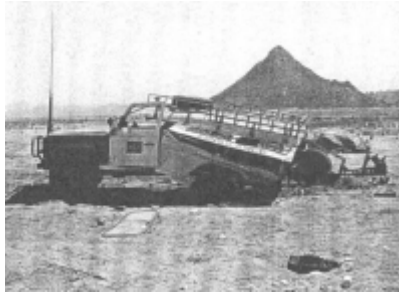
Before entering the minefield the general position of the 110 involved in the accident was established by binoculars from a distance of approximately 1.5 kilometres to the East.

The team then entered the minefield from the access route and along the main breach lane passing Administration/parking areas 1 and 2. It was evident from area 1 that the accident had occurred in a cleared area.

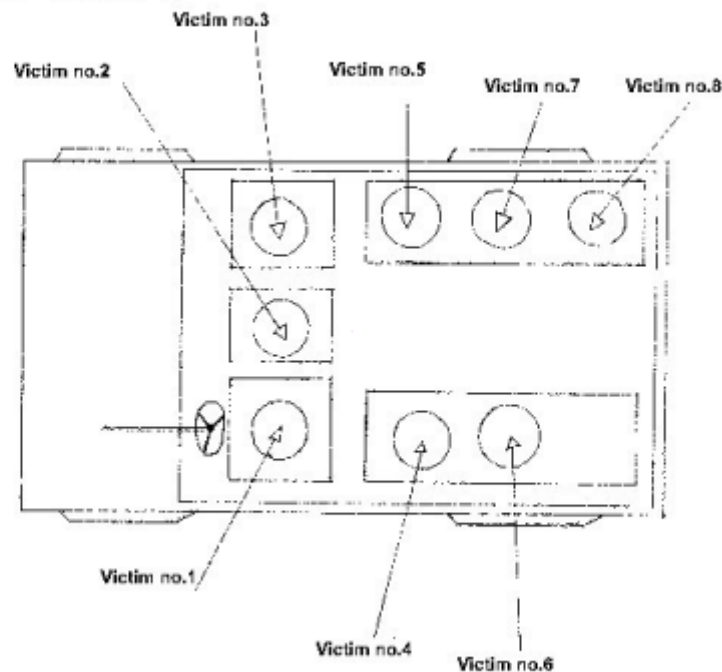
[Seating plan of vehicle – from an annex]

Eight people were travelling in the vehicle at the time of the accident. Three passengers died at the scene, one died on route to hospital, two were admitted to hospitals in Keren the remaining passengers were x-rayed at Keren Hospital and then sent to Asmara.
