DDAS Accident Report

Report date: 08/02/2011	Accident number: 589
Accident time: 12:05	Accident Date: 20/04/2010
Where it occurred: Jabir village, 3 (MF:476), Mafraq Region	Country: Jordan
Primary cause: Field control inadequacy (?)	Secondary cause: Unavoidable (?)
Class: Missed-mine accident	Date of main report: 29/04/2010
ID original source: None	Name of source: NPA Jordan
Organisation: [Name removed]	
Mine/device: M14 AP blast	Ground condition: dry/dusty grass/grazing area hard
Date record created:	Date last modified: 08/02/2011
No of victims: 1	No of documents: 2

Task Name: Jabir 3 (476), north border project, North SECTOR

FOR MINE INCIDENT Tuesday, 20 April 2010, EAST SECTOR, VILLAGE NAME: JABIR

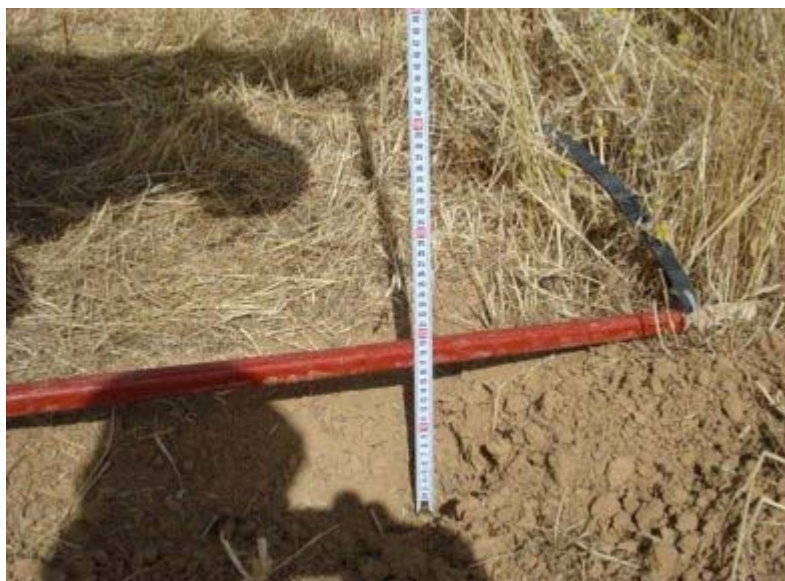
17) Comments (include measurements of any crater resulting from the explosion): Crater Depth: approx. 17 cm / Width: approx. 45 cm

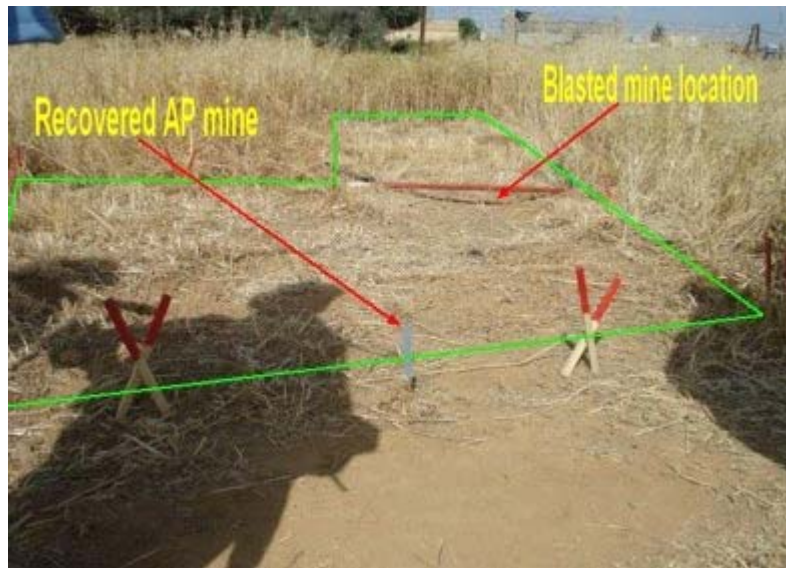
18. Describe the conditions at the site at time of the incident

Ground/Terrain: Hard, flat

Weather: Clear, mild

Vegetation: Light, grass

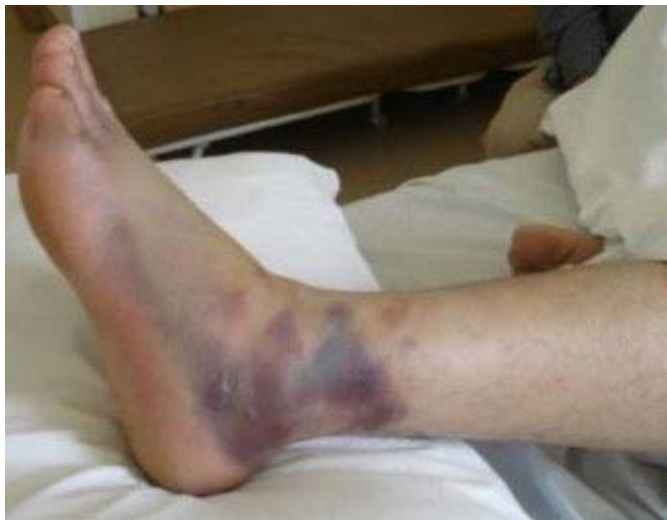
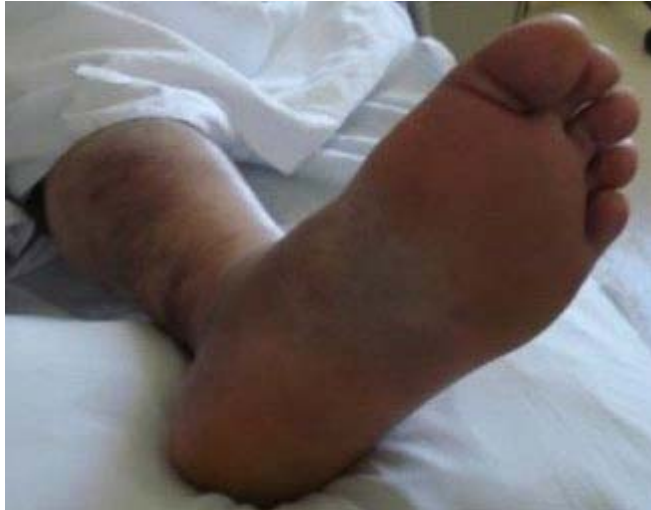
No formal Medical report was made available, but the photographs below show the injured foot with bruising where the shock wave exited the limb and no obvious injury where it entered.

The bruising on the top of the Victim’s foot where the shock wave left the leg and moved into air may be of interest to manufacturer’s of blast boots. It was not where the shockwave entered the foot that the flesh damage occurred, but where it left. This phenomenon can be observed in several other missed-mine accidents.

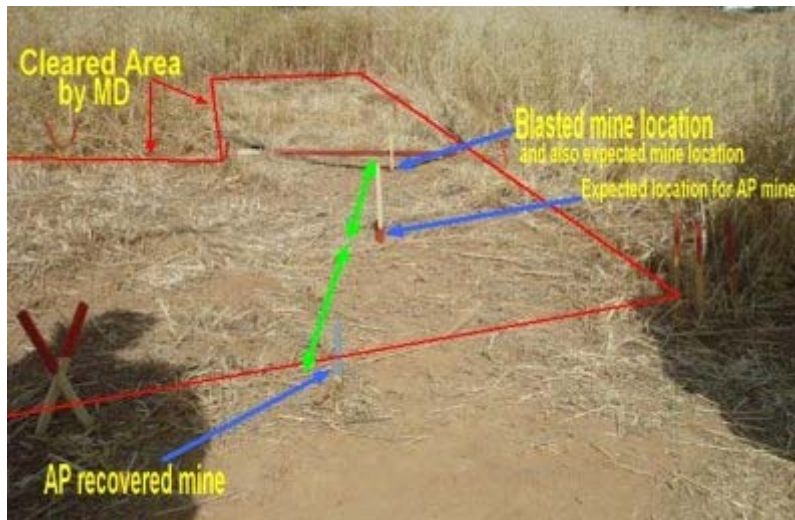
The primary cause of this accident is listed as a *Field Control Inadequacy* because the Victim was a field supervisor and failed to order the missing-mine drill to be used when the mine was not found where expected. This was apparently because he failed to recognise the direction of the mine-laying pattern and so be able to predict where a mine was missing. It may be that the direction of the pattern only became obvious after the accident revealed the position of a second mine in the pattern, so the secondary cause is listed as "*Unavoidable*".

The detectors in use could locate the minimum-metal M14 at 15cm (which is good) but not reliably at greater depth. The area had been traversed and QA checked with metal-detectors several times without a detector signaling, so it is unlikely that a detector failure was the cause of the mine being missed. Rather, it seems that the mine was too deep to be located with any metal detector. It is unfortunate that the MDD used in the area stopped just a short way from the accident site, as shown in the captions on the picture below.

It is recommended to take necessary disciplinary action against the team leader once he rejoins after his medical leave.
