DDAS Accident Report

Report date: 08/02/2011	Accident number: 589
Accident time: 12:05	Accident Date: 20/04/2010
Where it occurred: Jabir village, 3 (MF:476), Mafraq Region	Country: Jordan
Primary cause: Field control inadequacy (?)	Secondary cause: Unavoidable (?)
Class: Missed-mine accident	Date of main report: 29/04/2010
ID original source: None	Name of source: NPA Jordan
Organisation: [Name removed]	
Mine/device: M14 AP blast	Ground condition: dry/dusty grass/grazing area hard
Date record created:	Date last modified: 08/02/2011
No of victims: 1	No of documents: 2

Task Name: Jabir 3 (476), north border project, North SECTOR

IMSMA DETAILED REPORT

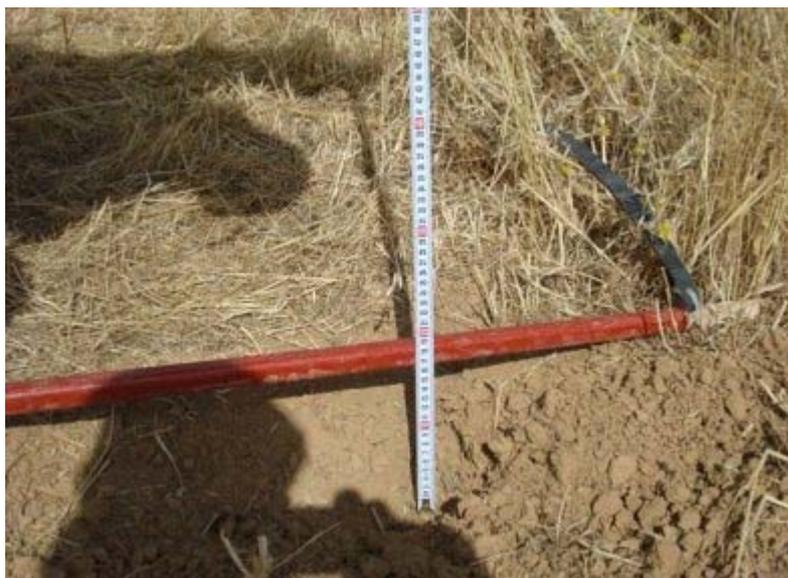
17) Comments (include measurements of any crater resulting from the explosion): Crater Depth: approx. 17 cm / Width: approx. 45 cm

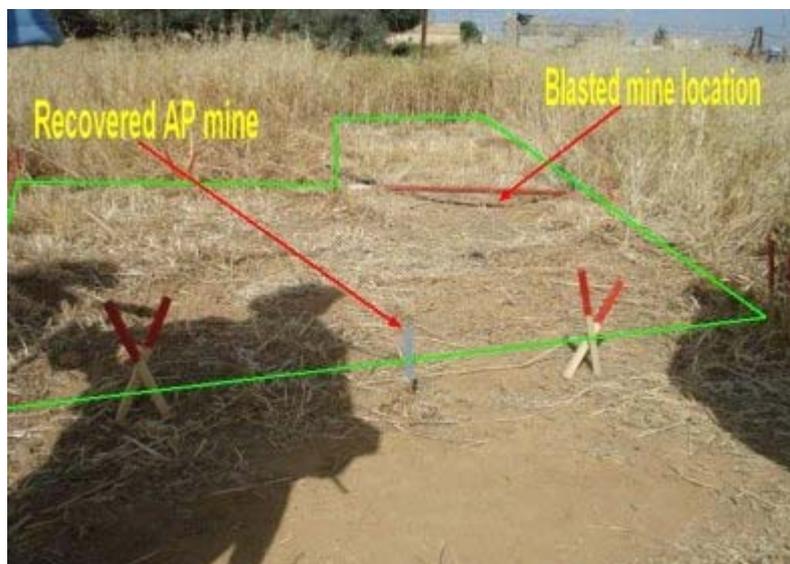
Ground/Terrain: Hard, flat

Vegetation: Light, grass

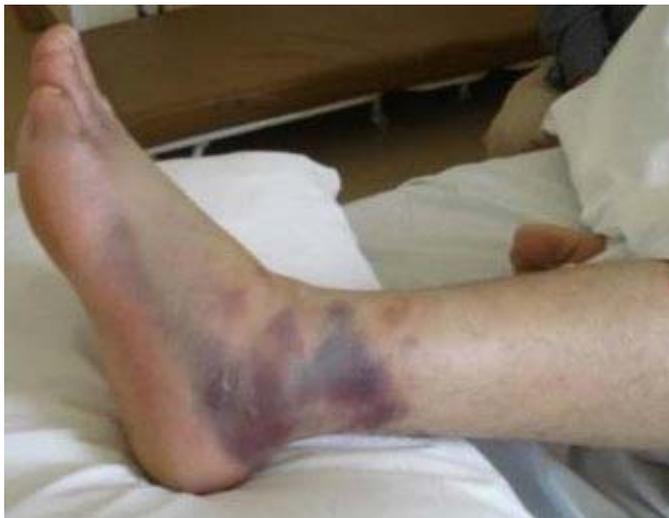
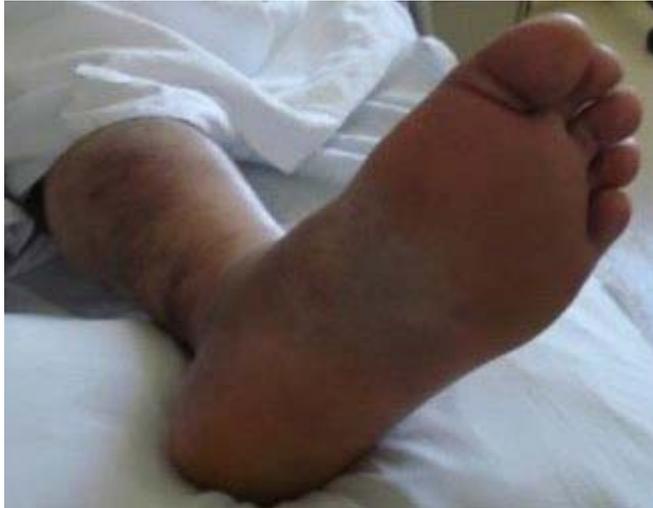
COMMENT: Fracture in left ankle. See Medical report.

No formal Medical report was made available, but the photographs below show the injured foot with bruising where the shock wave exited the limb and no obvious injury where it entered.

The bruising on the top of the Victim’s foot where the shock wave left the leg and moved into air may be of interest to manufacturer’s of blast boots. It was not where the shockwave entered the foot that the flesh damage occurred, but where it left. This phenomenon can be observed in several other missed-mine accidents.

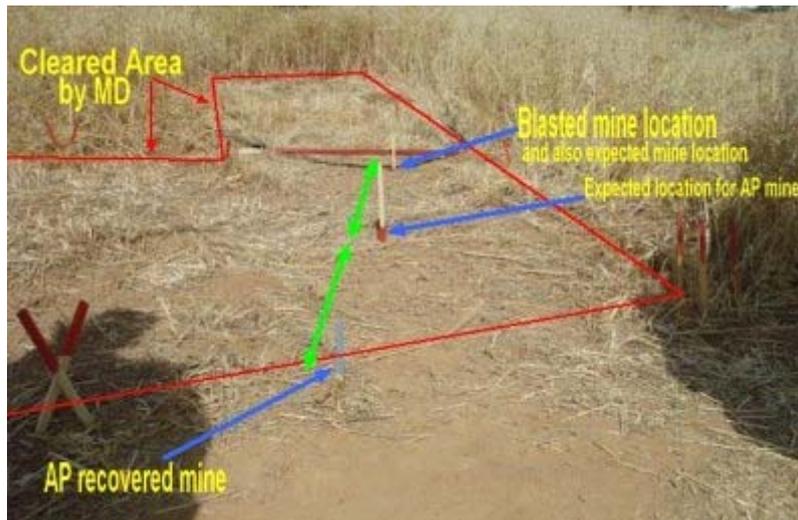
Missing mine drill was not applied in the accident area as per as our standards which lead to the accident.

The primary cause of this accident is listed as a *Field Control Inadequacy* because the Victim was a field supervisor and failed to order the missing-mine drill to be used when the mine was not found where expected. This was apparently because he failed to recognise the direction of the mine-laying pattern and so be able to predict where a mine was missing. It may be that the direction of the pattern only became obvious after the accident revealed the position of a second mine in the pattern, so the secondary cause is listed as "*Unavoidable*".

The detectors in use could locate the minimum-metal M14 at 15cm (which is good) but not reliably at greater depth. The area had been traversed and QA checked with metal-detectors several times without a detector signaling, so it is unlikely that a detector failure was the cause of the mine being missed. Rather, it seems that the mine was too deep to be located with any metal detector. It is unfortunate that the MDD used in the area stopped just a short way from the accident site, as shown in the captions on the picture below.

It is recommended to take necessary disciplinary action against the team leader once he rejoins after his medical leave.
