# DDASaccident595

# DDAS Accident Report

Subject: investigation Report & Lessons Learned of [Demining group] DT# 23 Demining Accident

## **LESSONS LEARNED SUMMARY OF [Demining group] DT-23 DEMINING ACCIDENT**

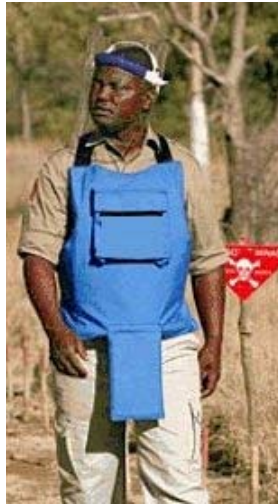
The primary cause of this accident is listed as a "*Field Control Inadequacy*" because the Victim's facial injuries imply that he was working with his visor raised and this error was not corrected. The secondary cause is listed as "*Inadequate equipment*" because the demining group's body-armour PPE does not include a collar that interfaces with the visor and stops blast getting beneath the visor (despite the requirements of IMAS 10.30).

*Typical frontal apron used by this demining group.*

While it is unlikely that the visor would have twisted and “broken down” if worn correctly, it is possible that the frontal body armour channeled the blast beneath the visor and caused unusual damage. The hand-tool “chisel” was also in breach of IMAS 10.30 and placed his hand too close to the blast so that a traumatic amputation occurred, so it was also “Inadequate equipment”. Because both the PPE and the hand-tool are “approved” by the UNMACCA, severe *Management Control Inadequacies* extend to that control group.
