DDASaccident597

Humanitarian Demining Accident and Incident Database
AID

DDAS Accident Report

United Nation Mine Action Office, Kurmuk 10/06/2006 Incident Report

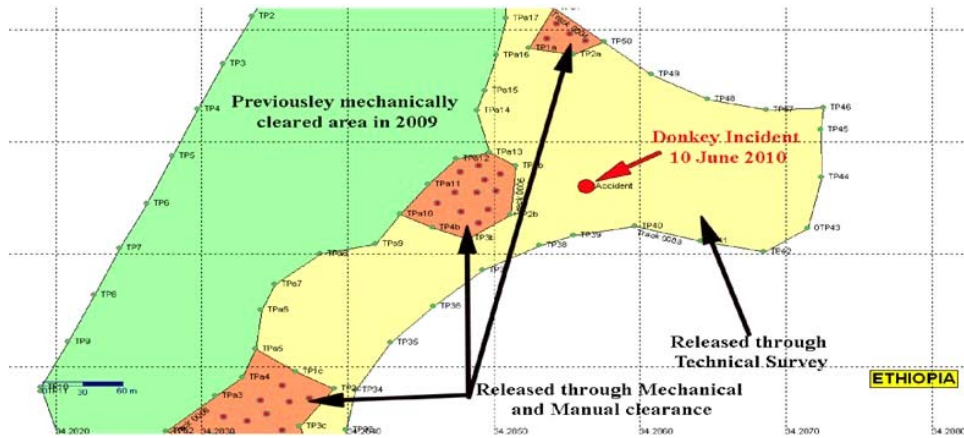
Figure 2: The completion map with areas marked as released through clearance (green and red) and released through technical survey (yellow)

The high threat flat area to the south east of the gully (see Figure 1 above) was cleared using the tiller of Armtrac 100 as was a flat area to the west of the gully. No mines or evidence of mine / ERW was found while operating the Armtrac in the flat areas above the gully. As a result, a decision was made [for Demining group] to release the land in the flat areas through technical survey in the completion report (see Figure 2).

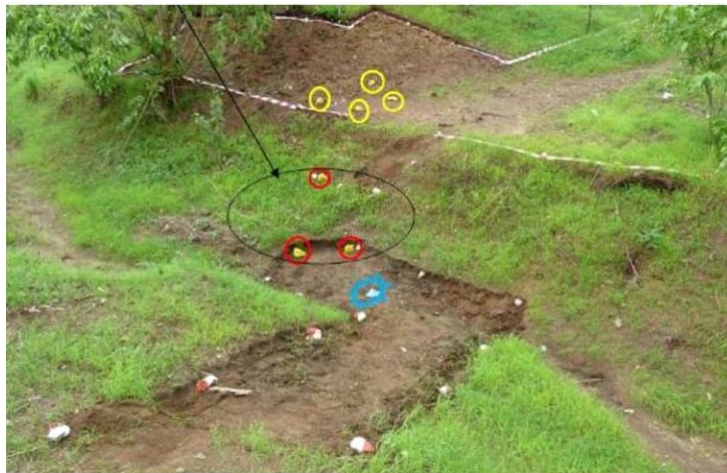
The floor of the gully was covered in silt but in the area where the detonation took place a number of large rocks could be seen sitting on a shoulder of silt at a greater height than the floor of the gully. There could be seen a line in the side of the gully of where recent erosion had taken place confirming that the water was eroding the gully sides with downwash of rain.

Picture 1: Photograph of the incident site with the donkey incident (blue) and seven mines (red and yellow circles) found during the subsequent clearance. Photo taken on 18th June 2010.

1.3 The accident area has been partially cleared during the initial clearance operations using a 1 metre MDD search lane going on the bottom of the gully. The entire gully has not been searched initially due to the misunderstanding of the MDD team leader and his failure to report and seek further advice from and the team managers. The fact that the gully has only

[Name removed], the UNMAO MDD QA Officer, visited MDD clearance operations during the clearance of that gully on 24th March 2010 with no adverse comments on the QA side. Having looked at the accident photos, [the QA Officer] confirms that the gully shape has changed from what it was in March 2010.

When the site was revisited again on Wednesday 16th June with the NMAC Damazin, [Demining group] and UNMAO Damazin personnel, changes were observed in the shape of the gully between the first visit on 14th June and 16th June. A serious rain storm on the night of the 15th June changed the shape and more erosion could be seen at the bottom of the gully.

2.2. Any gully identified in the future that have had accidents reported in them (i.e. are high threat) or is suspected by local community members, shall be subjected to full search from bottom to top and out on the shoulders to at least 5 metres away from the top edges of both sides. If dogs cannot be used, then manual, mechanical or a combination thereof shall be used.

2.8. It is recommended that [Demining group] continues clearing the area around the incident and the mines until they achieve 10 x 10 metres (as per the NSTGs Chapter 26 on Land

Release) around each mine found, and as per paragraph 4.2 above. The entire gulley shall be treated as a high threat area.
