DDASaccident597

DDAS Accident Report

United Nation Mine Action Office, Kurmuk 10/06/2006 Incident Report

Incident Location: Kurmuk, Blue Nile State

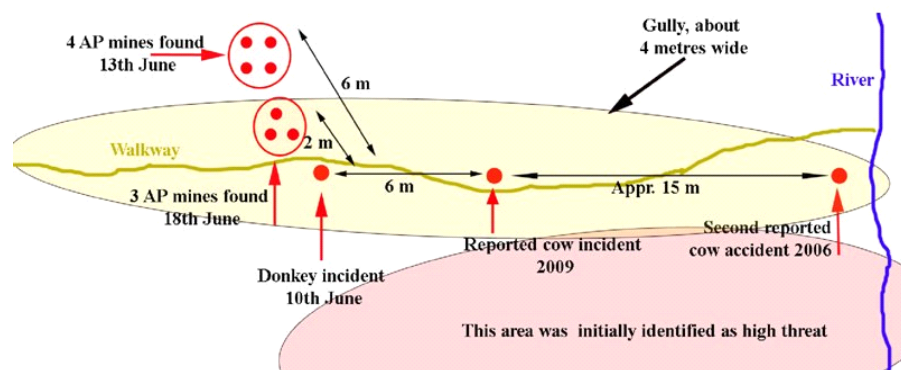
Figure 1: Schematic of the incident area and around it.

The gully where the incident took place has been used as a walk way for local people to collect water from the river, at the end of the gully. Near the river, a clear path could be seen where people would walk around to gain access to the river since the gully came to a sudden drop into the river and was too steep to walk down. The gully sides showed clear signs that over the years that water rushing down the gully had in time eroded the sides creating now what is a sizeable wide gully.

During the reconnaissance phase of task NR 553 in March 2010, [Four names removed] (IMCT team leader) stood at the river at the end of the gully and pointed out that a cow accident took place in the gully in 2009. A verbal decision was made that the gully was a high threat area along with the open area to the south-east of it.

The high threat flat area to the south east of the gully (see Figure 1 above) was cleared using the tiller of Armtrac 100 as was a flat area to the west of the gully. No mines or evidence of mine / ERW was found while operating the Armtrac in the flat areas above the gully. As a result, a decision was made [for Demining group] to release the land in the flat areas through technical survey in the completion report (see Figure 2).

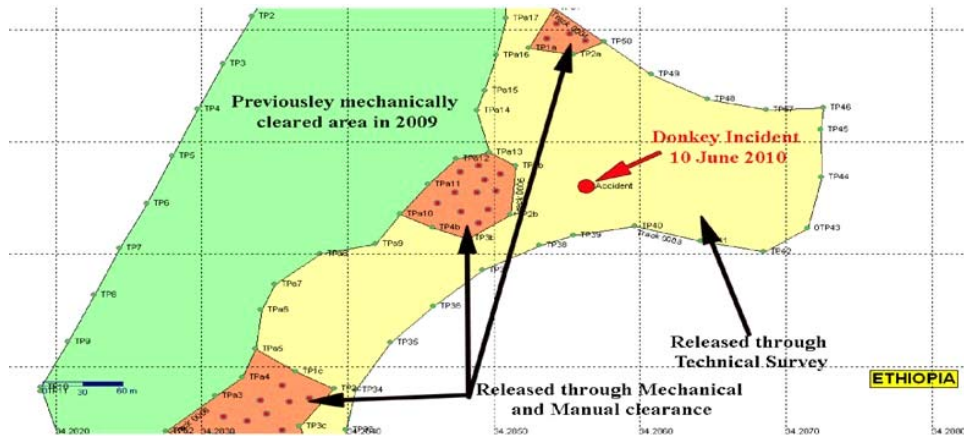
Figure 2: The completion map with areas marked as released through clearance (green and red) and released through technical survey (yellow)

That the UNMAO accepted the mechanical processing of the area outside the gulley as “clearance” is disturbing because it is widely recognized that mechanical processing is not equal to “clearance” as defined in the IMAS.

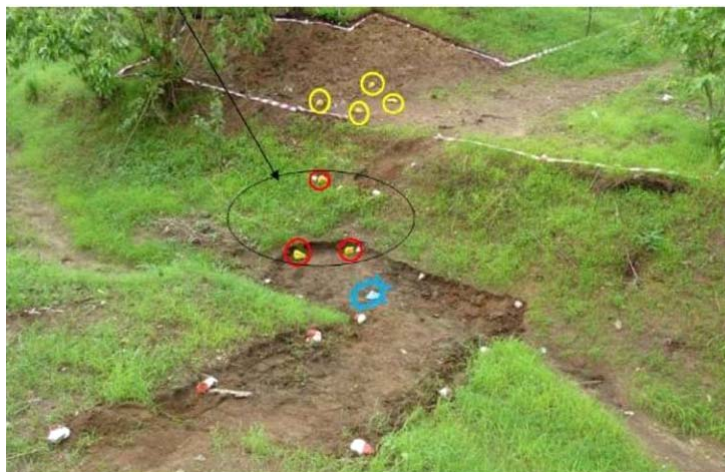
The floor of the gully was covered in silt but in the area where the detonation took place a number of large rocks could be seen sitting on a shoulder of silt at a greater height than the floor of the gully. There could be seen a line in the side of the gully of where recent erosion had taken place confirming that the water was eroding the gully sides with downwash of rain.

Picture 1: Photograph of the incident site with the donkey incident (blue) and seven mines (red and yellow circles) found during the subsequent clearance. Photo taken on 18th June 2010.

1.3 The accident area has been partially cleared during the initial clearance operations using a 1 metre MDD search lane going on the bottom of the gully. The entire gully has not been searched initially due to the misunderstanding of the MDD team leader and his failure to report and seek further advice from and the team managers. The fact that the gully has only

[Name removed], the UNMAO MDD QA Officer, visited MDD clearance operations during the clearance of that gully on 24th March 2010 with no adverse comments on the QA side. Having looked at the accident photos, [the QA Officer] confirms that the gully shape has changed from what it was in March 2010.

When the site was revisited again on Wednesday 16th June with the NMAC Damazin, [Demining group] and UNMAO Damazin personnel, changes were observed in the shape of the gully between the first visit on 14th June and 16th June. A serious rain storm on the night of the 15th June changed the shape and more erosion could be seen at the bottom of the gully.

The large number of mines found in an area recently released as “Cleared” is evidence of inadequate management at all levels.

2.2. Any gully identified in the future that have had accidents reported in them (i.e. are high threat) or is suspected by local community members, shall be subjected to full search from bottom to top and out on the shoulders to at least 5 metres away from the top edges of both sides. If dogs cannot be used, then manual, mechanical or a combination thereof shall be used.

2.8. It is recommended that [Demining group] continues clearing the area around the incident and the mines until they achieve 10 x 10 metres (as per the NSTGs Chapter 26 on Land

Release) around each mine found, and as per paragraph 4.2 above. The entire gulley shall be treated as a high threat area.
