# DDAS Accident Report

## **INCIDENT INVESTIGATION FOR [demining group] – MINE ACTION TEAM - JORDAN**

TASK NAME JABIR 3 (369B), NORTH BORDER PROJECT, EAST SECTOR

### **IMSMA DETAILED REPORT FOR MINE INCIDENT Monday, 1 Feb 2010**

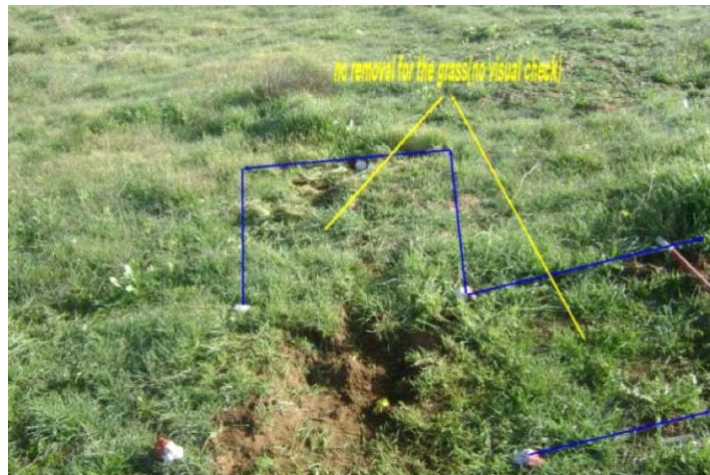
Mine Blast Location

During the recovery of AP mine deminer hit the mine with the heavy RAKE which initiate the mine and caused the incident.

Crater Depth: approx. 13 cm / Width: approx. 25 cm

Ground/Terrain: Medium hard, Flat

Vegetation: Heavy grass

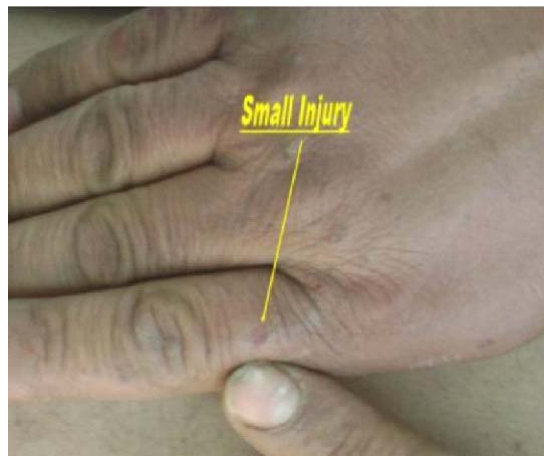
Injury

NATURE OF INJURY: Multiple Superficial Scratches in the Right hand

10. Did the incident result in any injuries? Yes.
11. List people injured and nature of injury: [Name removed, the Victim, deminer]: Multiple Superficial Scratches in his right hand.

INJURIES: minor Hand
