DDASaccident622

DDAS Accident Report

INCIDENT INVESTIGATION FOR [Demining group] – MINE ACTION TEAM - JORDAN

TASK NAME SABHA 7 (394)

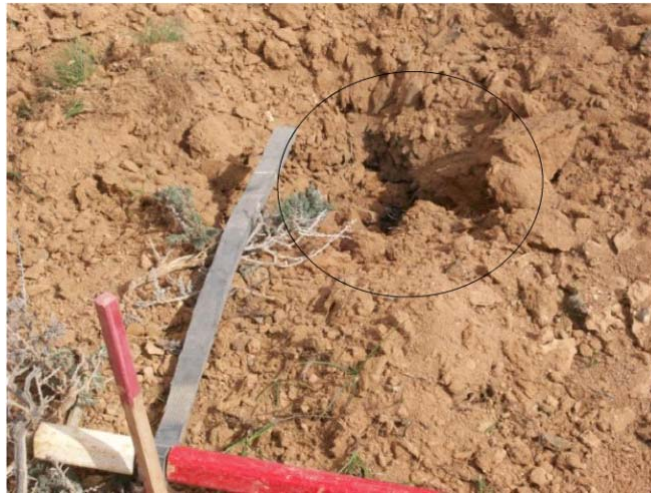
While the deminer was working in investigating a signal indicated by the metal detector in a Scattered Mine Line (SML) in Sabha 7 using the Heavy RAKE , an M14 activated by pressing the pressure plate

17. Comments (include measurements of any crater resulting from the explosion): Crater
Depth: approx. 15 cm / Width: approx. 40 cm

[The accident site.]

According to the preliminary investigation the incident is caused due an individual mistake that the deminer according to the SOP have to use first off all the Light RAKE to investigate the signal), then if there is a need to use the heavy RAKE he have to approach it 15 cm from the side and 15 cm from the front with a 15 cm depth (which was not followed properly) and instead of that he hack the mine from the centre of the signal.

From the investigation it is obvious that the Team Leader and section commander didn't apply the proper supervision for the work methodology and marking system and the internal QA. The team already refreshed to follow up the MD proper procedure for one day after the accident.

The team leader, section commander and the deminer will be warned for breaking the SOP.
