DDASaccident625

DDAS Accident Report

INCIDENT INVESTIGATION FOR [Demining group] – MINE ACTION TEAM - JORDAN

TASK NAME: JABIR 1 (477), NORTH BORDER PROJECT. EAST SECTOR

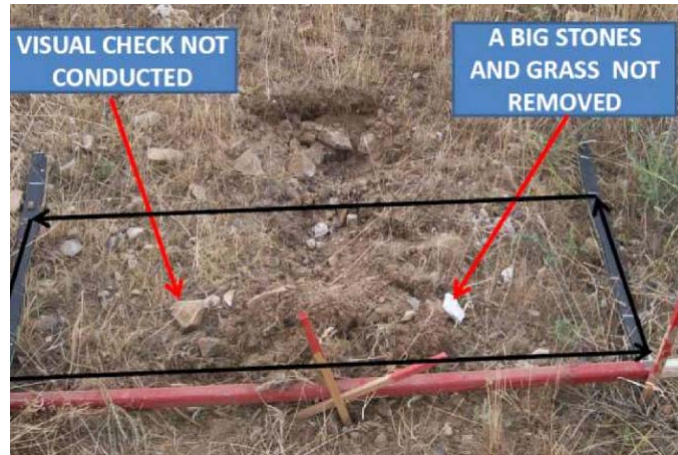
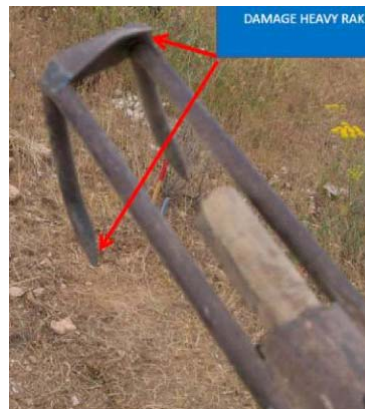
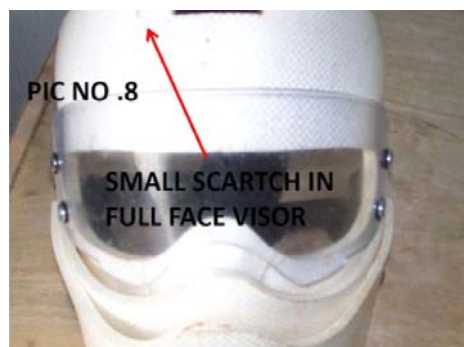
1. The deminer didn't use the light rake.
2. He didn't make the visual check because there were stones in the clearance box.
3. The deminer checked the signal out of the box and it was 70 cm from the base stick.
4. The base stick is in the right place.

5. He didn't do the right procedures in cutting grass and removing loose stones according to the SOP.
6. The area is hard with lots of stones which mean to be careful in using the heavy rake.
7. The depth of crater is 18 cm and the mine was on 13 cm depth.
8. He started progressing from the right side then he took it from the front which is wrong and caused a mine blast.
9. The heavy rake has been damaged because of the blast.
10. The marking sticks are put in the right place according to SOP.

1. The Deminer didn't follow the right drill before searching the mine.(visual check and clearing the loose stones in the clearance box).
2. The area is grassy and hard hence light rake is not effective.
3. He shouldn't check beyond 50 cm from the base stick (one clearance box) but he extended the search up to 70cm.
4. The mine blast incident occurred due to the individual mistake of doing wrong drills.

It is strongly recommended to issue a written warning to the deminer for not following the right procedure and drill which resulted in the mine blast incident.
